## 2 Survey of granite gables

A photographic survey was made of granite gable walls on a number of mornings following overnight rain to determine the patterns of wetting on their surface relative to weather conditions, façade orientation and façade design details. Weather conditions during the previous night were obtained from the Meteorological Office (Table 2.1).

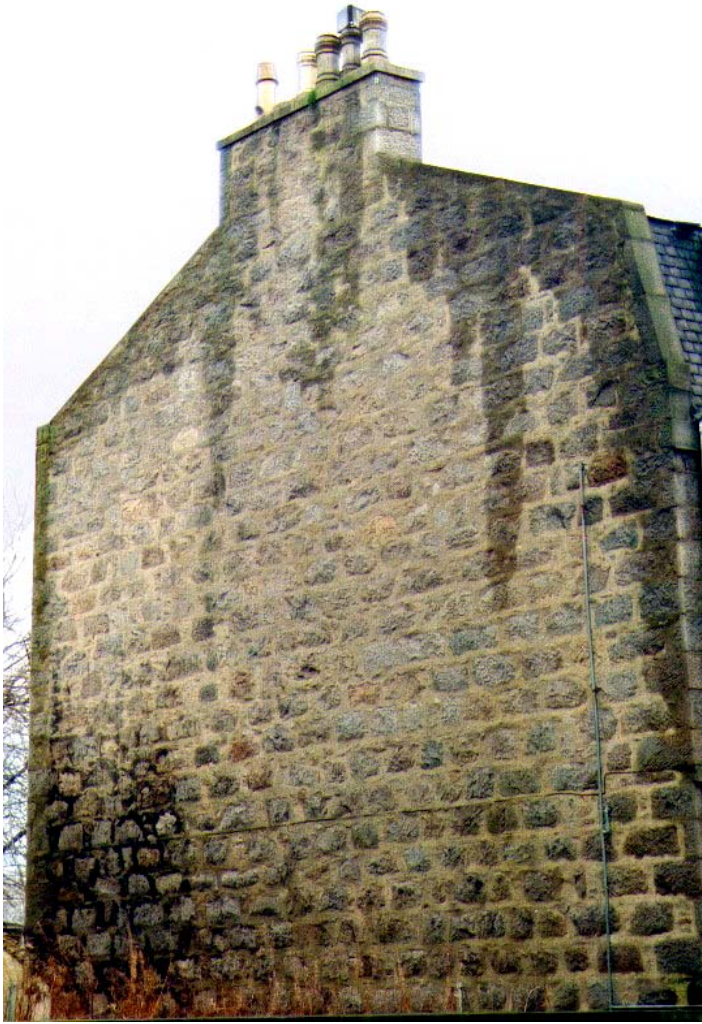
*Plate 2.1 Typical, simple granite gable. Three storeys in height with no detailing except a slightly projecting coping at the top of the chimney. This gable shows a typical wetting pattern from moderate rainfall with wetting of chimney, wall tops and corners. Run-off from these areas gradually extends down the gable.*

Wind driven rain most commonly impacts on façades at chimneys, corners and wall tops (Plate 2.1) because of changing patterns of air flow at these locations. However, irregularities and features on gables can affect distribution of damp patches (Plate 2.6). Many gables lack any features to control rainwater run off. Most of the gables in this study (approx. 80%) had copings flush with the wall, with only the chimney coping projecting (Plate 2.1). This is typical of many granite gables in Aberdeen. Approximately 20% of gables had projecting copings at roof level (Plate 2.2) and other features including string courses across the façade and/or at the chimney base (Plate 2.3). The features had some influence on the location of wetness although there was no difference in the mean amount of wetness observed on gables (36% for those with and without projecting copings and other details).

Wetting of gables begins from the upper surfaces and spreads downwards, wetting the sides more rapidly than the central area (Plate 2.1). If rainfall continues for a sufficiently long period, most or all of the gable will be wetted, however some areas dry relatively rapidly. Rapidly drying patches were noted on a number of gables appearing to correspond to the locations of fire places and flues (Plates 2.4 & 2.7) and or rooms (Plate 2.8) within the building. It is presumably heat loss through the wall that results in rapid drying in these locations. Outwith areas subject to rapid drying, the granite surface (due to its lower moisture capacity) dries before pointing (Plates 2.9 to 2.12). As the pointing dries it is clear that more moisture has been retained in and around cracks in the pointing.

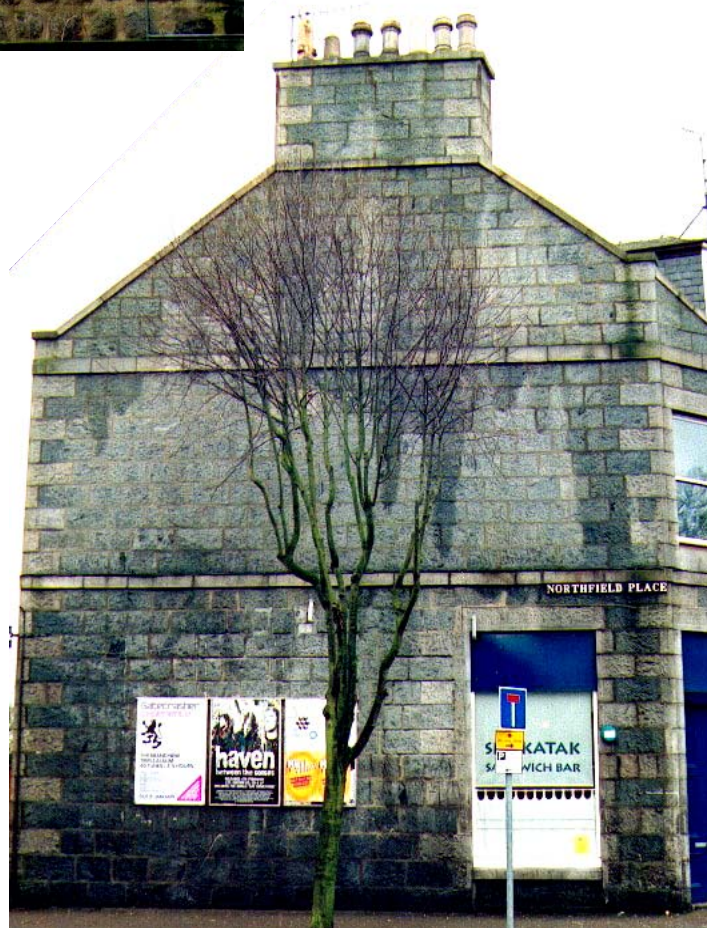
*Plate 2.2 This granite gable has two string courses.*

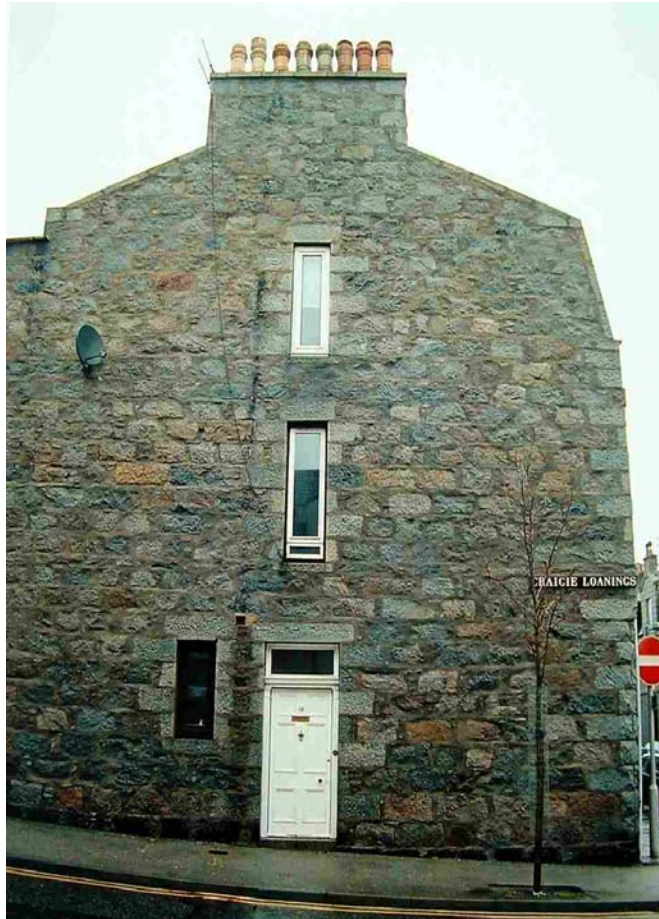
Plate 2.3 A simple granite gable with door and window openings. With the exception of the chimney coping and a satellite dish there are no projecting elements.

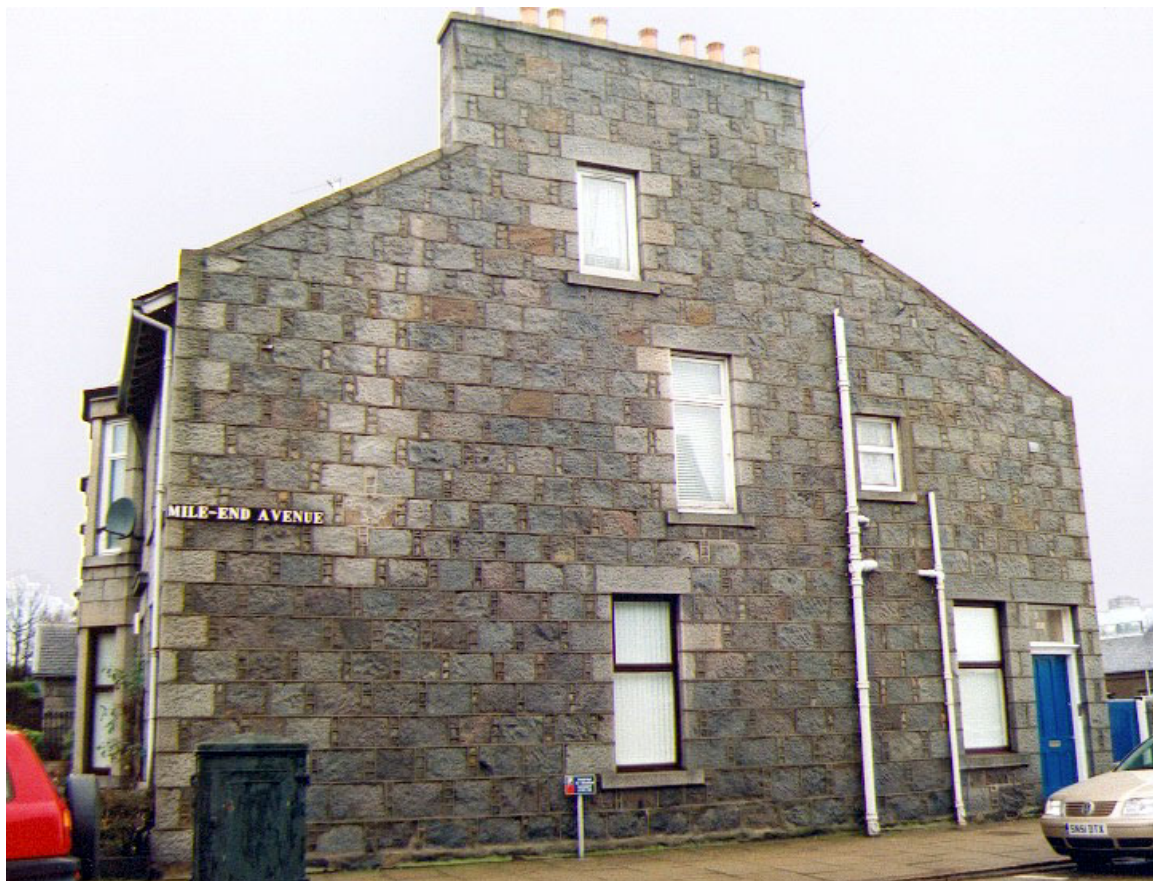
Plate 2.4 The irregularly distributed windows on this gable have projecting cills. Downpipes also project from the surface. The dry patch towards the left side is likely to indicate the presence of a working fireplace.

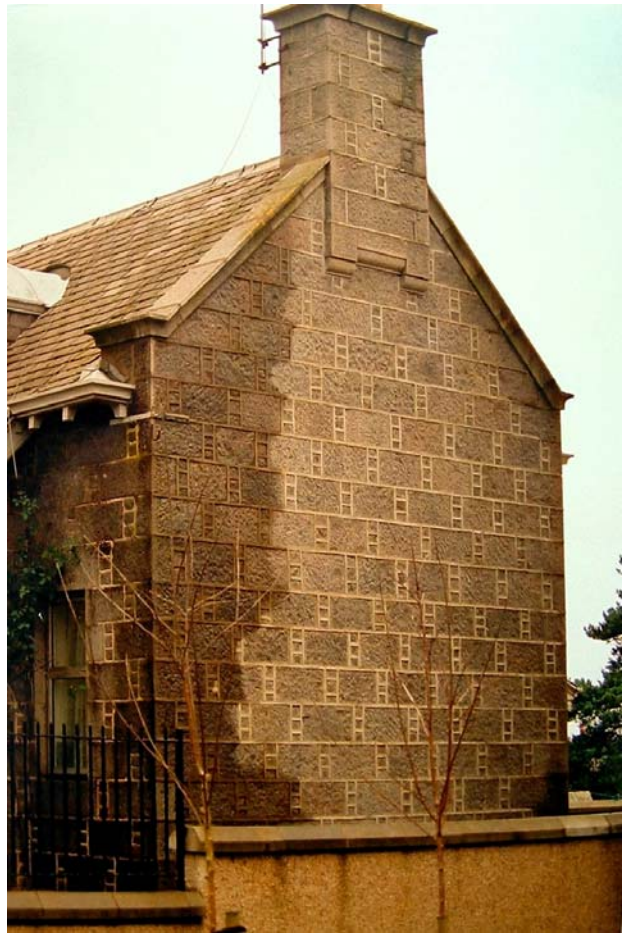
In most instances, pointing was flush with the stone surface, but some gables have been repointed using ribbon (or tuck) pointing where the pointing mortar stands proud of the surface (Plate 2.5). This technique is deprecated since it slows down the run-off of rainwater over the stone surface. The projecting pointing diverts water flow along the top surface of the pointing increasing the likelihood of penetration into the joint.

Plate 2.5 The more complex detailing on the coping and below the chimney is a rare feature of granite gables in Aberdeen. This gable has been repointed using ribbon (or tuck) pointing where the pointing mortar stands proud of the surface.

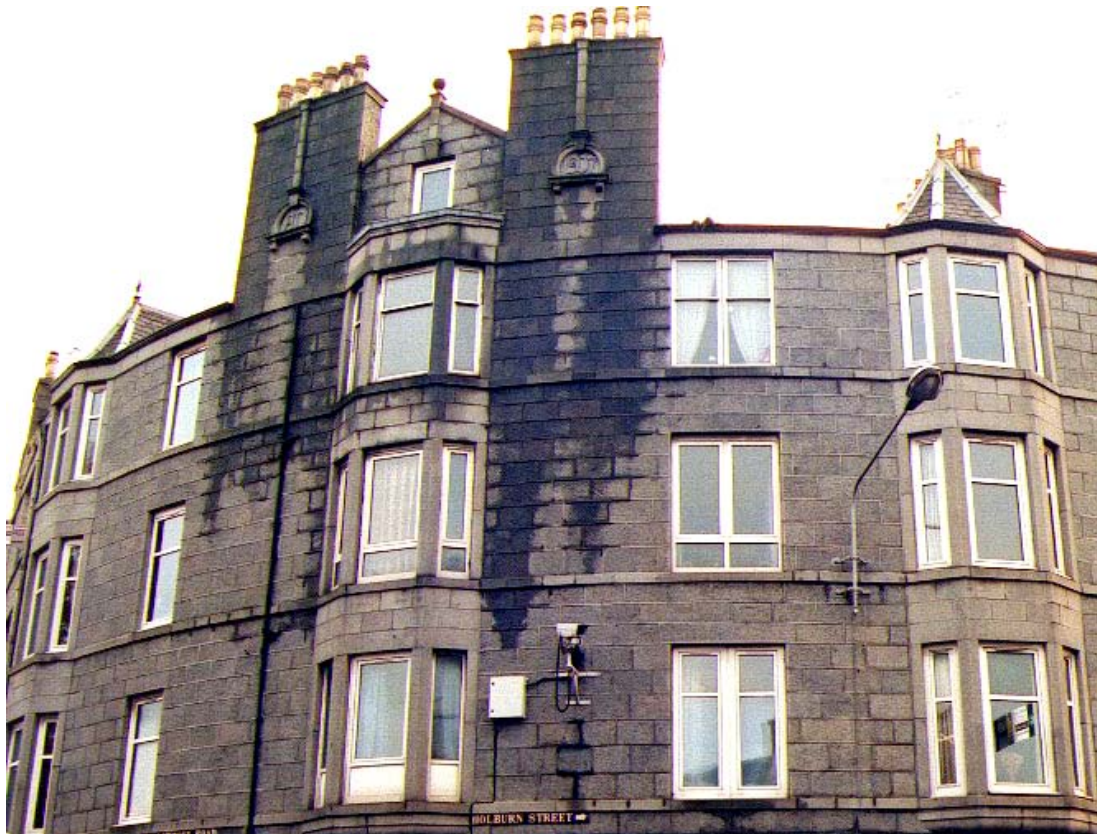
Plate 2.6 The projecting chimneys on this façade (which in this instance were directly facing the wind driven rain (2 knots)) have clearly influenced the impact of rain on the façade. Wind flow has been slowed by the projecting features.

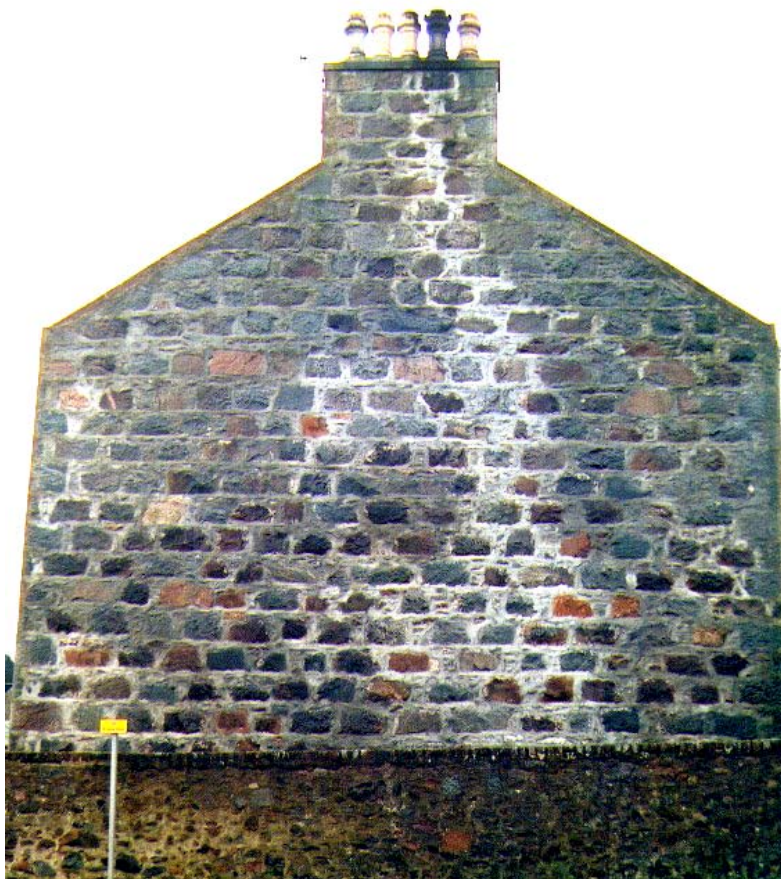
Plate 2.7 The dry patch on this gable appears to correspond to the position of fire places and flues.

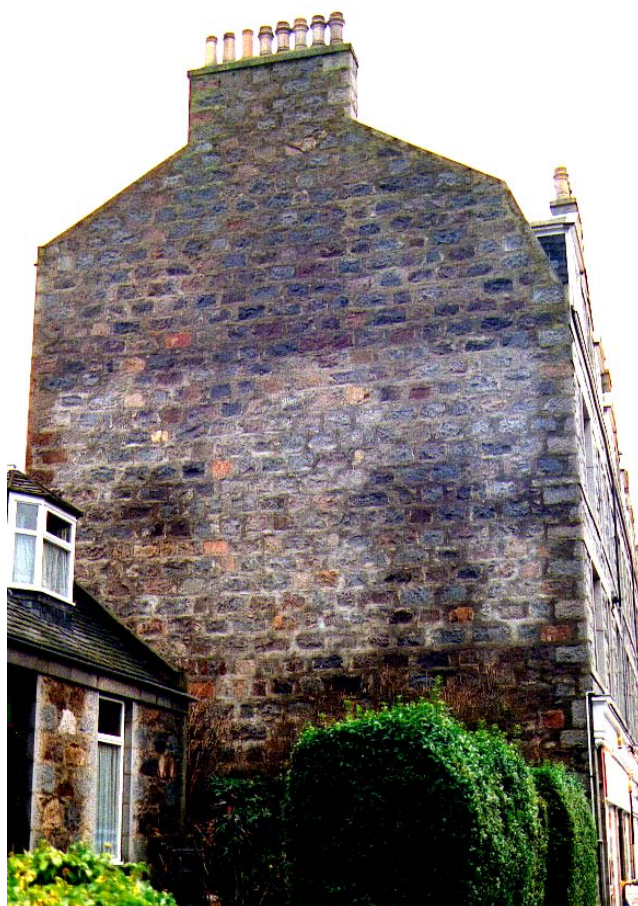
Plate 2.8 Dry areas on this gable appears to correspond to the position of rooms at the first and second storeys.

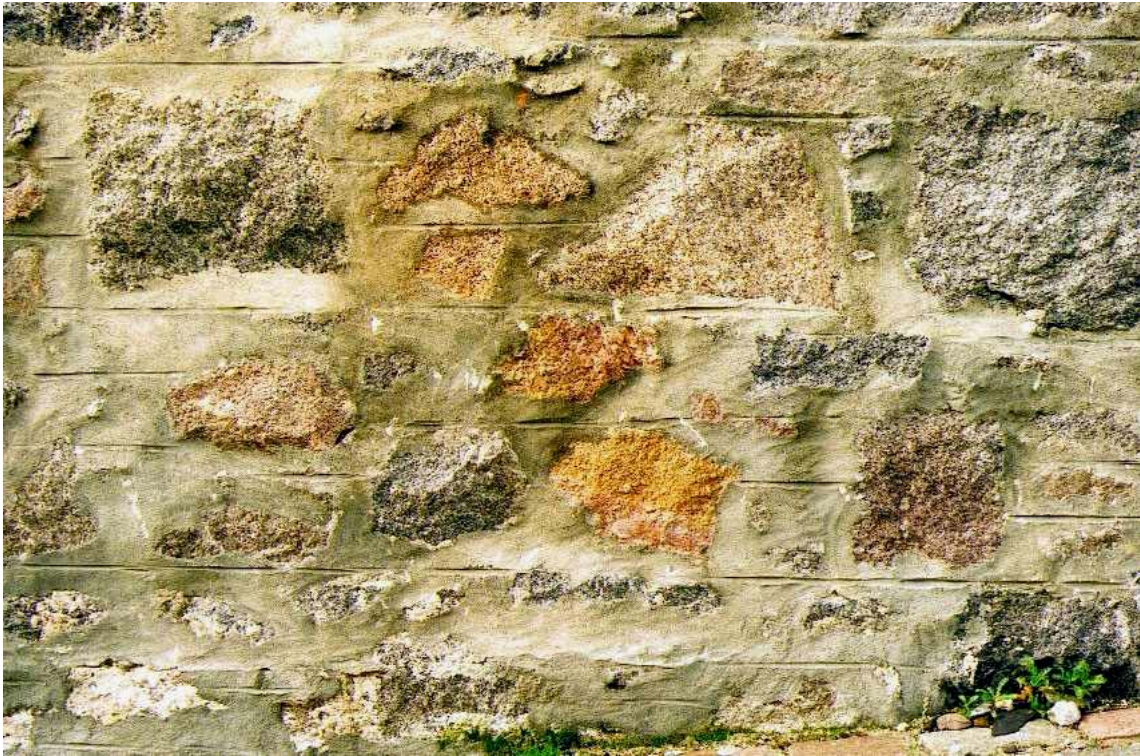
*Plate 2.9 The pointing mortar dries more slowly than the granite since it is more porous and permeable and holds more moisture than the granite.*

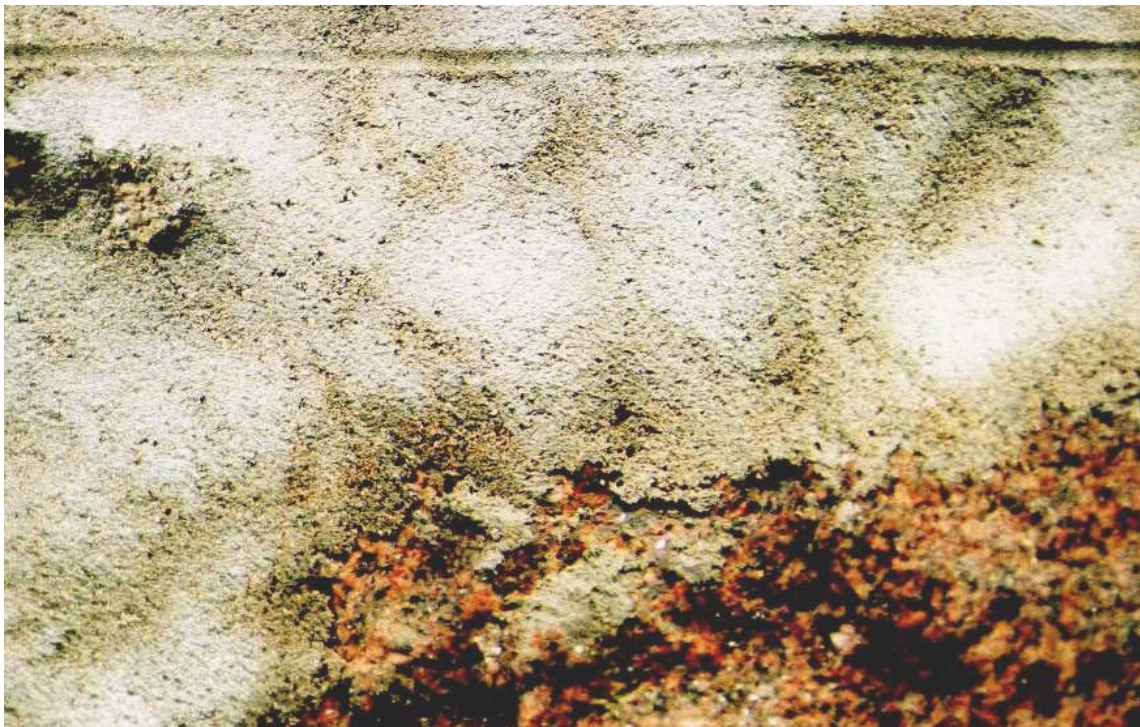
*Plate 2.10 Where moisture can get easier access through cracks between mortar and stone, moisture is retained for longer. In this example, the mortar around the stone remains damp after the rest of the wall has dried.*

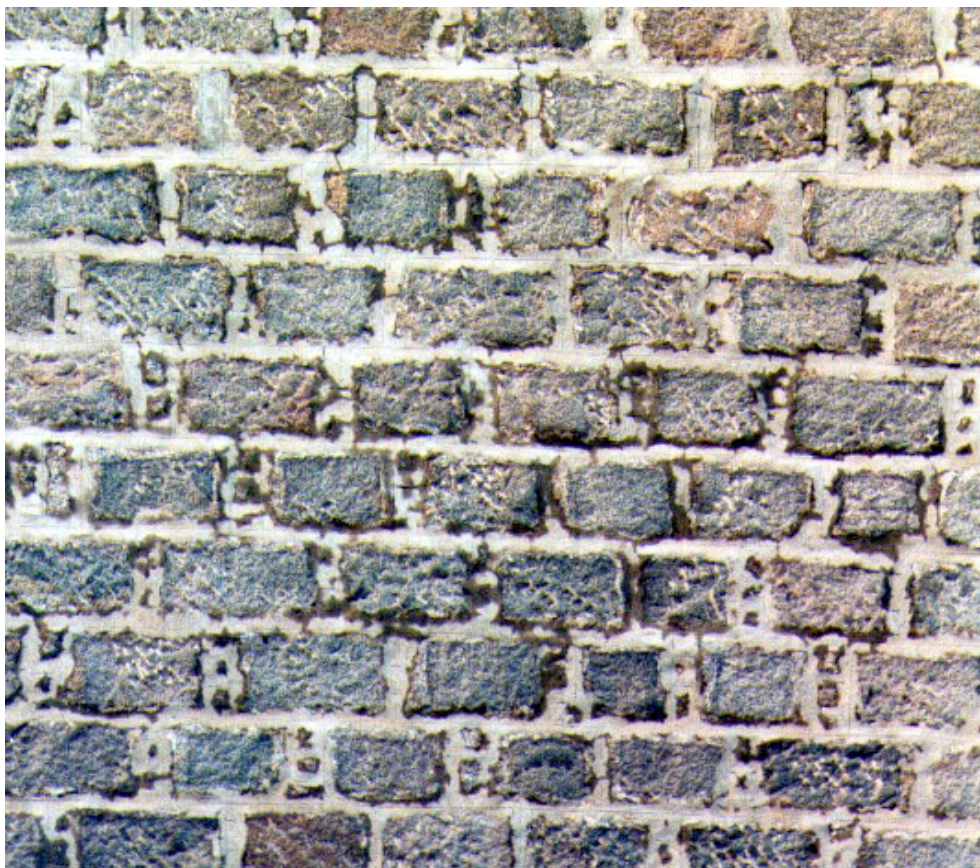
Plate 2.11 On this largely dried wall surface, remaining areas of dampness occur on the pointing, especially where it is cracked.

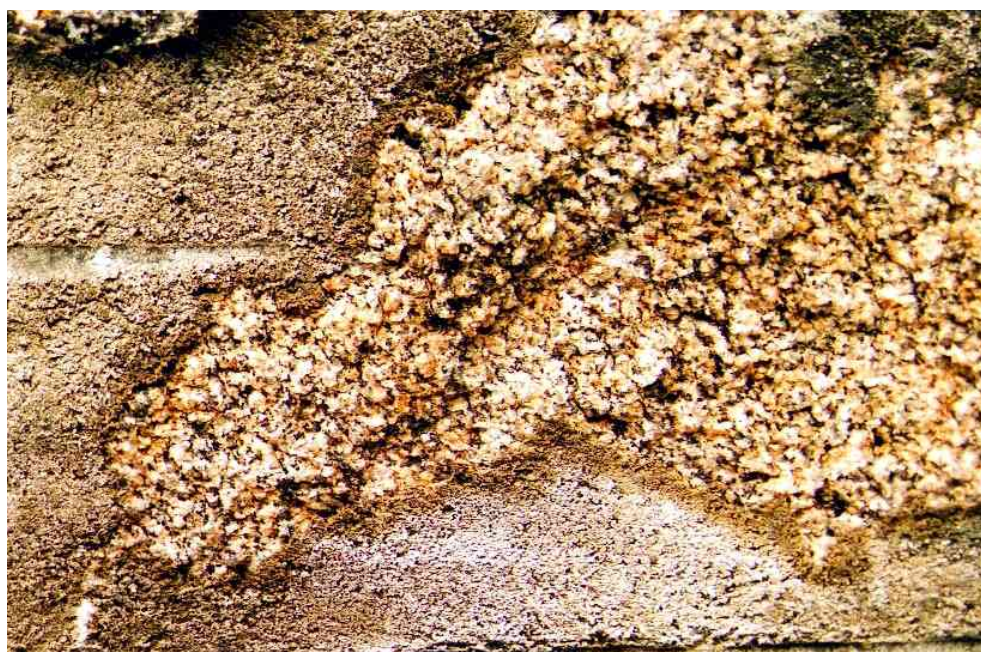
Plate 2.12 The darker features on this pointing mortar show the location of hairline cracks where more moisture has been taken up by the mortar.

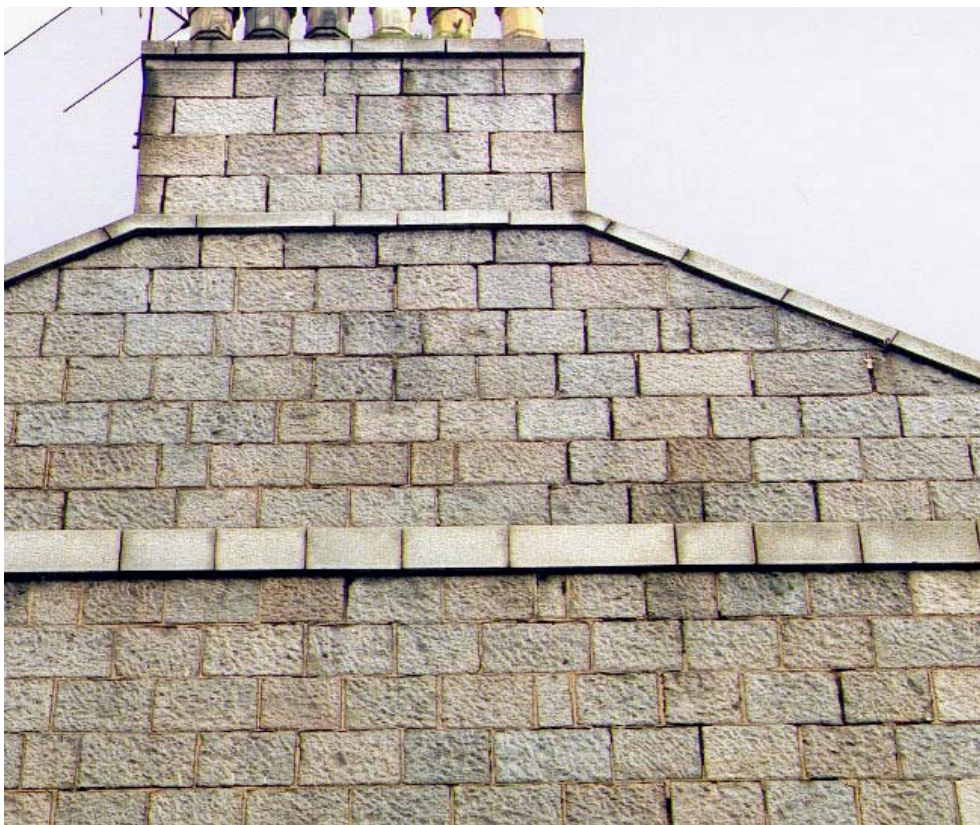
It was noticeable on a number of buildings that the pointing was in a very poor state of repair with pointing missing from many vertical and horizontal joints (Plates 2.13 & 2.14). In some cases it appeared that there might be an association with the position of flues, which may suggest that greater temperature variations and/or attack by flues gases could cause degradation of pointing (and possibly also of bedding mortar).

Plate 2.13 Most pointing mortar has been lost from both horizontal and vertical joints in the area of the chimney and on the right half of the wall.

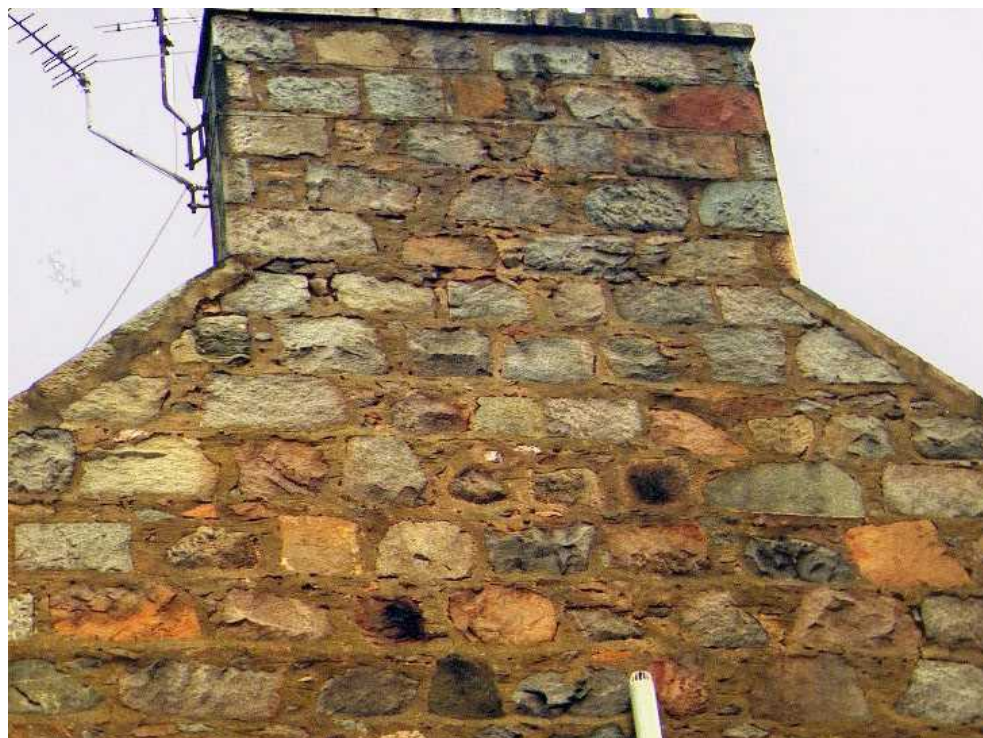
Plate 2.14 The pointing mortar on the upper area shown in this photograph is in very poor condition.
