4 Field studies

4.1 Field visits

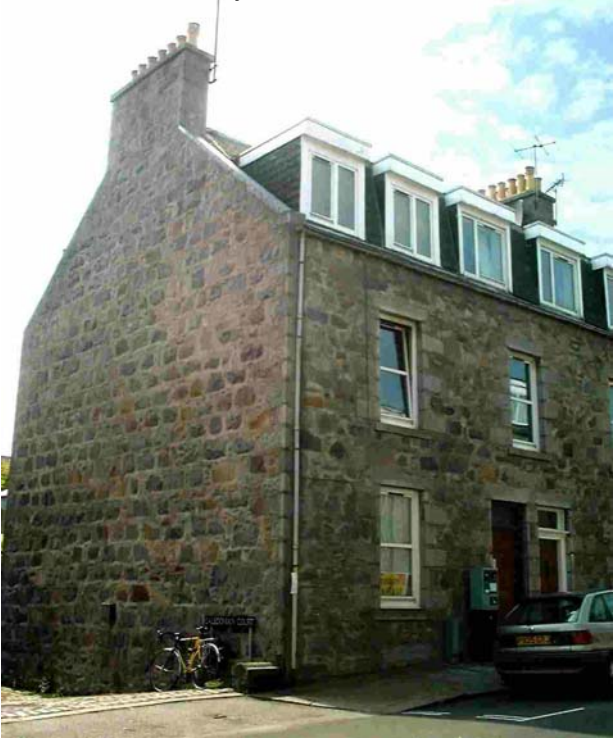
Plate 4.1 Case study one.

This granite tenement block was constructed around 1874. Damp problems were occurring mainly on the gable wall at first floor level, which is south-east facing (Plates 4.1 & 4.2).

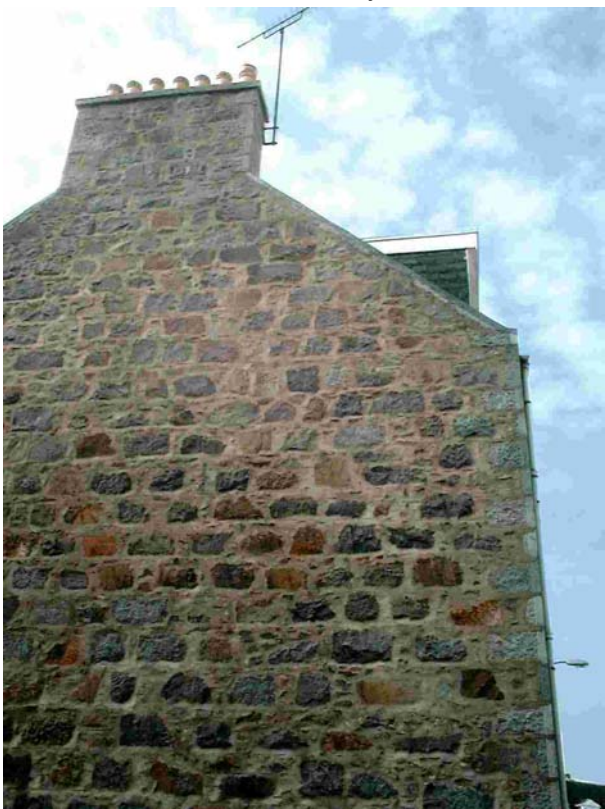
Plate 4.2 Gable of Case study one.

Externally, the granite rubble gable wall has been repointed flush with a small overlap of pointing onto the granite (Plate 2.9). The quality of granite on the gable wall was variable. There were some good quality grey granite blocks but many other blocks were of relatively porous, weathered pink or pale orange coloured granite. On some of the more porous granite blocks decay around the margins adjacent to the cement pointing implies that the mix was too hard for some of the poorer quality granite blocks (Plate 2.10). All chimneys were capped and ventilated (with “elephants feet” or gas fire ventilation).

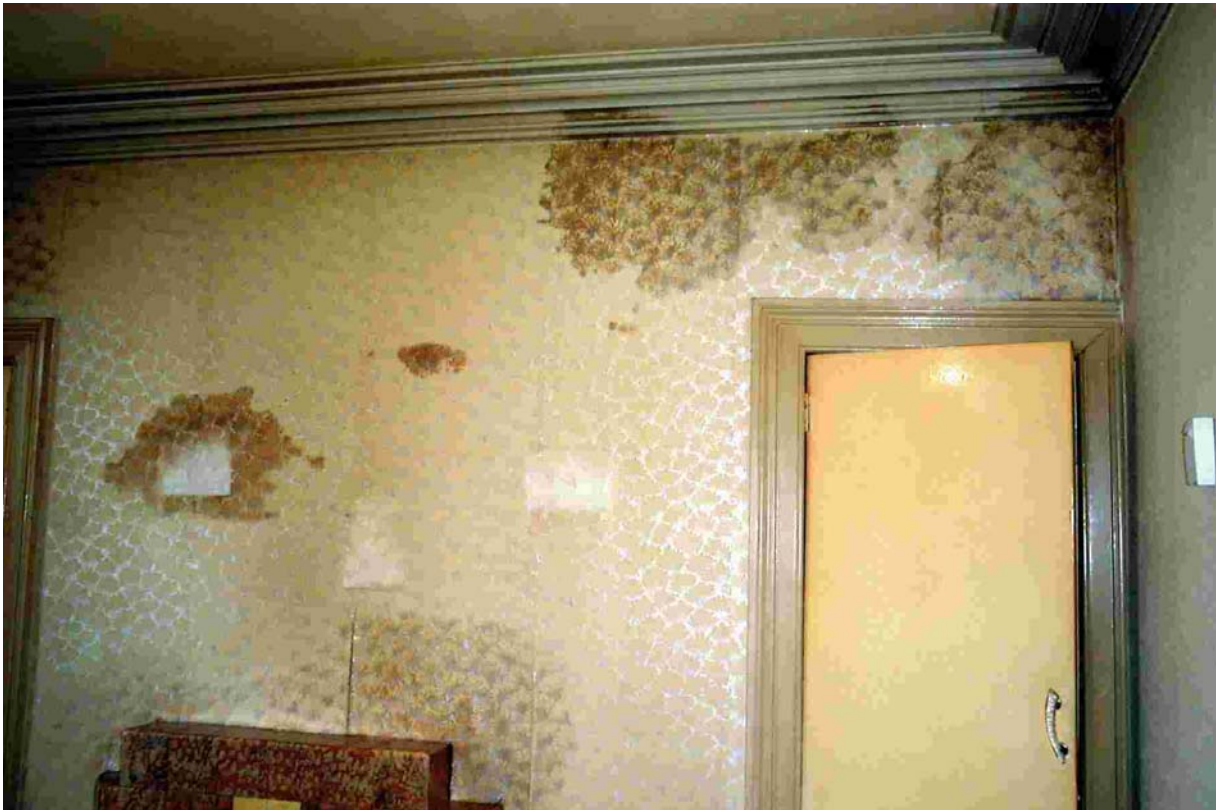
The source of damp could not be determined by initial visual inspection. On tapping the sitting room wall surface it was evident that many damp patches coincided with solid areas, dry areas sounding hollow. It was reported that five years previously the wall had been opened up and bridging rubble removed from the cavity.

Plate 4.3 Dampness on internal gable wall.

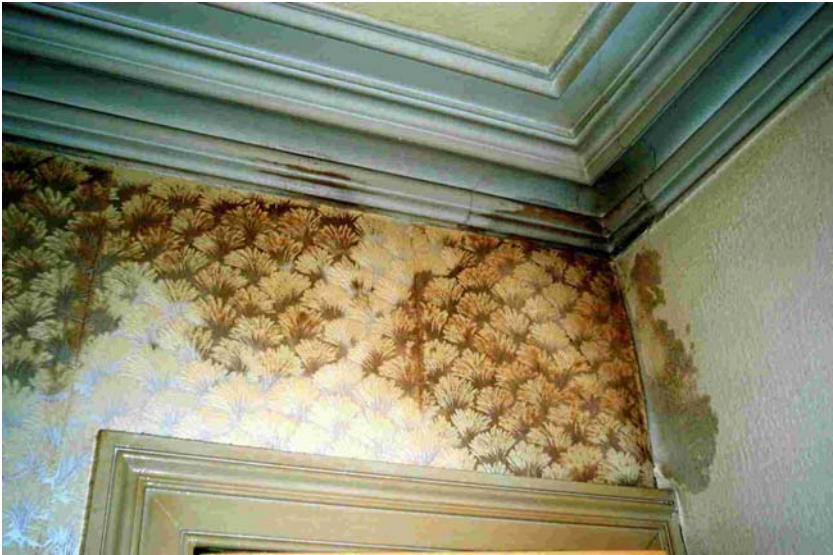
Plate 4.4 Dampness on internal gable wall.

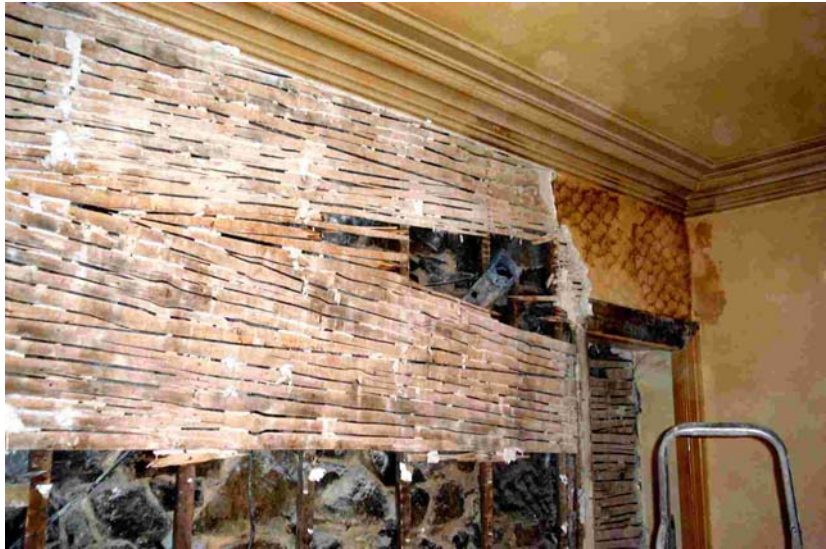
Since initial inspection the internal wall has been taken down and rebuilt. The area affected by damp was inspected during the taking down process. It was observed that there was only few centimetres gap between the external wall and lath & plaster (Plates 4.5 & 4.6). Bedding mortar was badly decayed and this debris formed much of the fill that was bridging the void. The narrow void space was commonly blocked with debris, which filled a number of areas, including those affected by dampness. In the rebuilding process, timber safe lintels over the alcoves (which were badly affected by damp), were replaced with concrete with lead caps. A breathable membrane was installed behind the newly reconstructed internal wall. This should prevent damp from coming through as before although it does not solve the problem of the source of the damp.

Plate 4.5 Stripping internal wall.

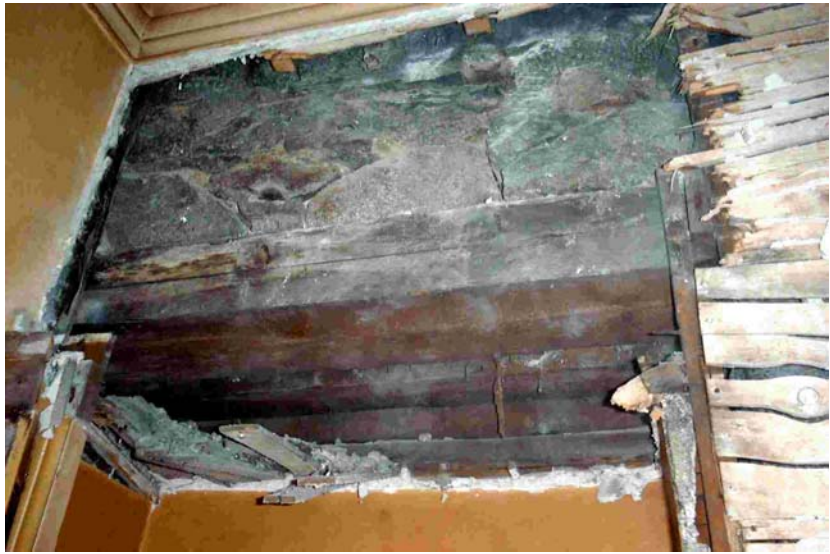
Plate 4.6 Stripping internal wall. Wall and timber safe lintel above alcove.

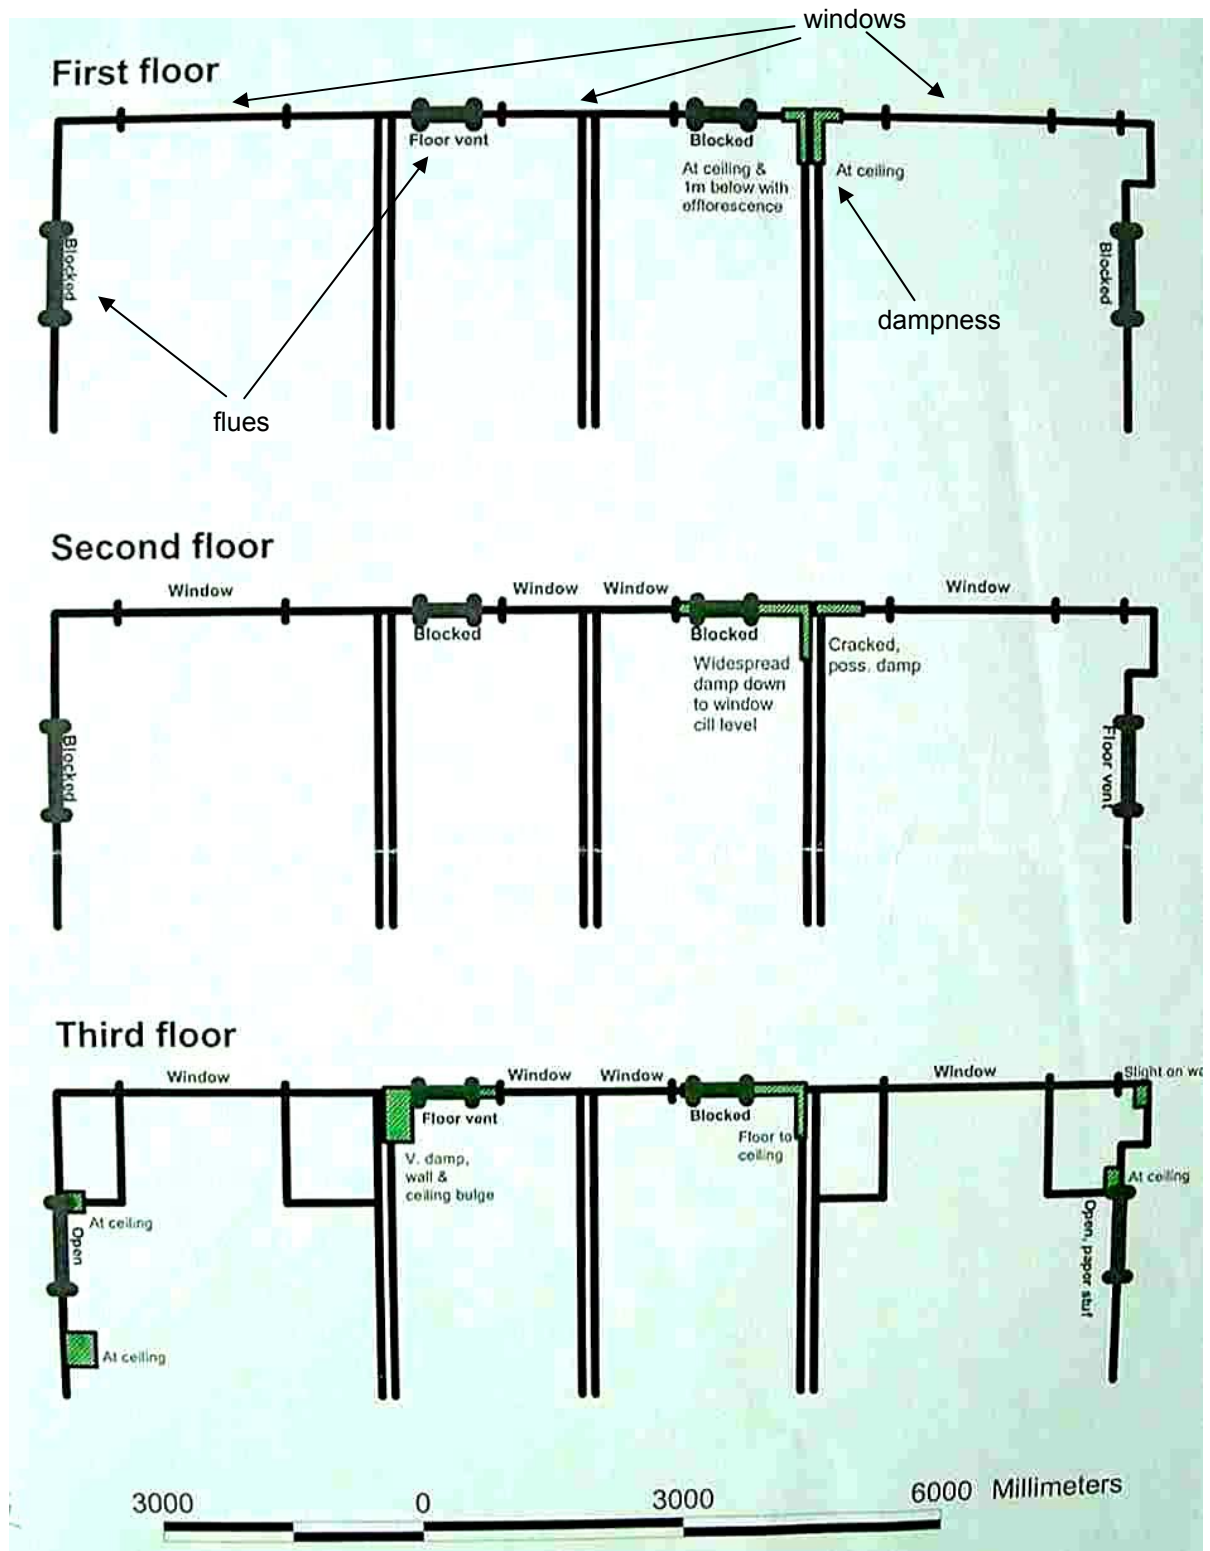
Dampness was entering at roof level on the upper storey on the left (north-west) side flats. The plaster on the ceiling of the 3rd floor (top) flat was bossed and dampness was present in the walls of this flat and flats below down to the 1st floor. There was also a small area of damp in the front right corner of the topmost of the right side flats. Water penetration through the roof had been reported previously and this problem had been fixed. There was evidence in the top left flat of an area of dampness at ceiling level which was likely to be caused by water penetration through the roof.

Most water penetration is believed to be coming from damaged skews in the front chimney. However, poorly maintained guttering may be contributing to dampness at lower levels.

Figure 4.2 Locations of internal dampness at case study two.

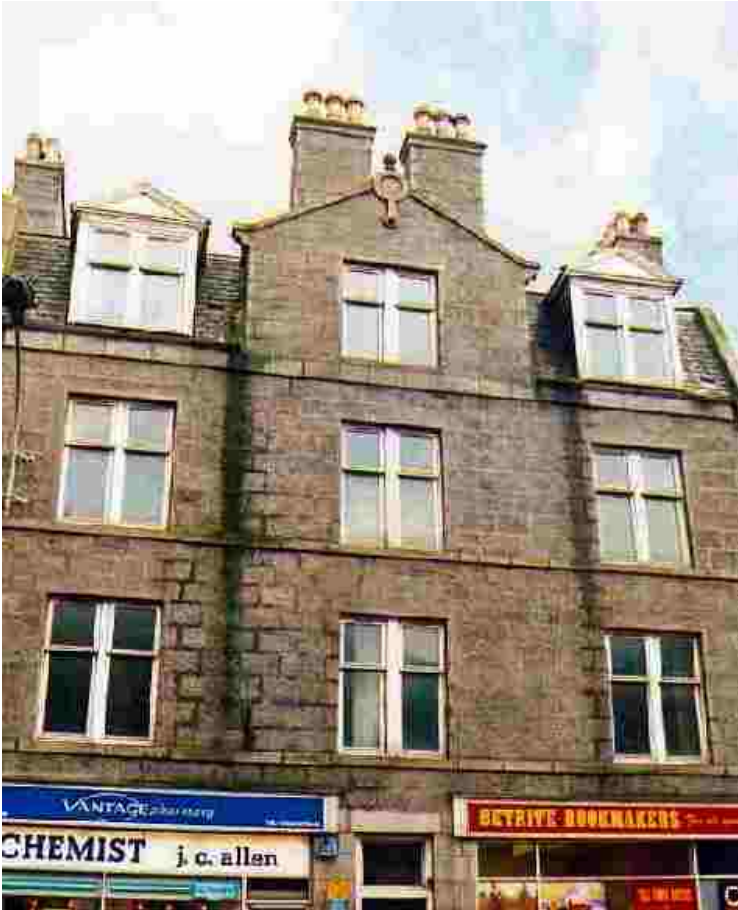
Examination of the front of the building shows two areas of rainwater run-off over the face of the building (Plates 4.7 & 4.8) starting from blind ends of guttering at 3rd floor level. The rainwater gutter at 3rd floor level was (at the time of inspection) not properly graded to run towards the outlet. This cannot be the source of damp penetration in the 3rd floor since that dampness begins at roof level, one storey above the external gutters. The run-off over the facade could however be a contributory factor to internal dampness observed at 1st and 2nd storey levels.

Plate 4.7 Front facade of case study two showing green algal growth on area affected by rainwater run-off.

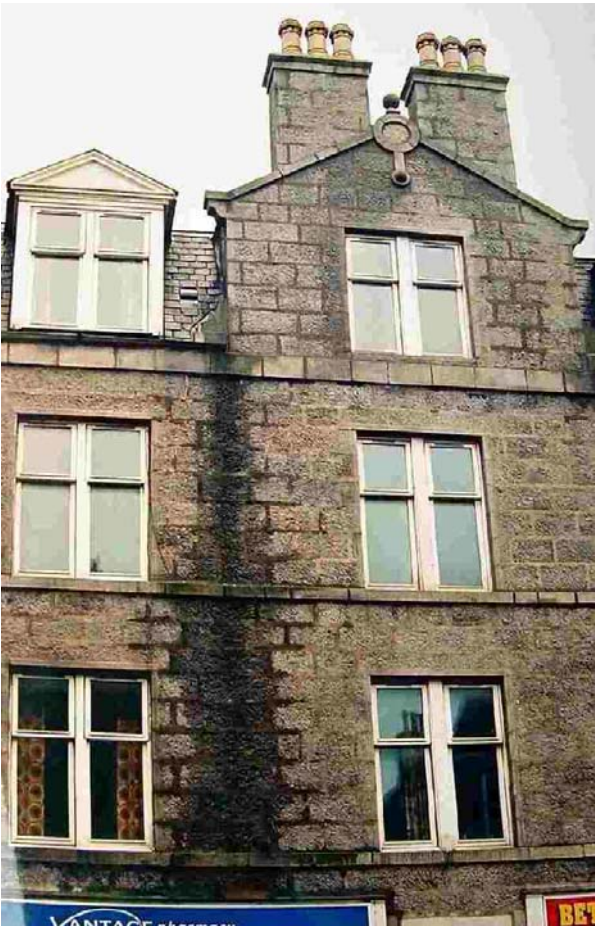
Plate 4.8 Front facade after a period of rain showing degree of wetting around area affected by rainwater run-off.

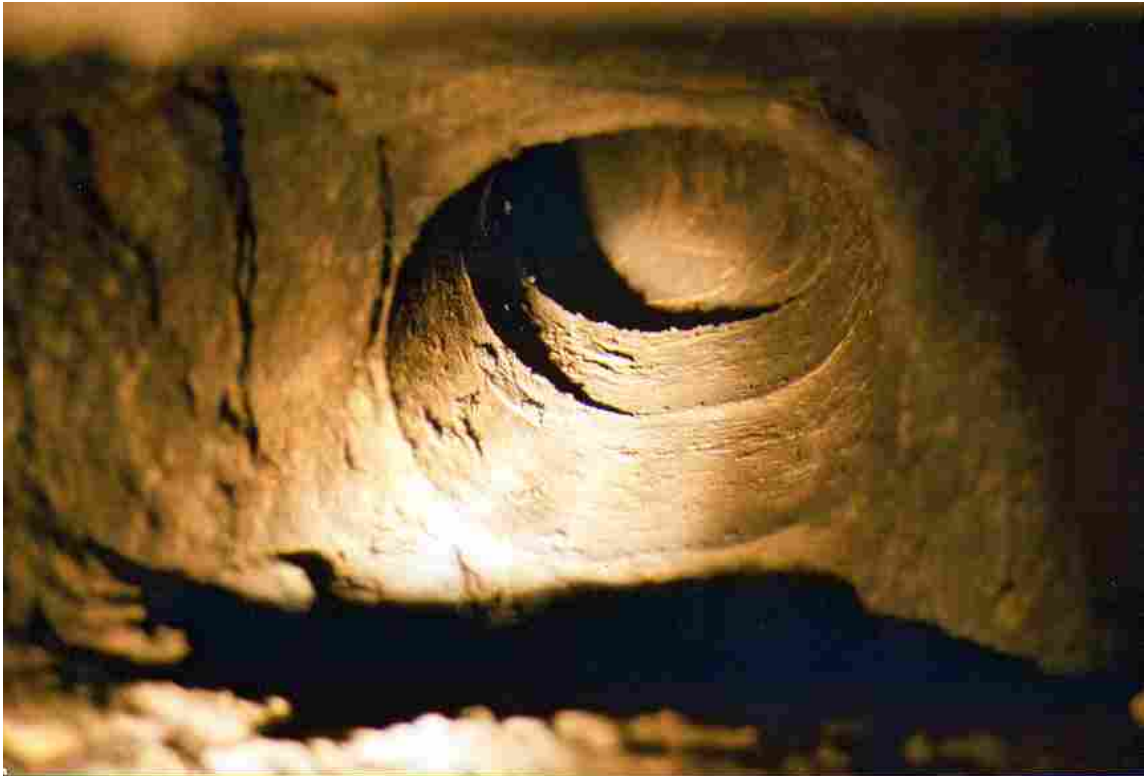
Plate 4.9 Flues are lined internally as can be seen in this view up a chimney.

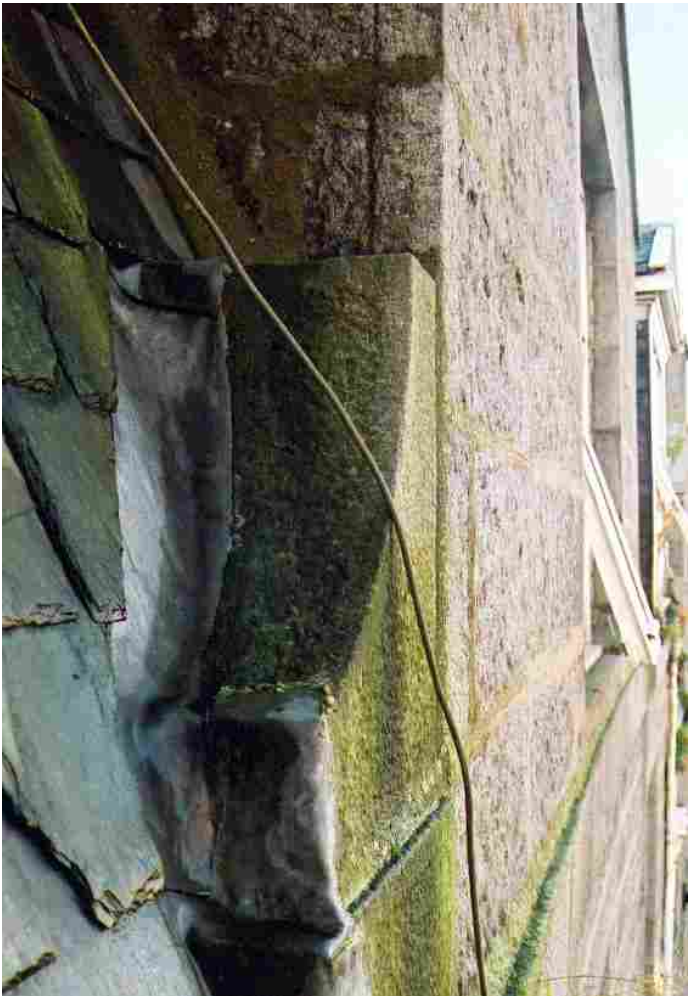
Plate 4.10 Detail at 3rd floor level shows leadwork and green algae on stone indicating that some run-off comes from roof level.

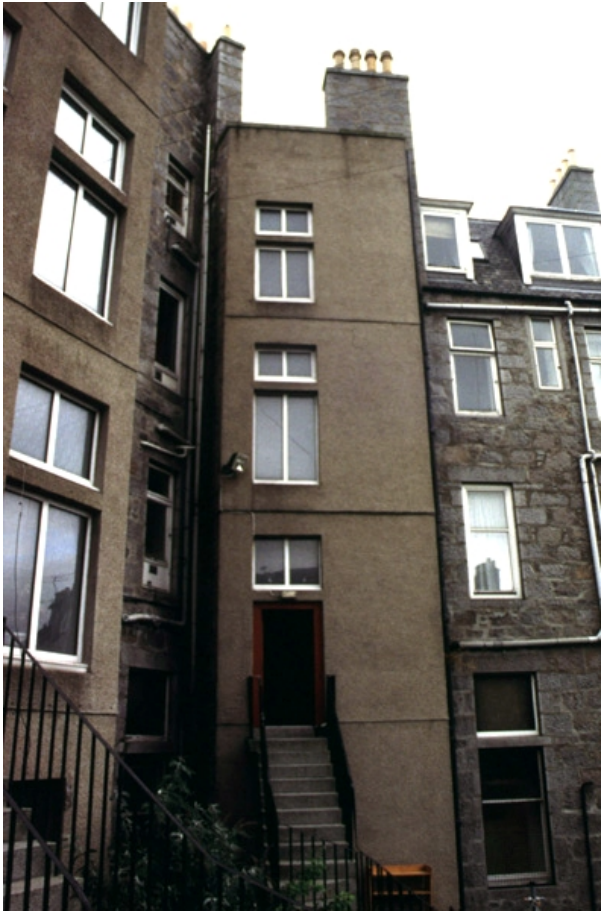
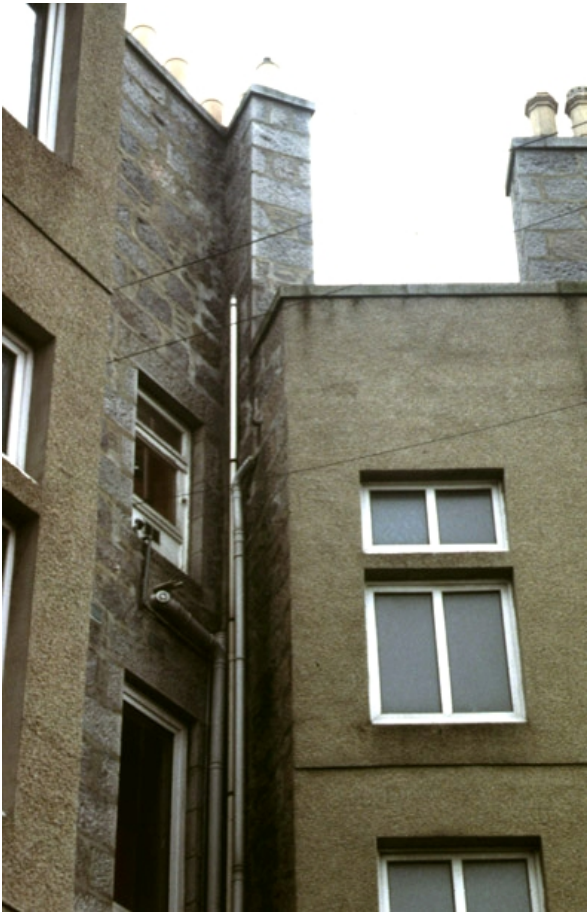
Examining the exterior of the stair tower from ground level in the back garden it was apparent that the dry dashed walls were in good condition. Pointing on the granite wall on the north side (where dampness was located internally) appeared to be in sound condition. Green algal and moss growth was apparent on this wall, extending downwards from close to the roof level and in approximate line with the exit of a downpipe and overflow from the parapet gutter at the roof of the stair tower (Plates 4.11 & 4.12).

Plate 4.11 Rear of case study three. Dampness affects the internal walls of the stairwell on the return to the left of the harled wall.

Plate 4.12 Detail of area shown in Plate 4.11.

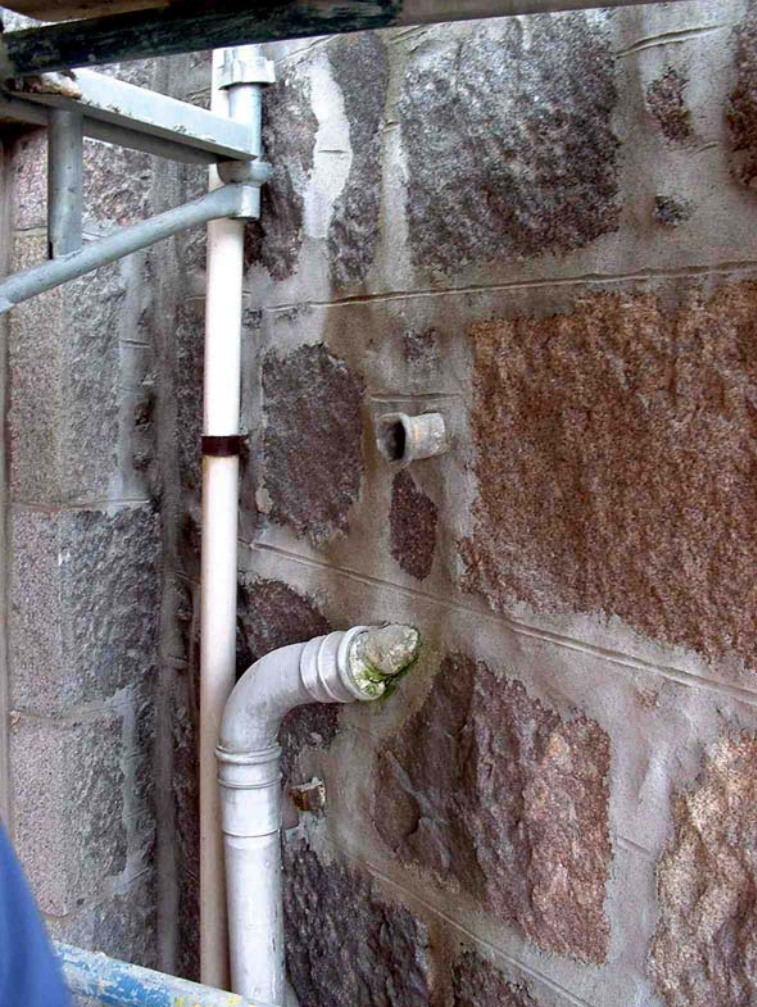
It appears likely that the dampness and decay in the stairwell are due to water leaking into the wall from roof level due to a blocked parapet gutter.

Plate 4.13 External detail of parapet gutter overflow after unblocking (Feb 2003).

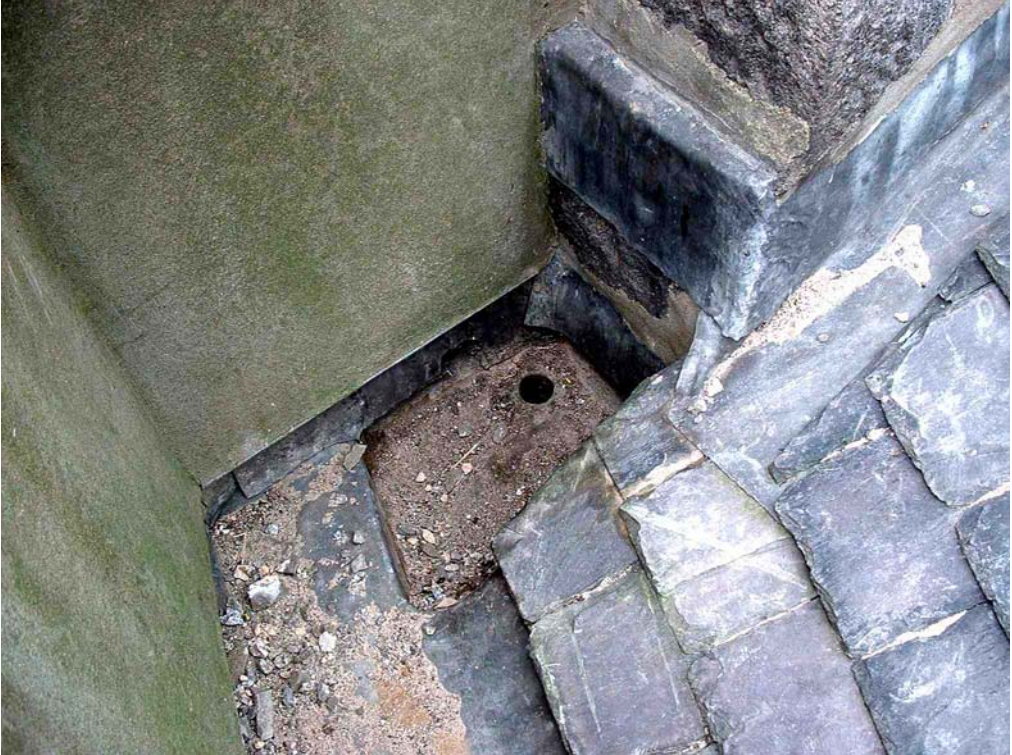
Plate 4.14 Parapet gutter and overflow after unblocking (Feb 2003).

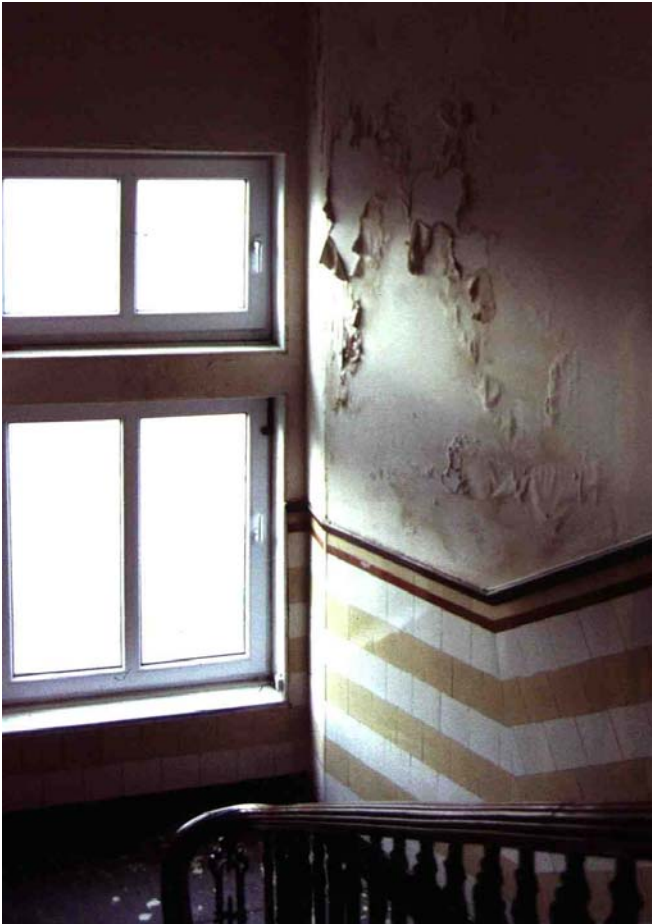
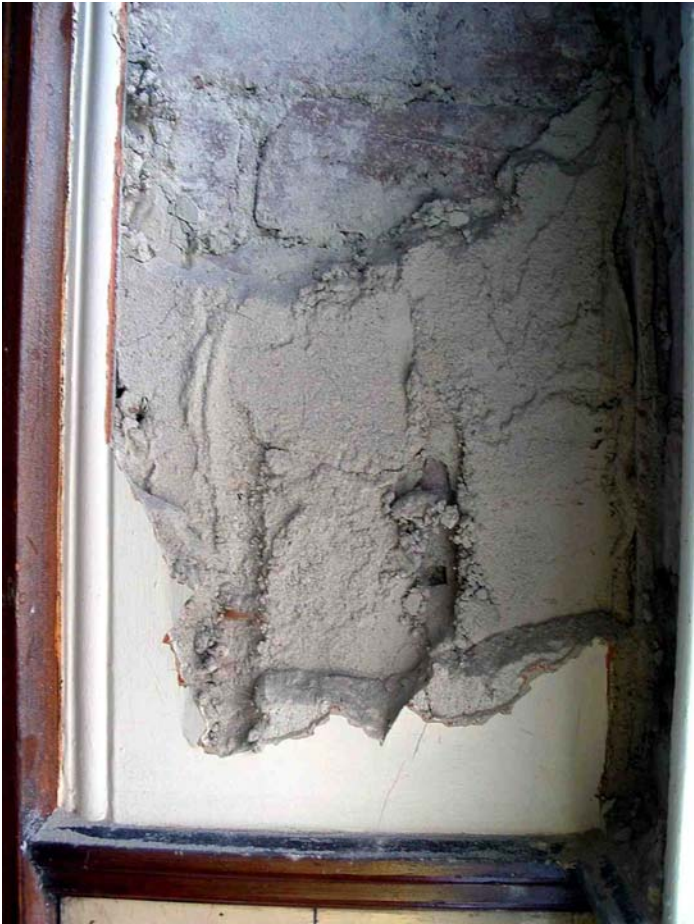
Dampness, efflorescence and bossing can be seen on the interior of the granite wall in the stairwell (Plate 4.15). The dampness is worst at roof level and decreases downwards to the first half landing. The dampness described in the previous report (from 1996) was similar to that observed during the current inspection. Additionally, there was a minor amount of dampness on the south side of the stairwell near roof level (this was not noted in the report from 1996 and may have occurred since that time). No dampness was present internally to the third floor flat right and no previous problems were known from this flat. The top left flat (fourth floor) had evidence of a previous damp problem above the kitchen window that faces out onto the external surface of the stair tower.

Plate 4.15 Internal walls of stairwell. Plastered on the hard and affected by dampness, with bossing and peeling of surface.

The stairwell will be replastered on the hard, but with 'tanking' behind. This will be in the form of a water repellent plaster on expert recommendation.

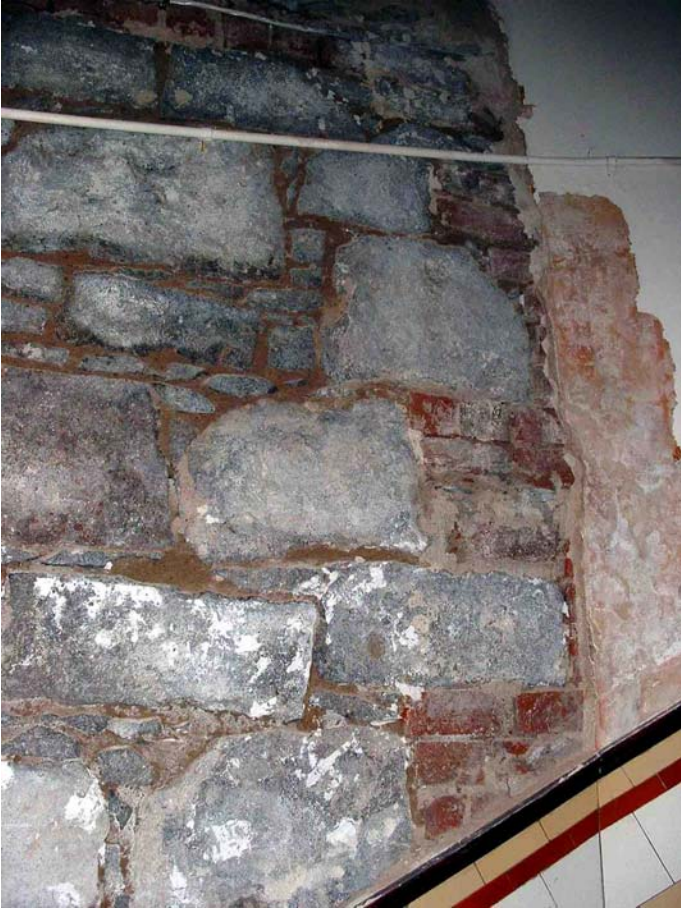
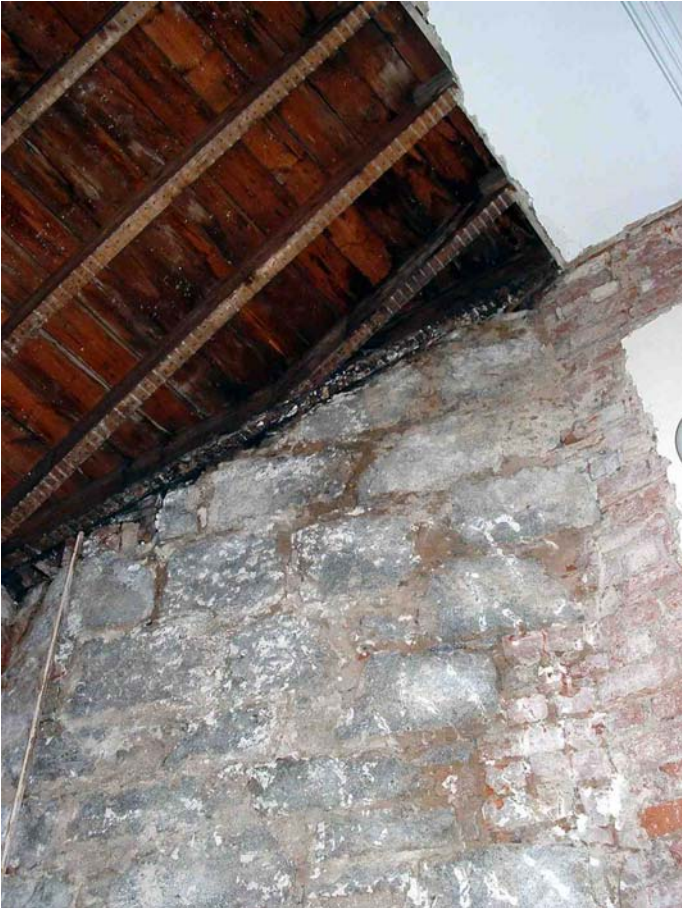
Stairwells, which were plastered on the hard have been stripped on the north side back to granite and brick (Plate 4.16). The external wall here is pointed, not harled (as the rest of the external stairwell is). These areas were previously affected by bad blistering due to water penetration. The ceramic tiles have not been removed as there was no evidence of any loosening suggesting water damage behind.

Plate 4.16 Plaster on the hard partially removed (Feb 2003).

Plate 4.17 Plaster removed from area affected by dampness at first floor level (Feb 2003).

Plate 4.18 Plaster removed from area affected by dampness at upper level (Feb 2003). This revealed damp wood.

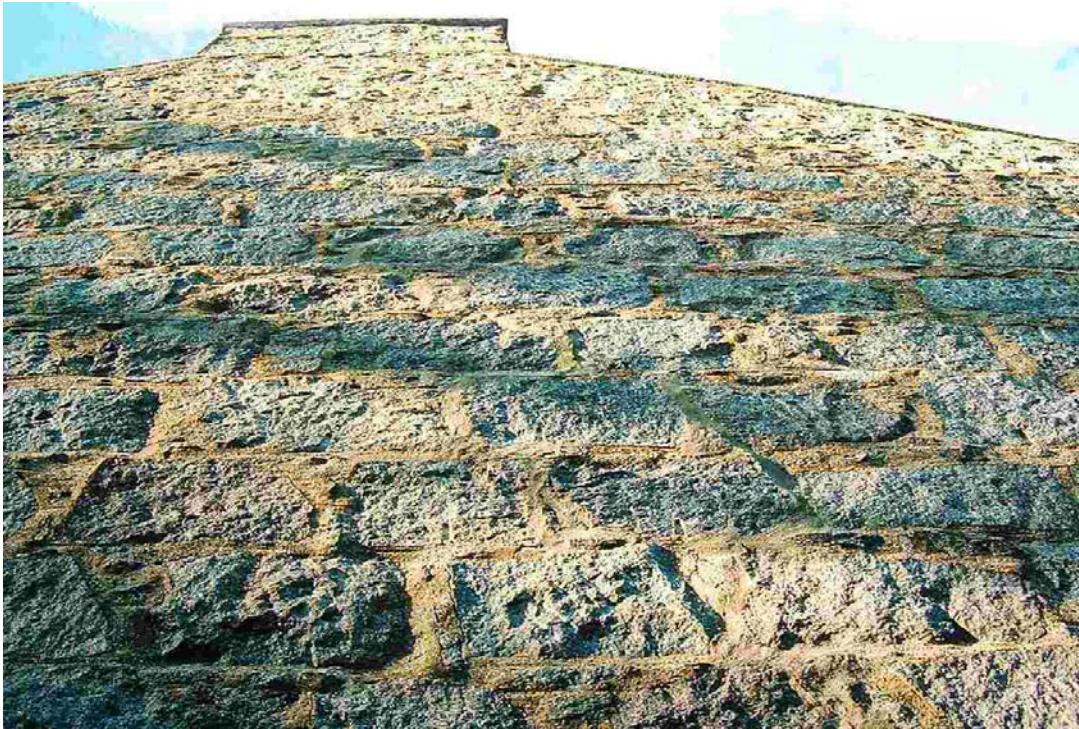
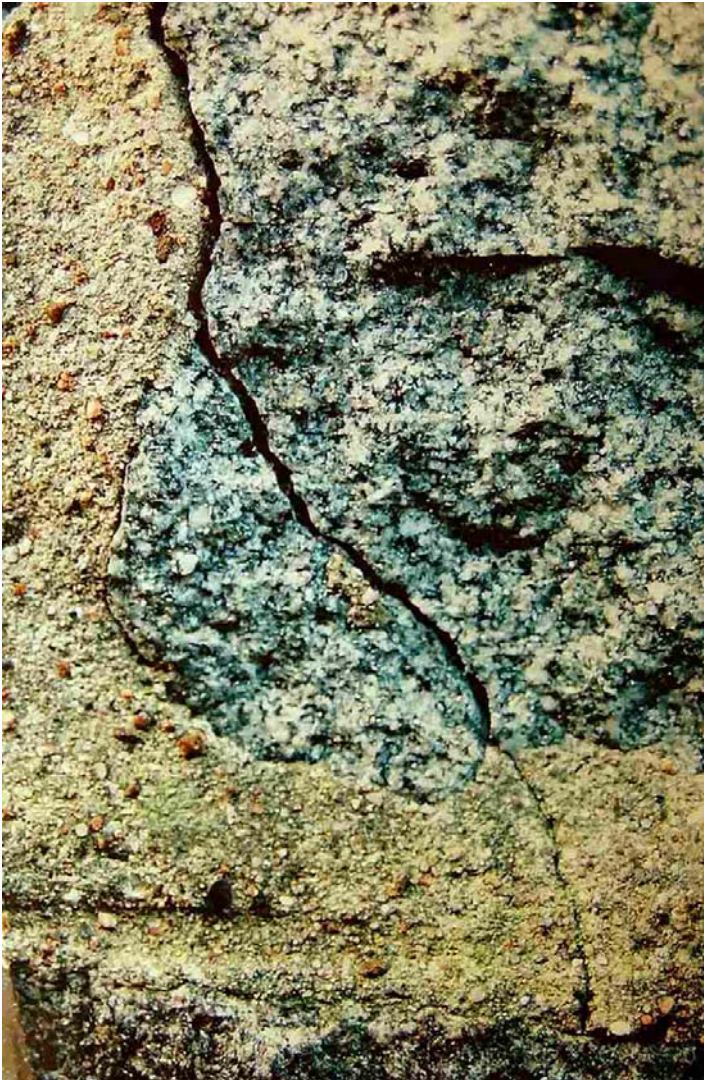
Plate 4.19 Gable of case study four.

The highest levels of damp seemed to coincide with the expected location of open flues suggesting that water penetration may be through the open chimneys. Given the poor state of lime mortar on the interior wall surface, there may be significant loss of mortar associated with the flues. Voids in the mortar may provide easy routes for the penetration of water through the wall, resulting in moisture exiting through the interior surfaces. However, it was also reported that during wet weather moisture had been observed glistening on the surface of the wall to the left (north-east) side of the gable. Possibly this moisture is getting in under raised ridge tiles. The dampness may be trapped in the gable by the use of hard cement mortar on the exterior of the property (although the permeability of the external pointing has not been quantified).

Plate 4.20 Cracked pointing and granite due to settlement.

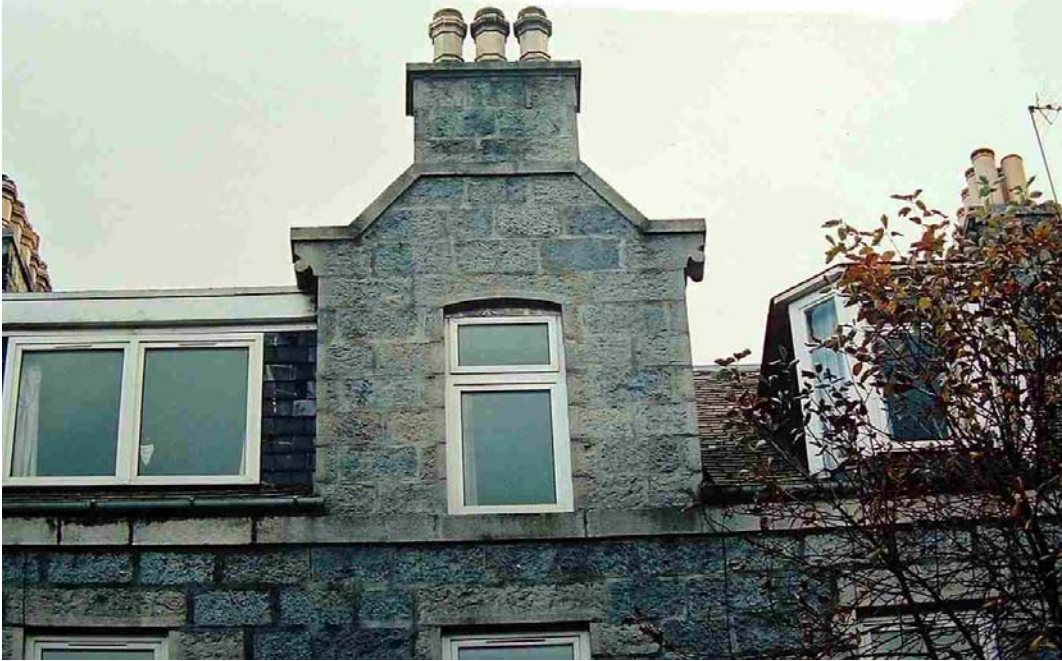
The damp problem is located in the top floor of a north-west facing granite tenement. There is a sloping roofed granite faced dormer window at the front of the property. The damp problem is located in this room where the ceiling adjoins the front wall. The dormer is detached to its right, but abuts a newer, flat roofed dormer window on its left. The affected wall contains flues for three chimneys. Which are capped with elephants feet. The granite is good quality ashlar and the pointing appeared (from ground level) to be in sound condition. No problems at roof level were visible from street level although the skewes and slates behind the chimney and the mortaring around chimney pots were not visible.

Plate 4.21 Case study five. Affected central bedroom on top floor with granite faced dormer.

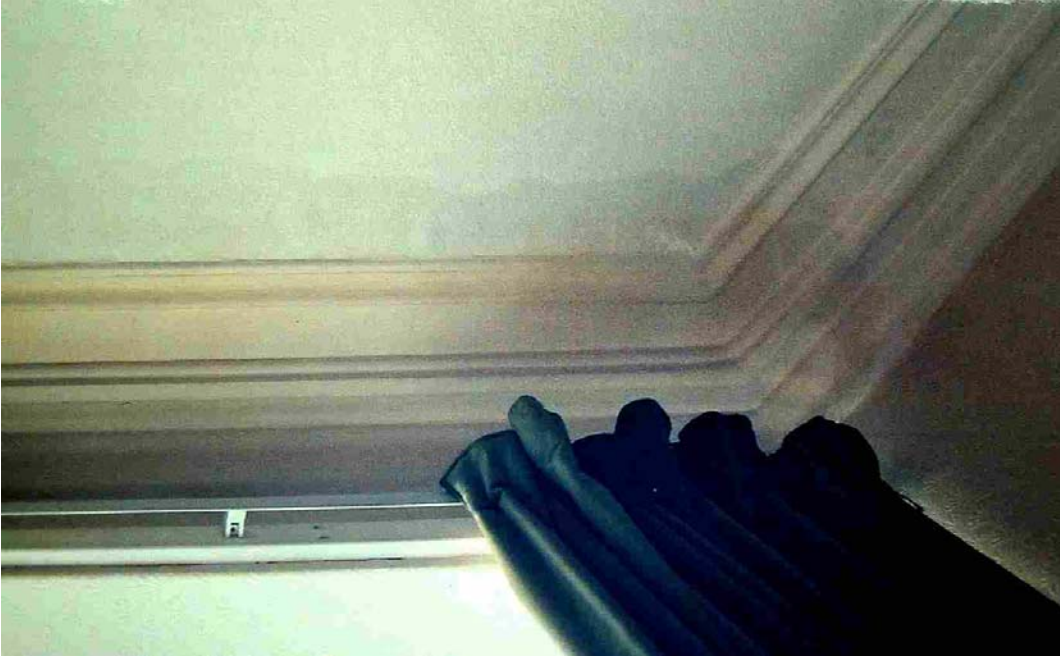
The source of moisture is not known, but appears to be a problem originating at roof level. It is possible that rainwater accumulating against the wall where it abuts the newer dormer window to the left (when facing the property) is the source of dampness. Condensation in the flues has been ruled out by inspection. The penetration of damp into the interior of the flat was caused by bridging across the wall cavity as a result of collapses of deteriorated bedding mortar.

Plate 4.22 Damp patch above window.

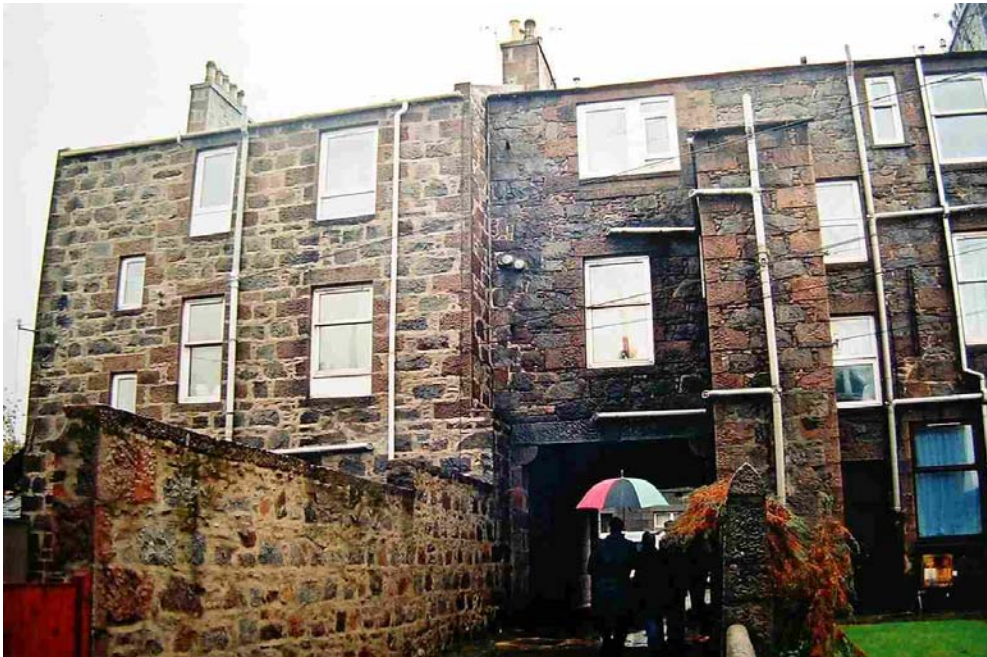
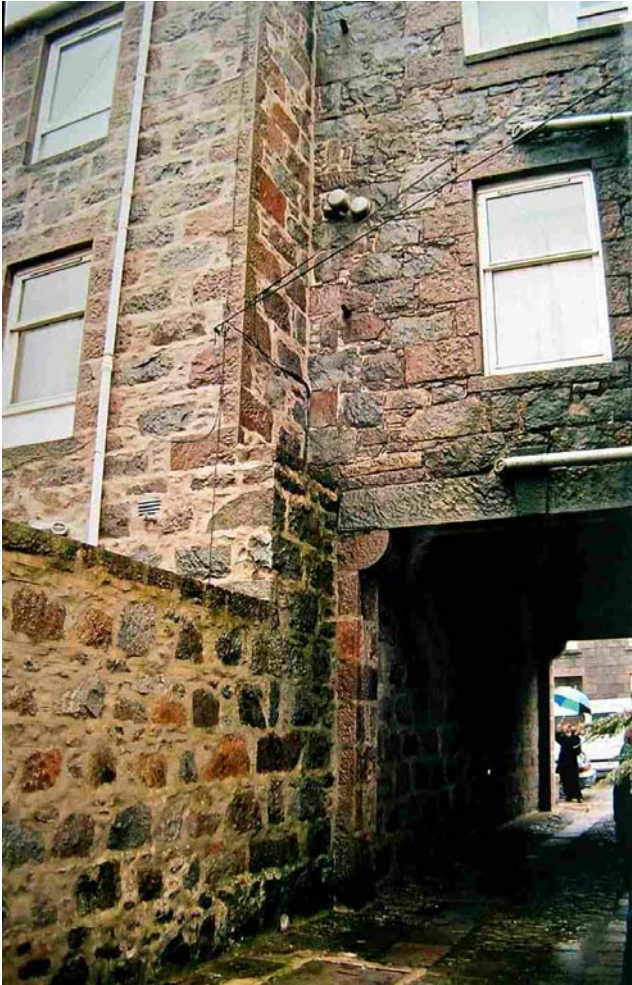
Plate 4.23 Rear of case study nine.

The small area of damp in the rear of the ground floor, west flat appears to have been solved by improving drainage. Dampness in the east gable was first reported after repointing. The source of moisture has not been established but internal problems were solved by removing bridging debris and reinstating the wall cavity.

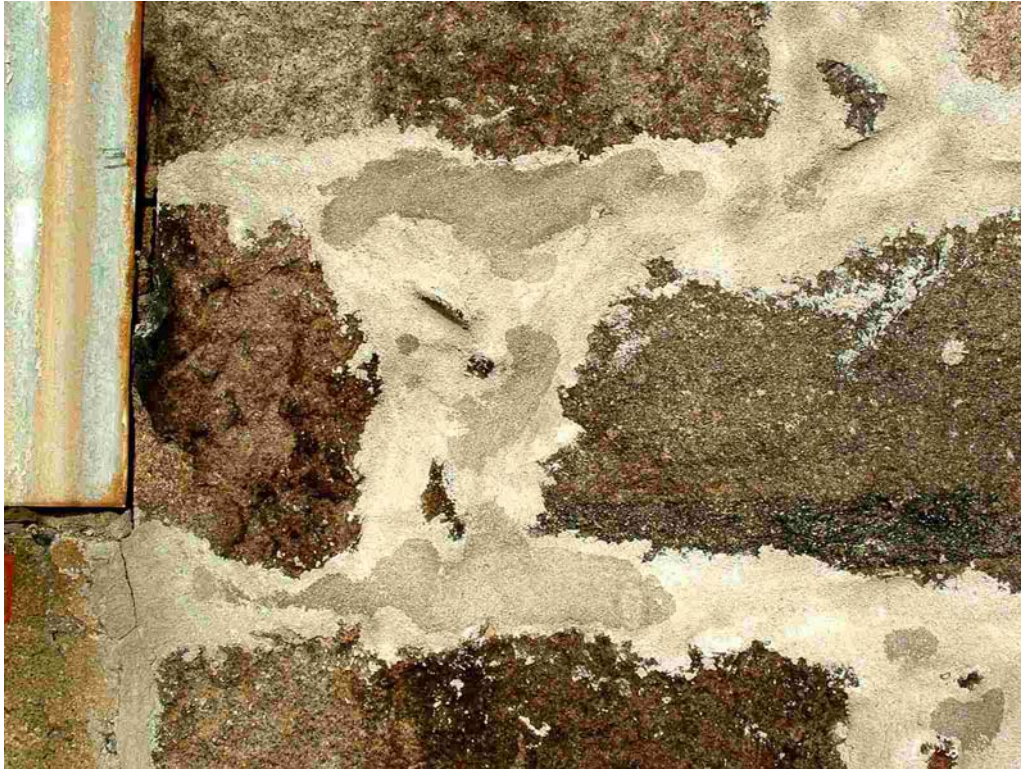
Plate 4.25 Two colours of mortar were visible on some areas of the gable (at its left end, as shown here) and on the front façade. The 'darker' coloured mortar was normally surrounded by 'lighter' coloured mortar.

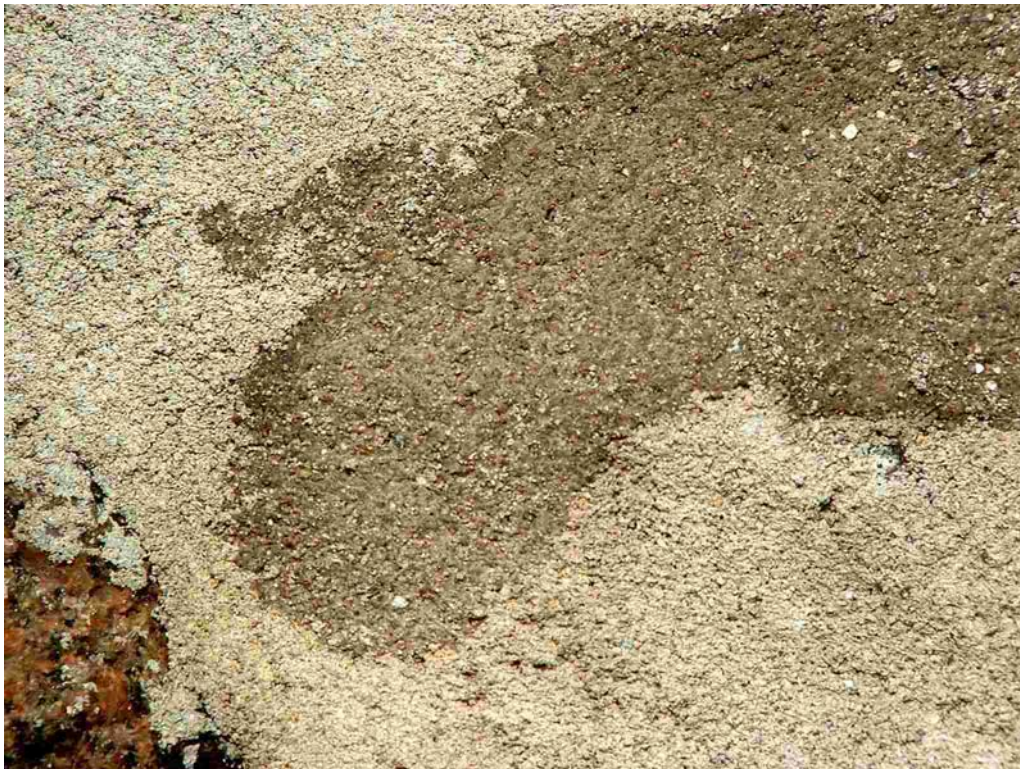
Plate 4.26 Close-up showing the 'darker' and 'lighter' coloured mortars at the left end of the gable. The darker colour is not caused solely by differences in degree of dampness although the 'darker' mortar here is damp and the 'lighter' mortar is dry (tested by electrical conductivity).

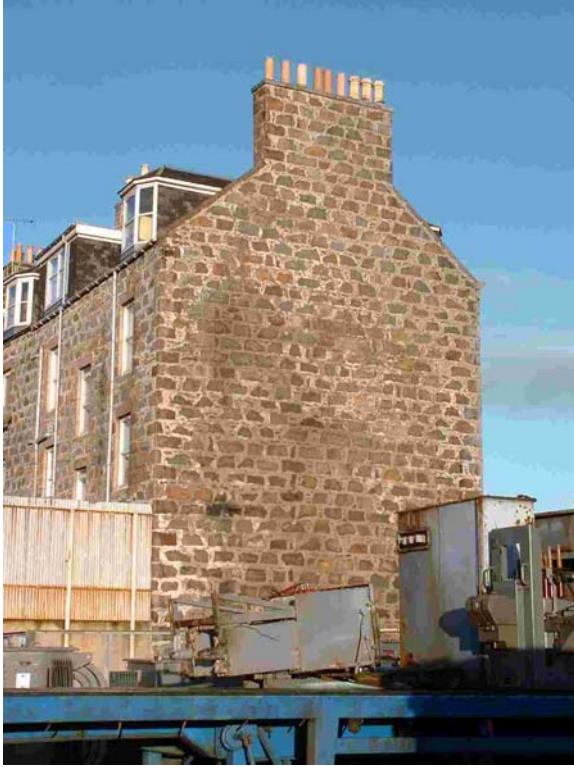
Plate 4.27 Gable photographed in January 2003 showing distribution of dampness (darker coloured areas on pointing).

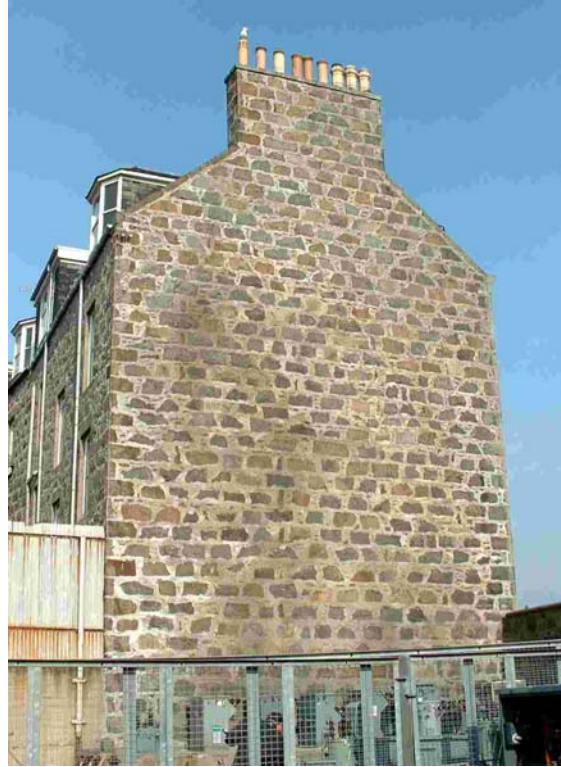
Plate 4.28 Gable photographed in March 2003 showing distribution of dampness after a period of 1-2 weeks without rain.
