4 Field studies

4.1 Field visits

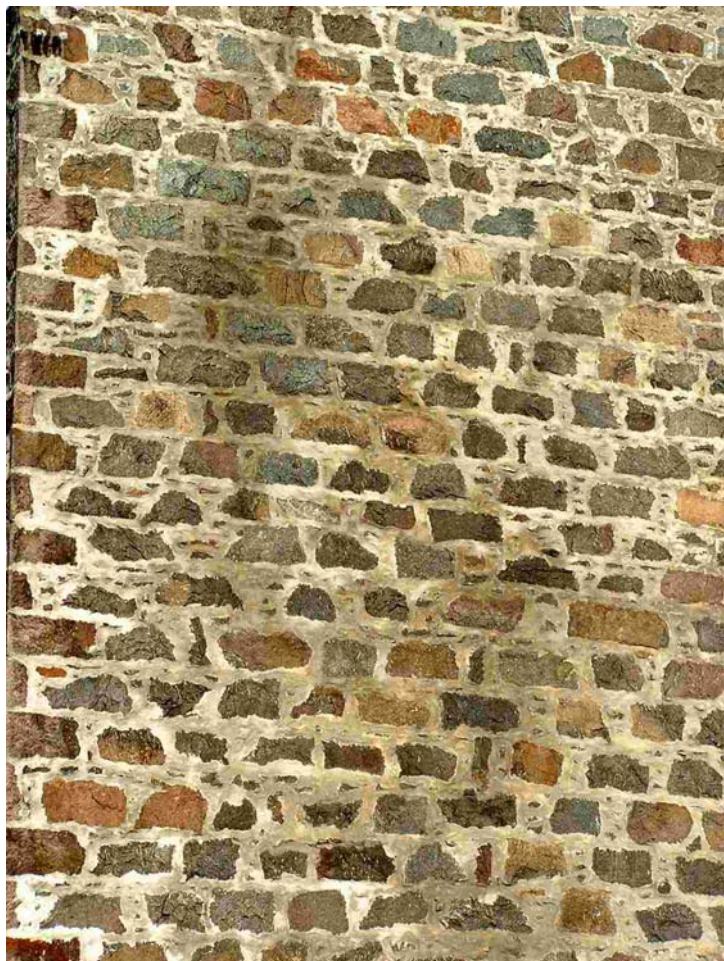
Plate 4.29 This close-up of the area to the upper left of Plate 4.28 (March 2003) shows darker, damp areas of pointing on the left and lower centre. There is an area with two differently coloured mortars (darker and lighter) in the upper right of the picture.

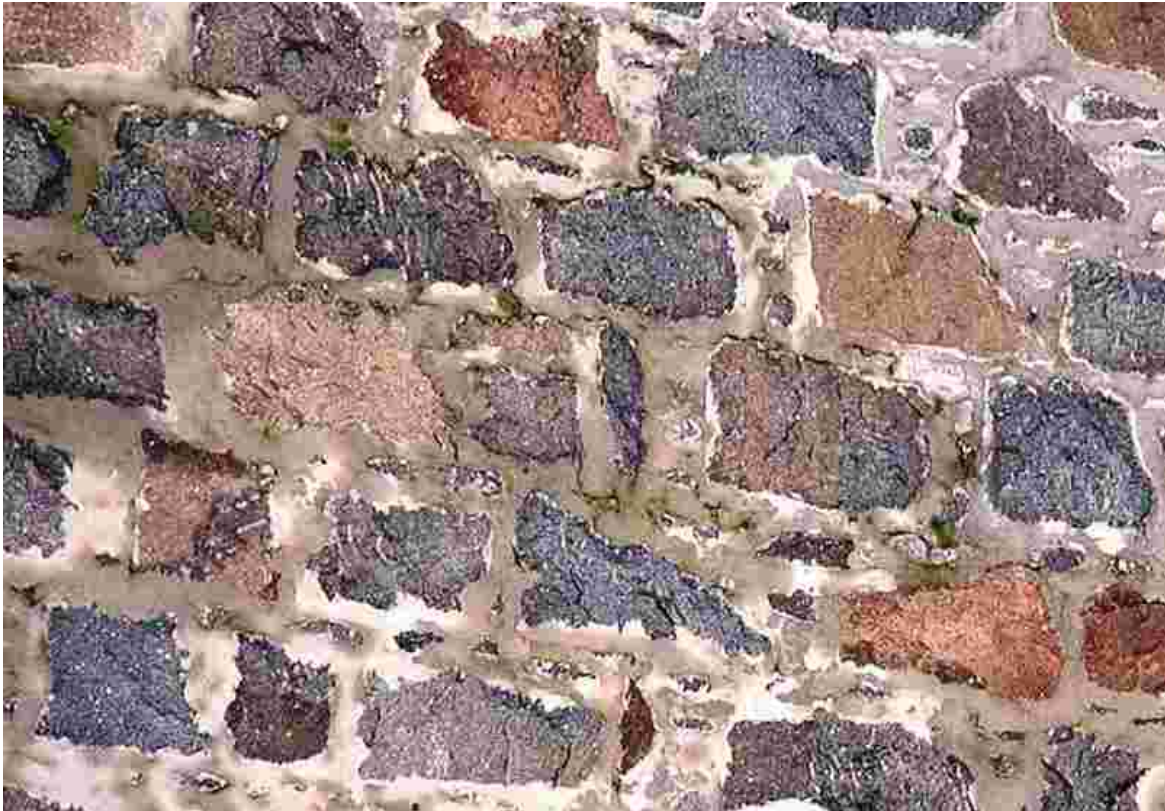
Some areas of pointing were cracked and affected areas appeared to retain a lot of moisture, having relatively abundant green algal growth when observed in January 2003 (Plate 4.30). Algal growth requires relatively long periods of dampness and would not normally be expected on a southerly facing gable wall. Green algal growth was no longer visible on the gable during an inspection in March 2003, but was still visible on the front façade (Plate 4.31).

Plate 4.30 Damp pointing on the gable with green algal growth apparently colonising the area around cracks (photographed in January 2003).

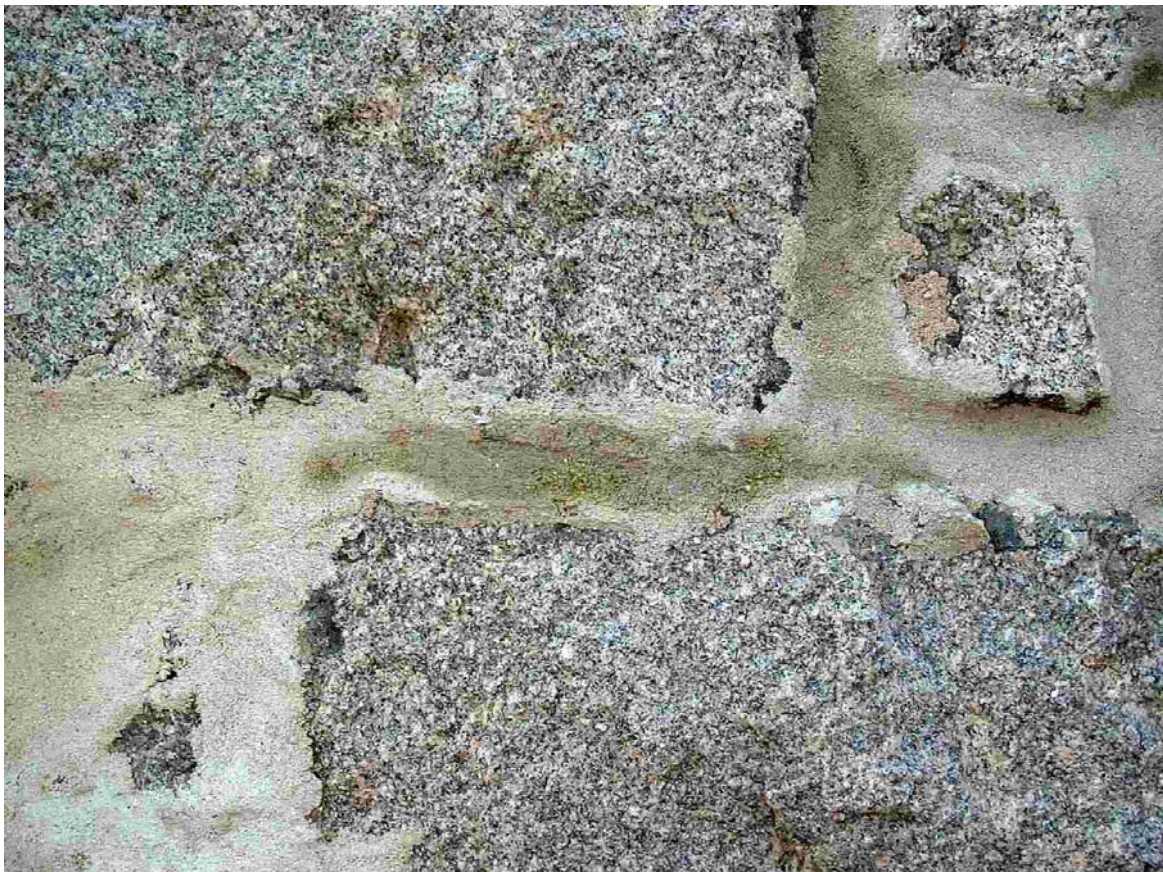
Plate 4.31 Damp pointing (darker area) on the front façade with green algal growth (photographed in March 2003).

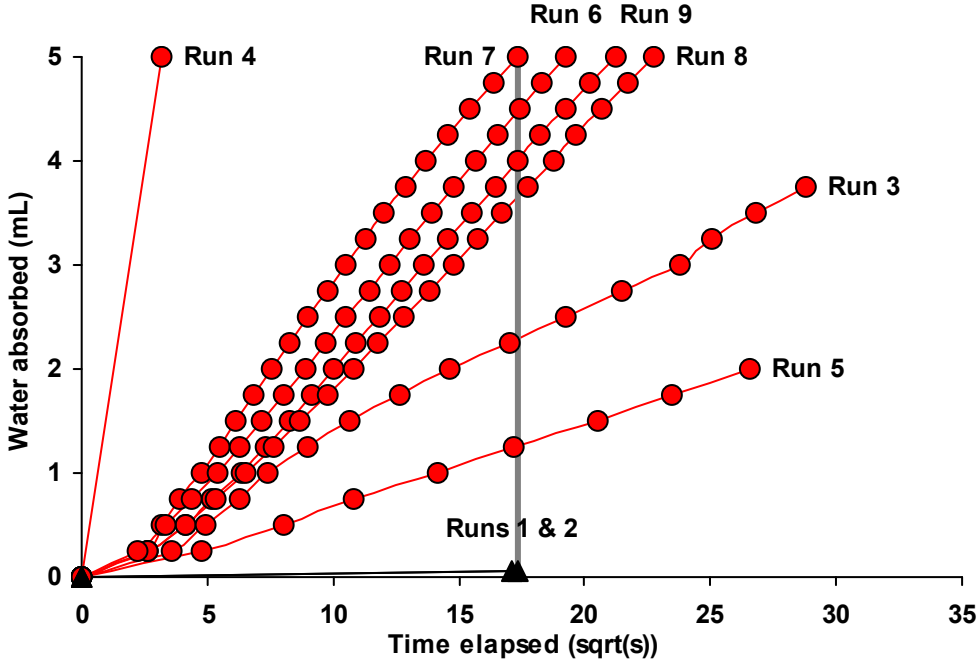
The mortar mix was specified as 1:1:6. Water absorption coefficients measured on some of the drier areas of the gable are close to those in the literature for 1:1:6 mortar (Tables 4.1 & 4.2). However, water absorption coefficients on damper areas of the gable are much higher than those expected of 1:1:6 mortar. It has been suggested² that pointing which absorbs more than 5mL water in 5 minutes is too permeable. Run 7 achieves this rate of absorption and Runs 6, 8 and 9 are close to it. Run 4 (which may be exceptional) had a much higher rate of water absorption.

Figure 4.8 Water absorption data from RILEM tube measurements. The vertical line shows 5 minutes duration. Pointing which takes up more than 5mL in 5 minutes can indicate a serious problem with excessive water absorption. Note that the less water absorbent areas (Runs 3 & 5) correspond with drier areas of the gable and the more absorbent, with wetter areas.

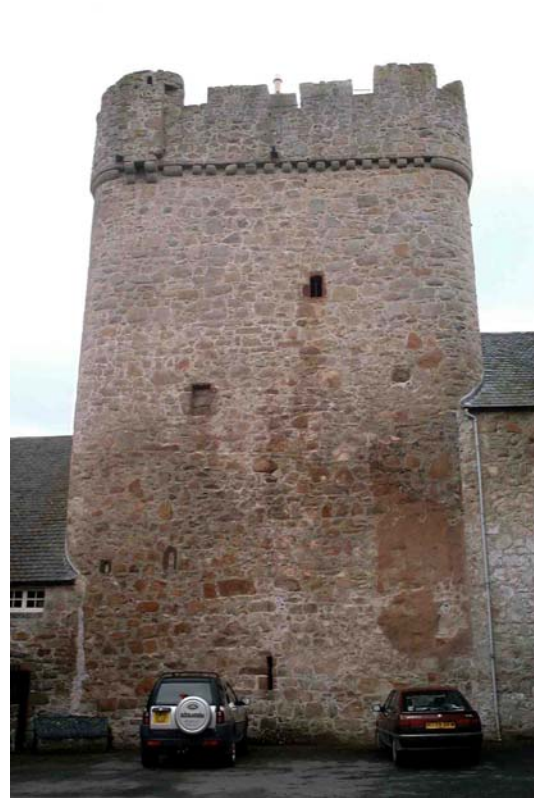
Plate 4.36 West wall of the keep. Damp patches can be observed on the lower parts of the wall.
