Appendix 1

Historical Mapping & Photography included:

9 North Deeside Road, Bieldside, ABERDEEN, AB15 9AD

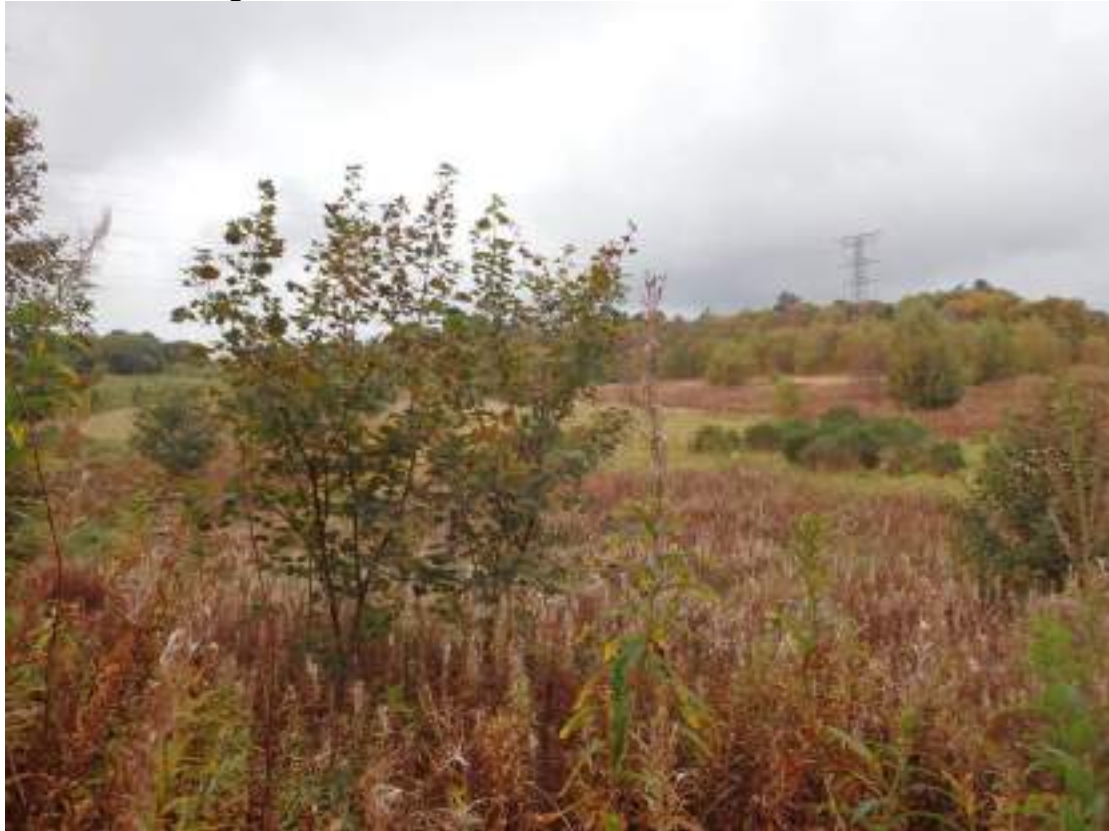
Photo 1: Looking north across

Surface condition and safe walking	<p>e.g. Tarmac/concrete/grass etc; broken/smooth?</p> <p>In general the site is covered with grass and herbage (rosebay willowherb dominant). Areas of shrubs and tree are located across the site (Photo 1, Photo 5, Photo 14, Photo 19 and Photo 27).</p>

Surface topography	<p>e.g. Elevation/slopes/mounds on site & adjacent?</p> <p>The topography of the site is undulating, however in general the site slopes to the south (Photo 1, Photo 10, Photo 26 and Photo 27). The centre southern field has a dip/bowl in the south western corner of the site (Photo 26 and Photo 28). A smaller dip is located in the south western corner of the western field (Photo 3 and Photo 4).</p>	
Surface slopes and steep faces, details of land reshaping	<p>e.g. Man-made/natural/height/angle?</p> <p>A step in ground level is noted between the centre and western field in the south section of the site (Photo 24). The railway track to the east is noted to be on a bank</p>

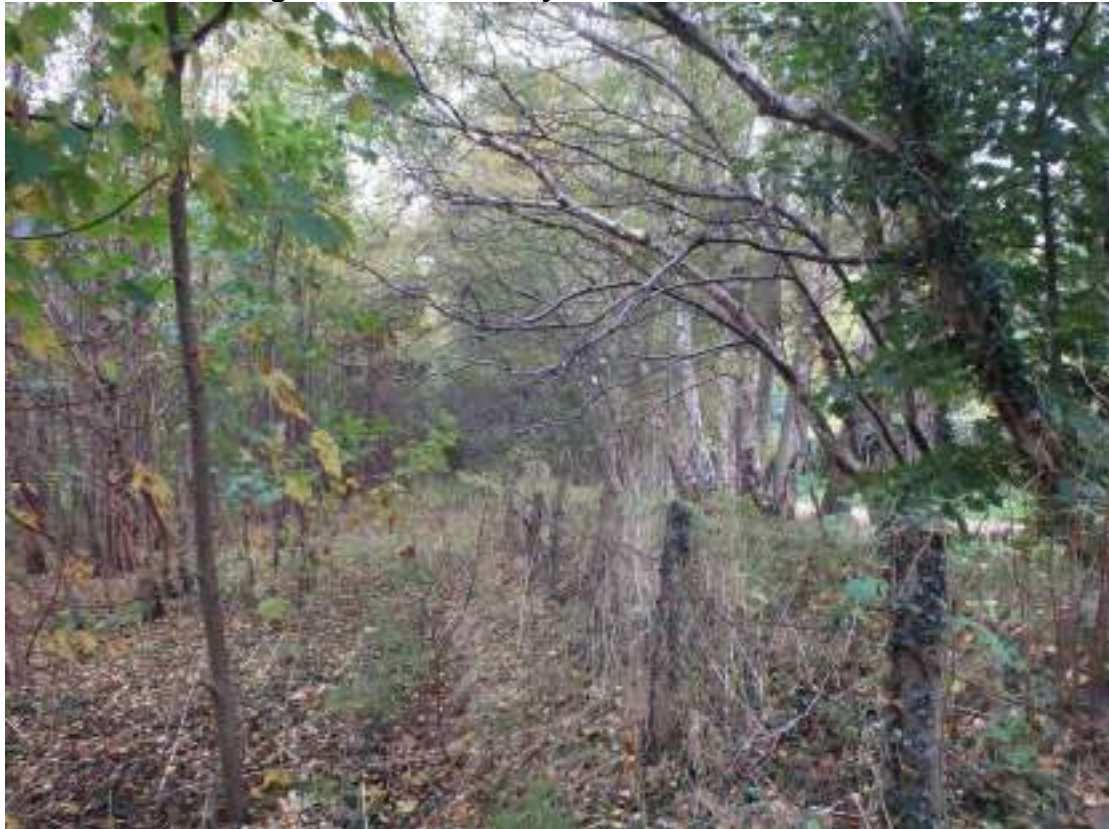
(above GL) (Photo 6 and Photo 16) and where it enters the old platform to the east is in a cut (Photo 29). The road in the north of the site is above the site's GL with a possible retaining wall (Photo 12).	
Evidence of subsidence	e.g. damage to buildings/surface depressions None	
Evidence of landslip, slides or failures.	e.g. Abrupt changes in slope profile/tilting trees, posts or walls None	
Evidence of cuttings or toe slope excavations	e.g. Locations/gradient None.	
Evidence of imported soil, tipped material or rubbish	e.g. Does it have an odour?/is it hot? Few areas of garden debris across the site where this has been dumped from surrounding properties. Few areas of rubbish left across site including beehives in the south east corner, and BBQ waste near Pitfodels Station Road. (Photo 4, Photo 7 and Photo 11).	
Retaining walls	e.g. Height/construction/condition? A potential retaining wall was noted to the north of the site (Photo 12).

Photo 6: West along dismantled railway line

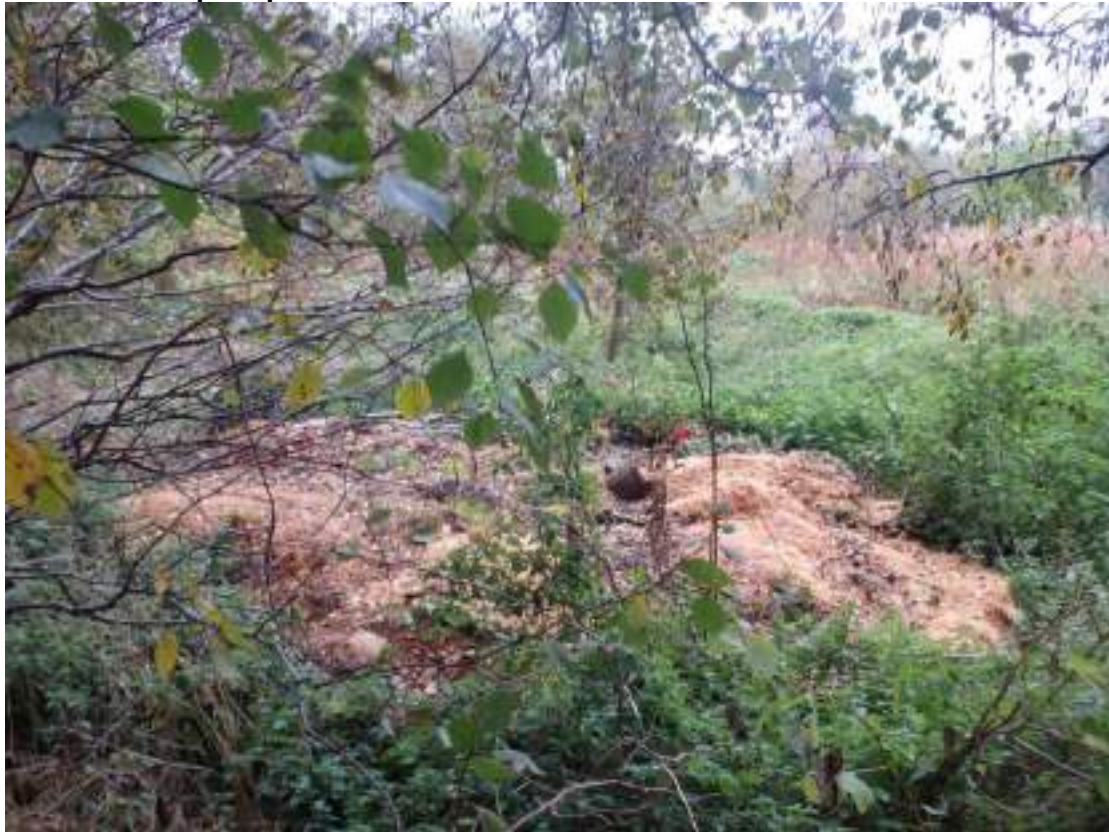
Visible surface Contamination	e.g. Fly tipping/oil etc Areas of rubbish noted across the site and included garden waste, beehives etc. (Photo 4, Photo 7 and Photo 11).	
Unusual odours, fumes or dust	e.g. Type/source? None noted.	
Spillages/ Accidents	e.g. Type/source? None noted.	
Waste Products	e.g. Type/processes? None.	
Delivery and Storage	e.g. Materials/uses/storage? None.	
Materials and processes currently carried out on site	e.g. Raw materials/products? None.	
Plant or machinery on site	e.g. Type/size/use? None.	
Water supply	e.g. Location? None.	
Confined space or restricted working area	e.g. Height/width? None.	
Overhead cables	e.g. Telephone/electricity-33KV/275KV/height? Overhead cable noted crossing the site from the north west of the northern field to the south east corner of the western field.

Photo 7: Compost pile

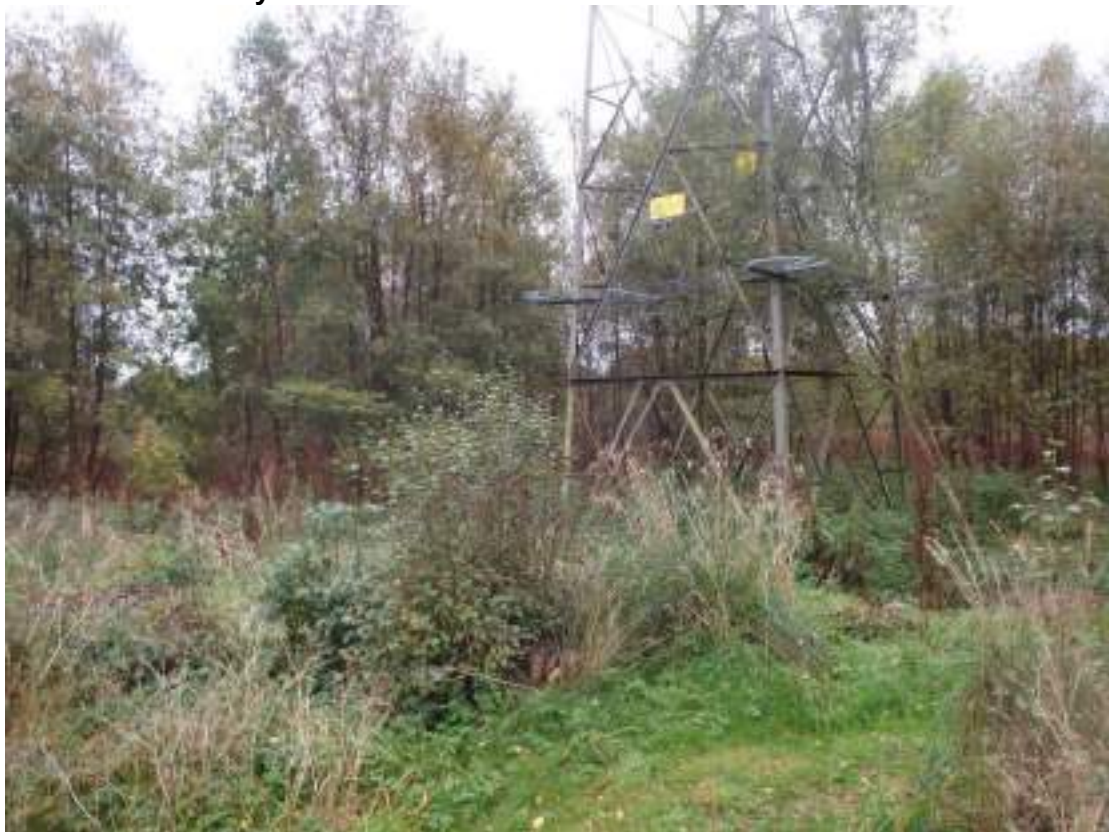
Photo 8: Electricity Pylon within central field

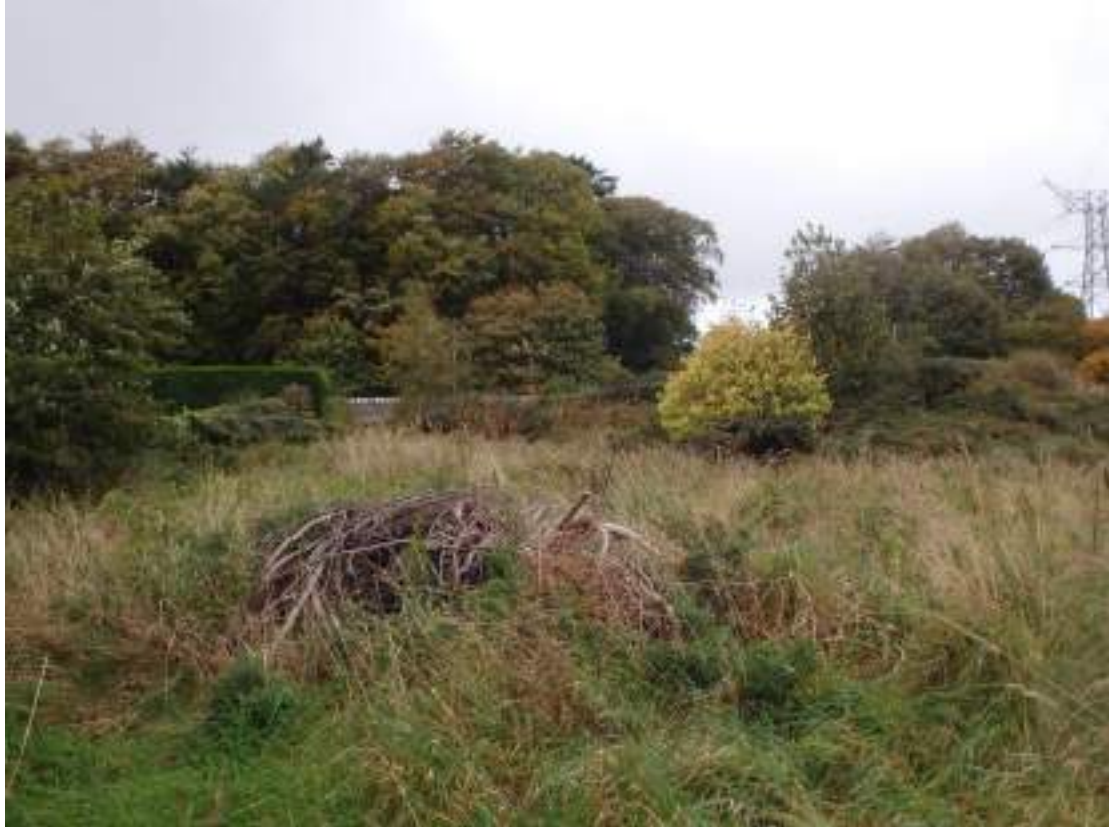
Photo 11: Plant debris and north western corner of northern field

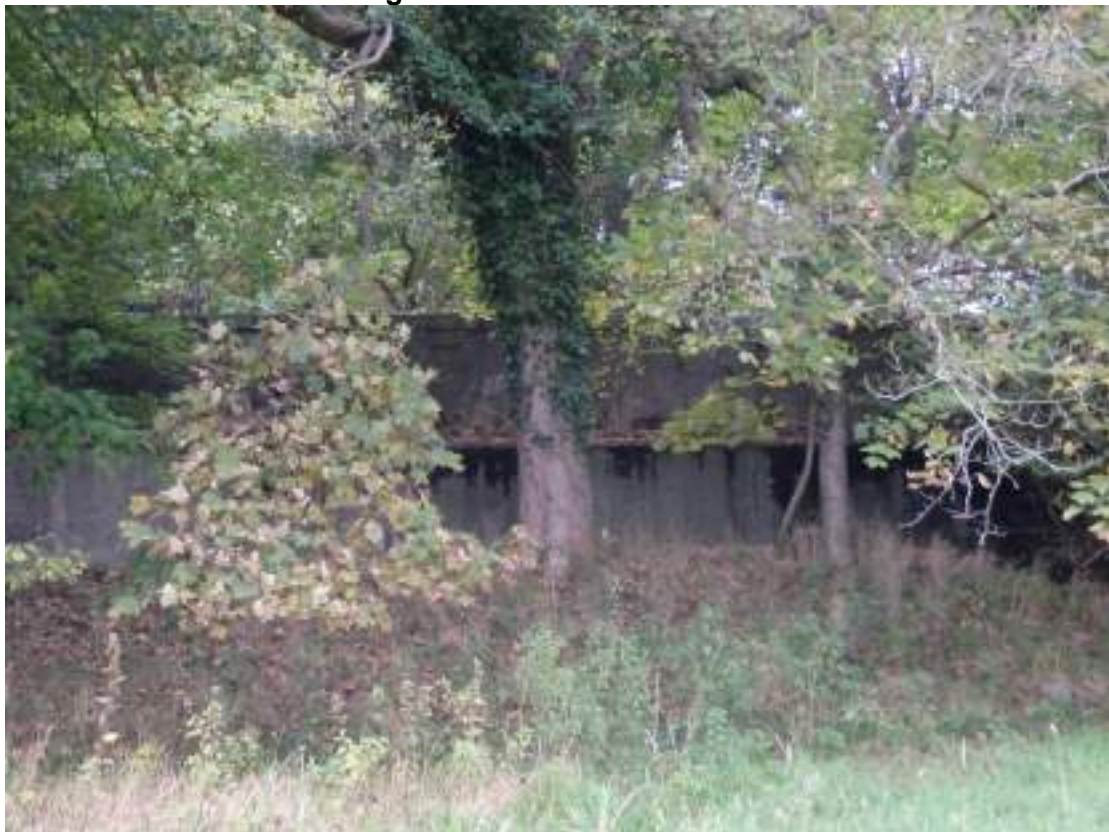
Photo 12: Potential retaining wall in north west of northern field

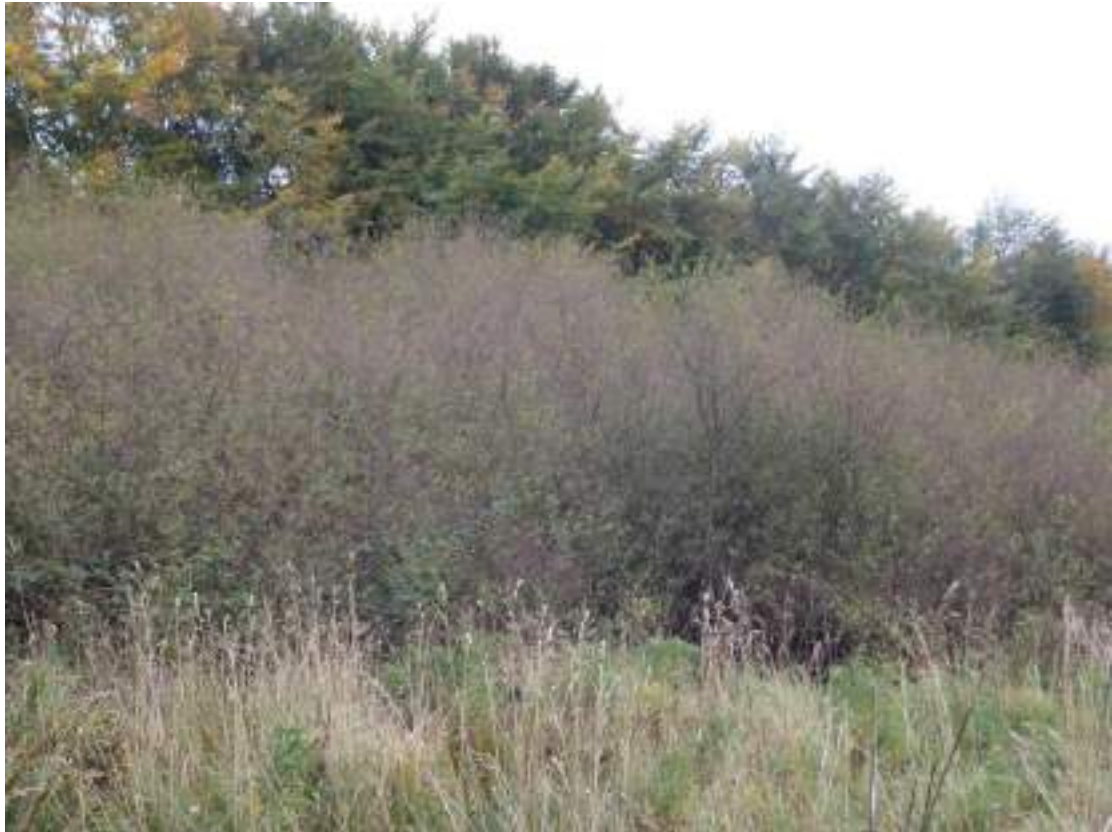
Areas and type of vegetation	Thicket of birch noted in north east corner of northern site (Photo 14). Site boundaries surrounded by mature trees (Photo 2, Photo 5, Photo 6, Photo 9 and Photo 20. Area of thick young trees recorded in south eastern field (Photo 19). Grass and rosebay willowherb dominant.	
Evidence of distress	e.g Dead/dying No	
Tree / Hedgerow species and height	Birch, sycamore, pine, etc.	
Evidence of former trees	e.g Tree stumps Trees across the site.

Photo 14: Trees in north east corner of northern field.

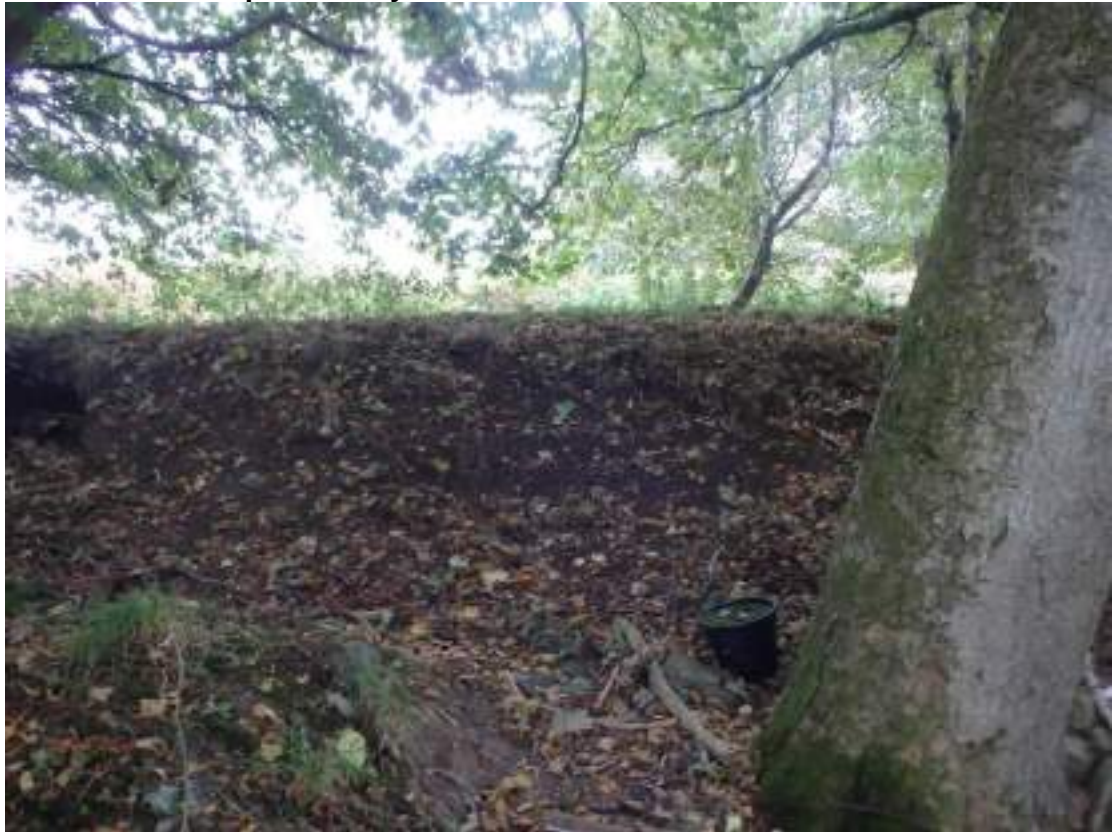
Surface Soils	e.g. Compressible ground/made ground/desiccated clays/pits Made Ground was noted on the bank of the railway track. No other soil exposed (Photo 16).	
Rock Outcrops	e.g. Stream beds/service excavations/cuttings/surface exposures/cliff or slope faces/quarries/pits No rock outcrops.

Photo 16: Bank up to railway track

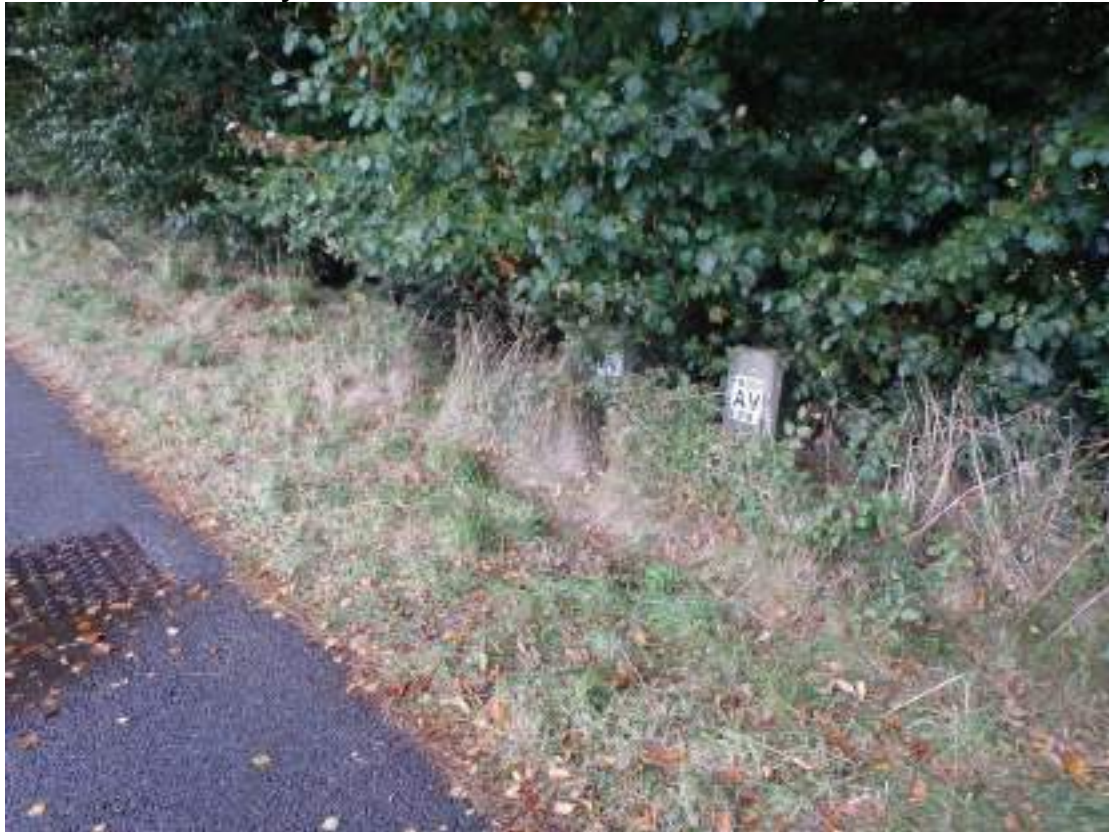
Known history of site	e.g. from historic plans/desk study information/anecdotal evidence? Agricultural, dips in ground still noted in southern site from unknown activity.	
Previous structures	e.g. Size/construction/brick/timber/asbestos/use? None – Railway line crossed the site dividing the site in the north and south.	
Existing buildings/ structures	e.g. Size/construction/brick/timber/asbestos/use? None- railway track dismantled, now a footpath.	
Old foundations	e.g. Size/construction? None	
Building dilapidation and distress	e.g. General condition/cracking? No	
Neighbouring structures under distress	e.g. General condition/cracking? No	
Underground services, manholes, drains, tanks or pits	e.g. Type/size/depth? On railway path cable head stones and cover noted (Photo17)

Photo: 17: Electricity cable headstone and cover on railway track

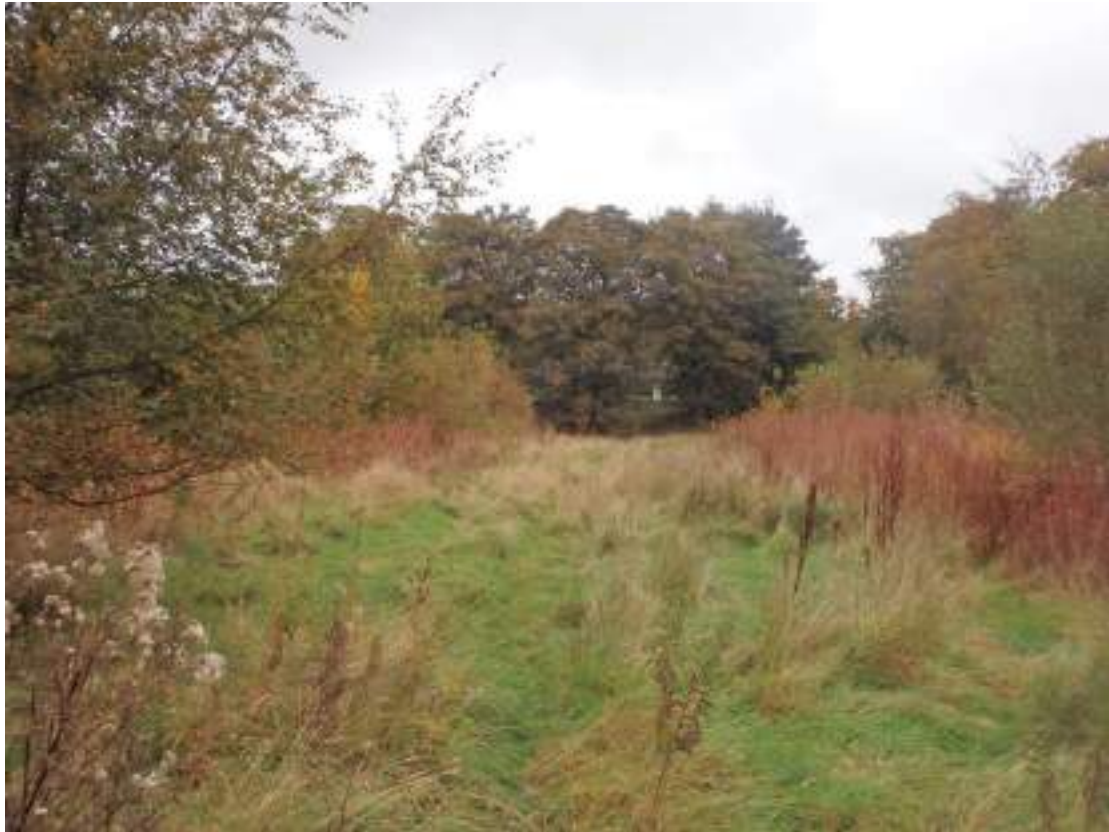
Photo 19: North eastern corner of eastern field

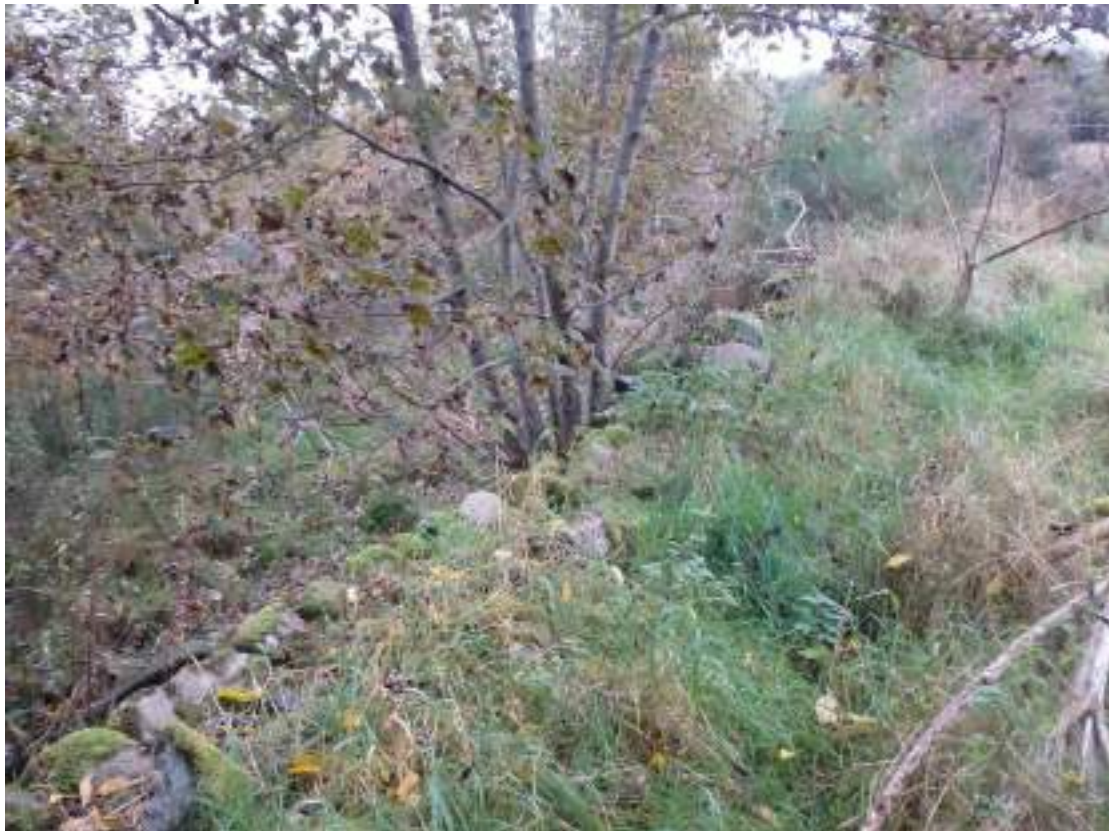
Photo 24: Step between central and eastern field

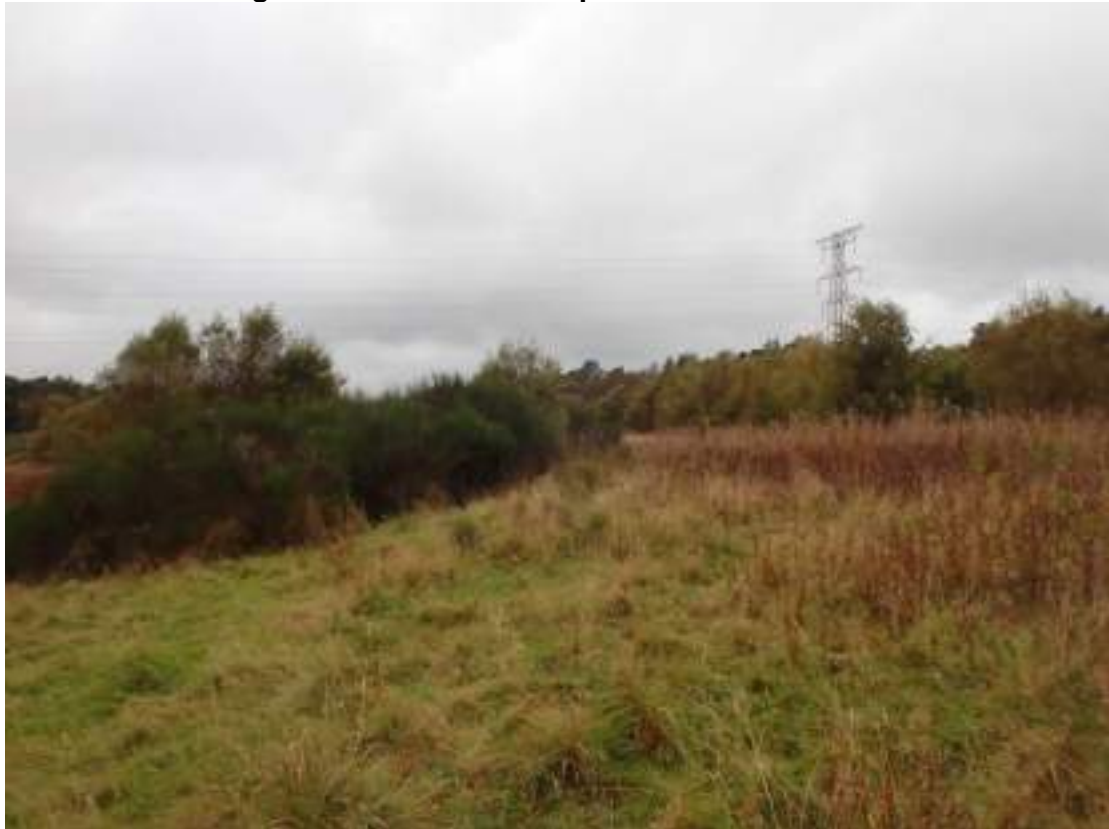
Photo 26: Looking north west across slope in central field

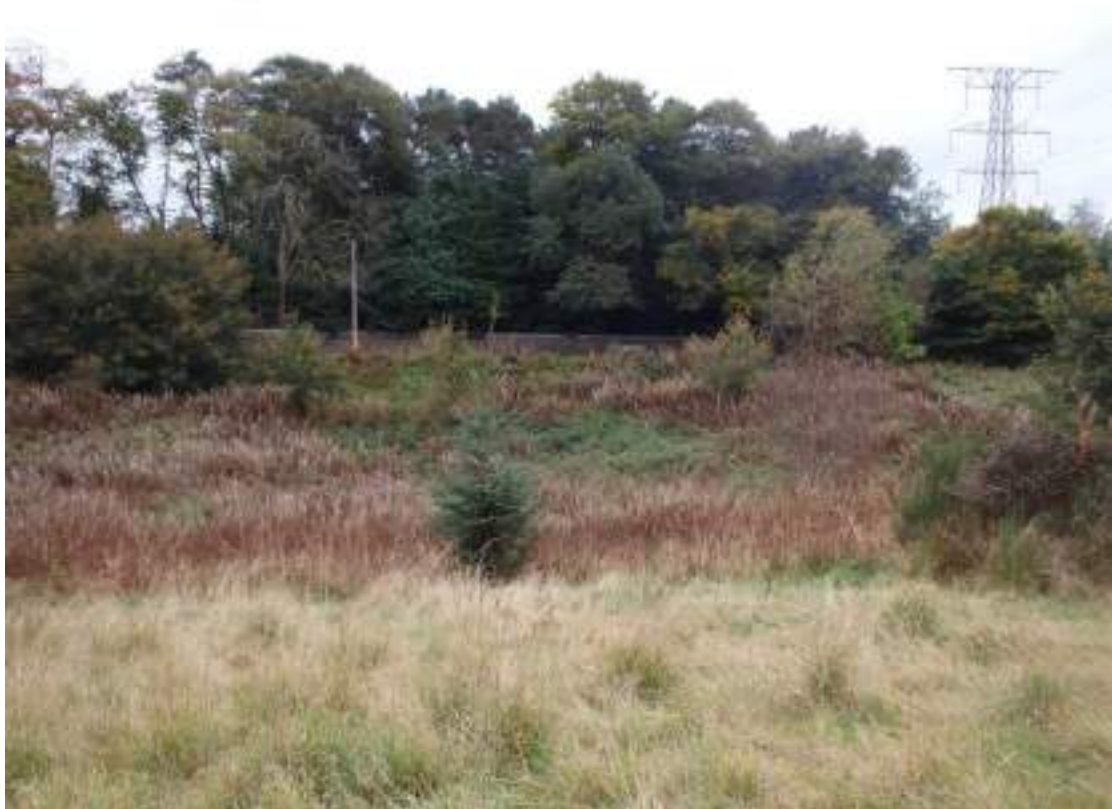
Photo 28: Looking south from top of hill in central field.

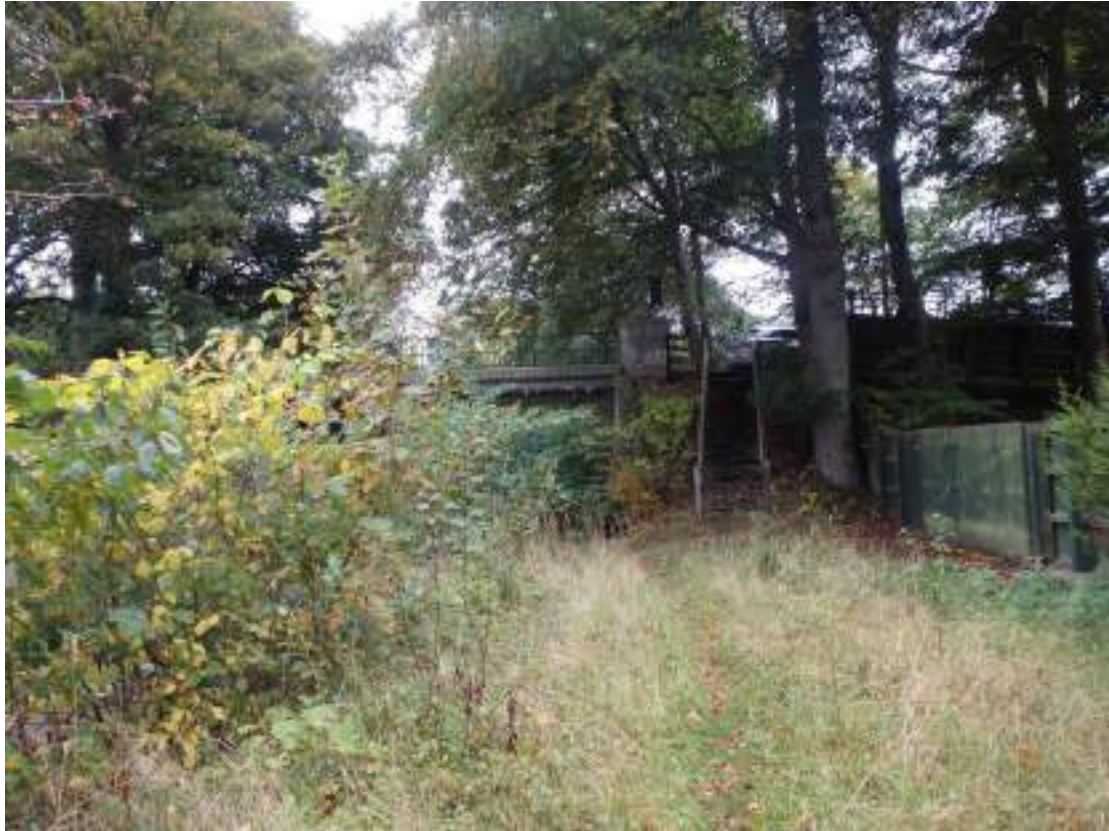
Photo 29: Old Station

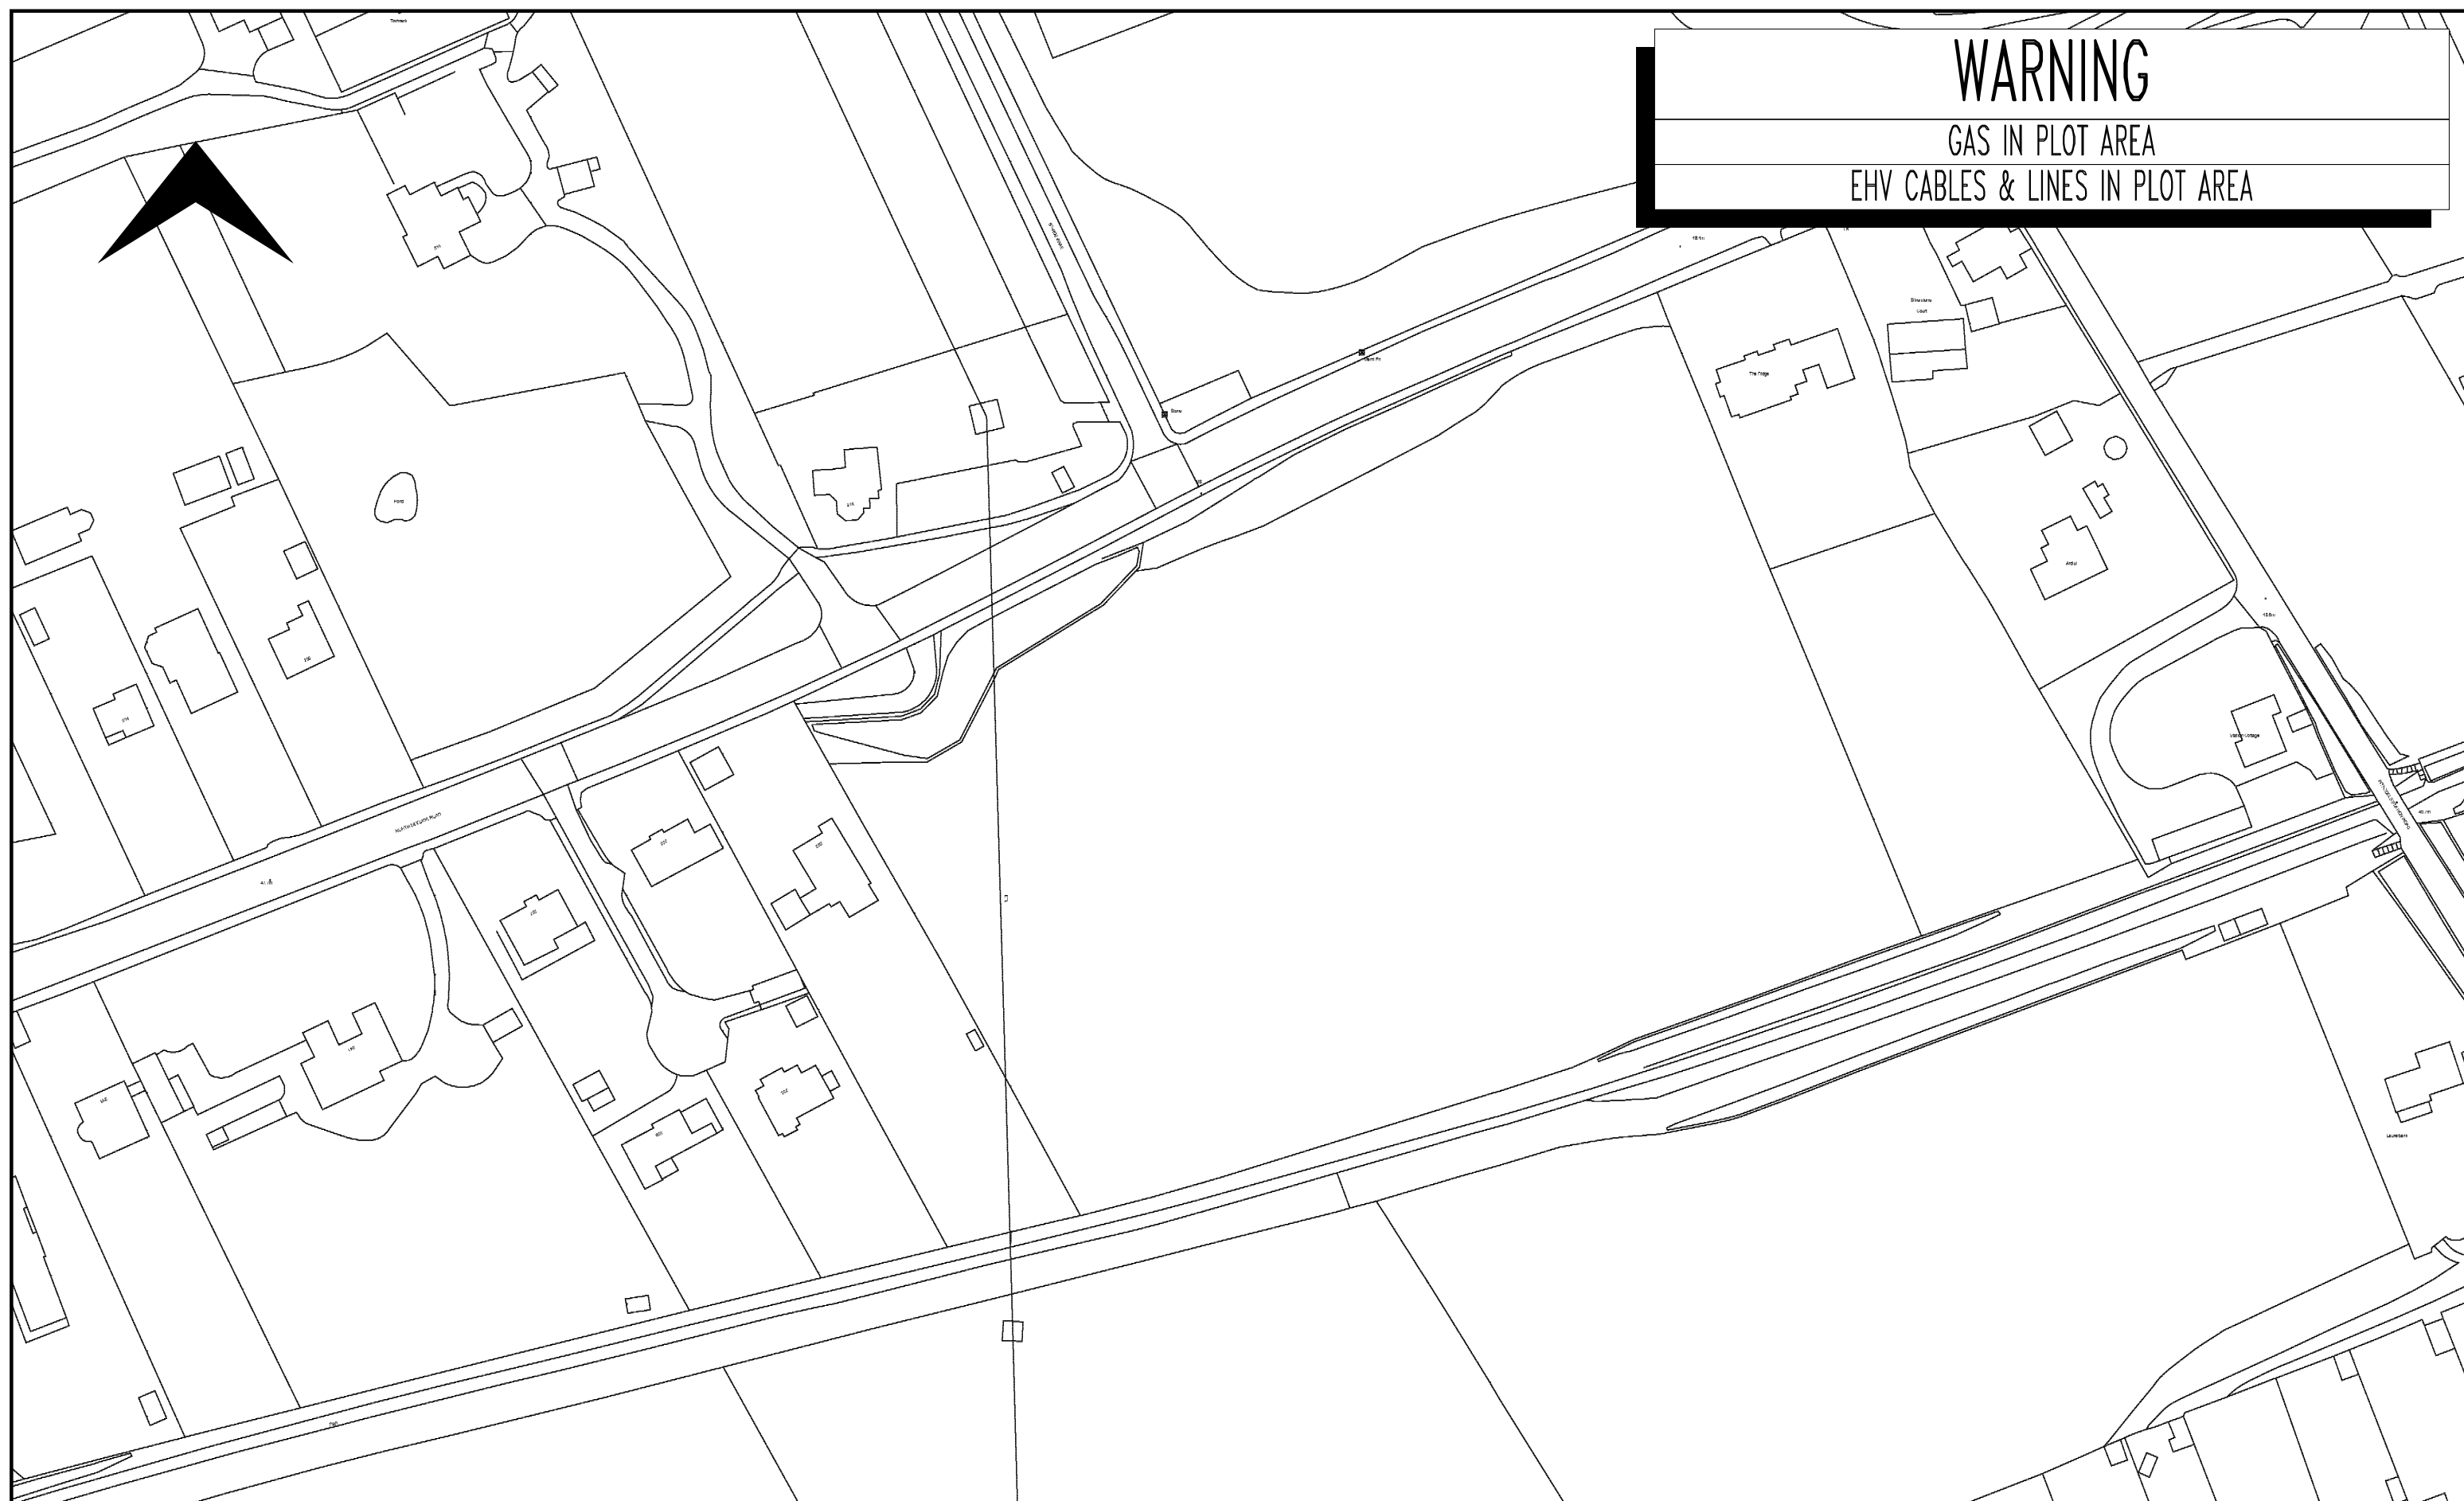
WARNING
 GAS IN PLOT AREA
 EHV CABLES & LINES IN PLOT AREA

NORMAL DEPTH TO THE TOP OF THE PIPE WHEN LAID.

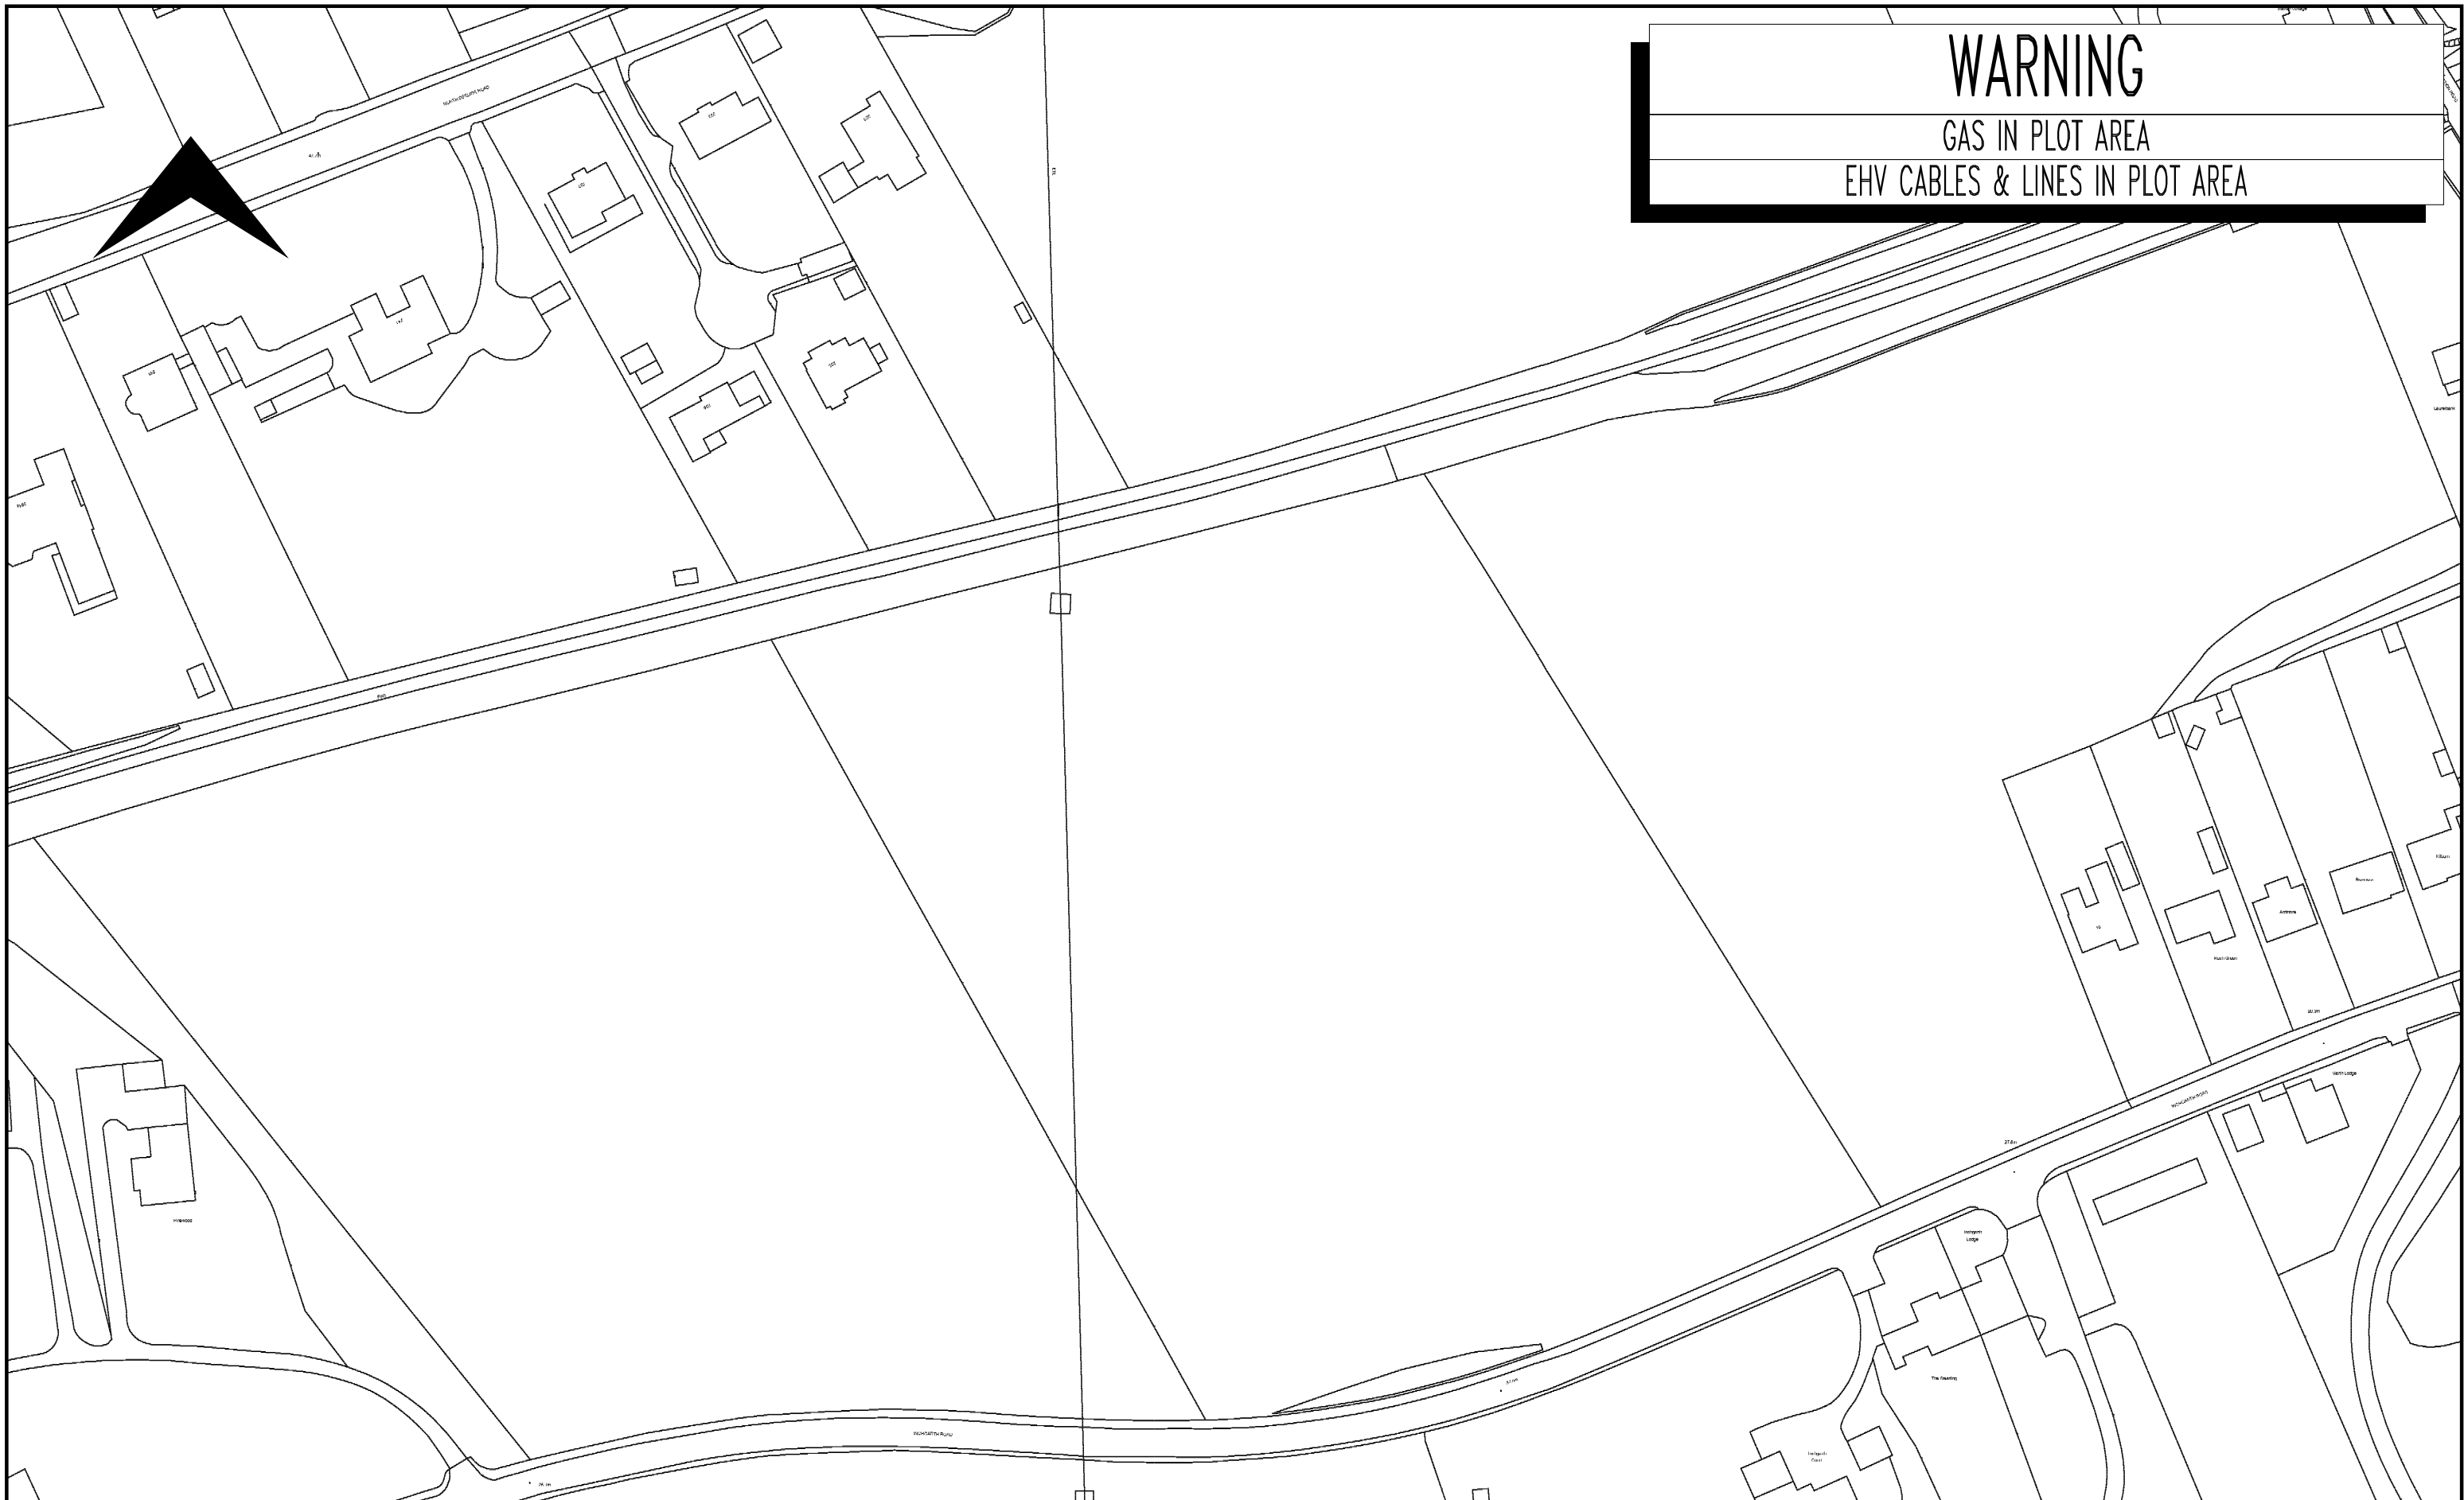
Grid Ref: NJ90430317
 Scale: 1:1250
 Date: 13/10/2016
 All Voltages

WARNING
 GAS IN PLOT AREA
 EHV CABLES & LINES IN PLOT AREA

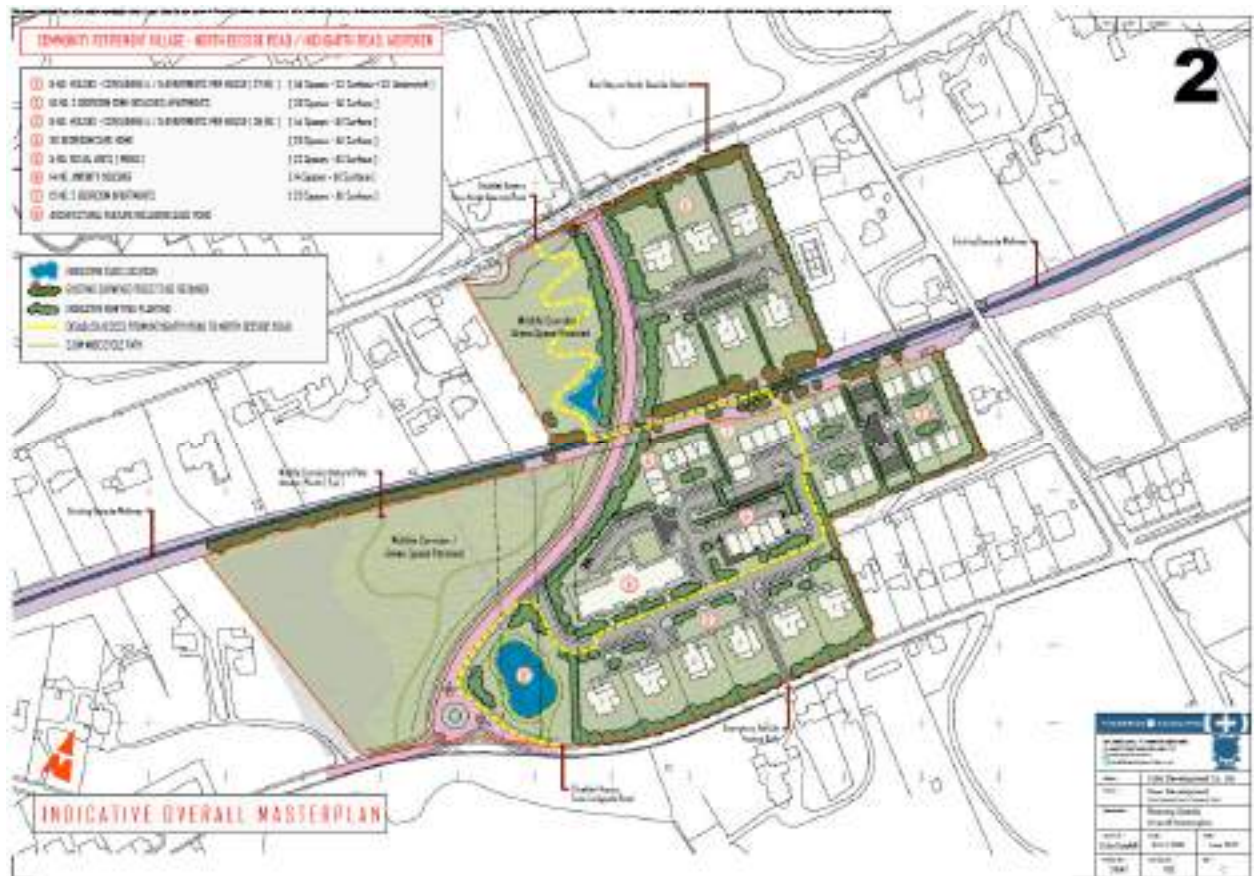
Drawing Number 3847/102C

Appendix B – Site Layout Drawing
