Appendix 1

Historical Mapping & Photography included:

9 North Deeside Road, Bieldside, ABERDEEN, AB15 9AD

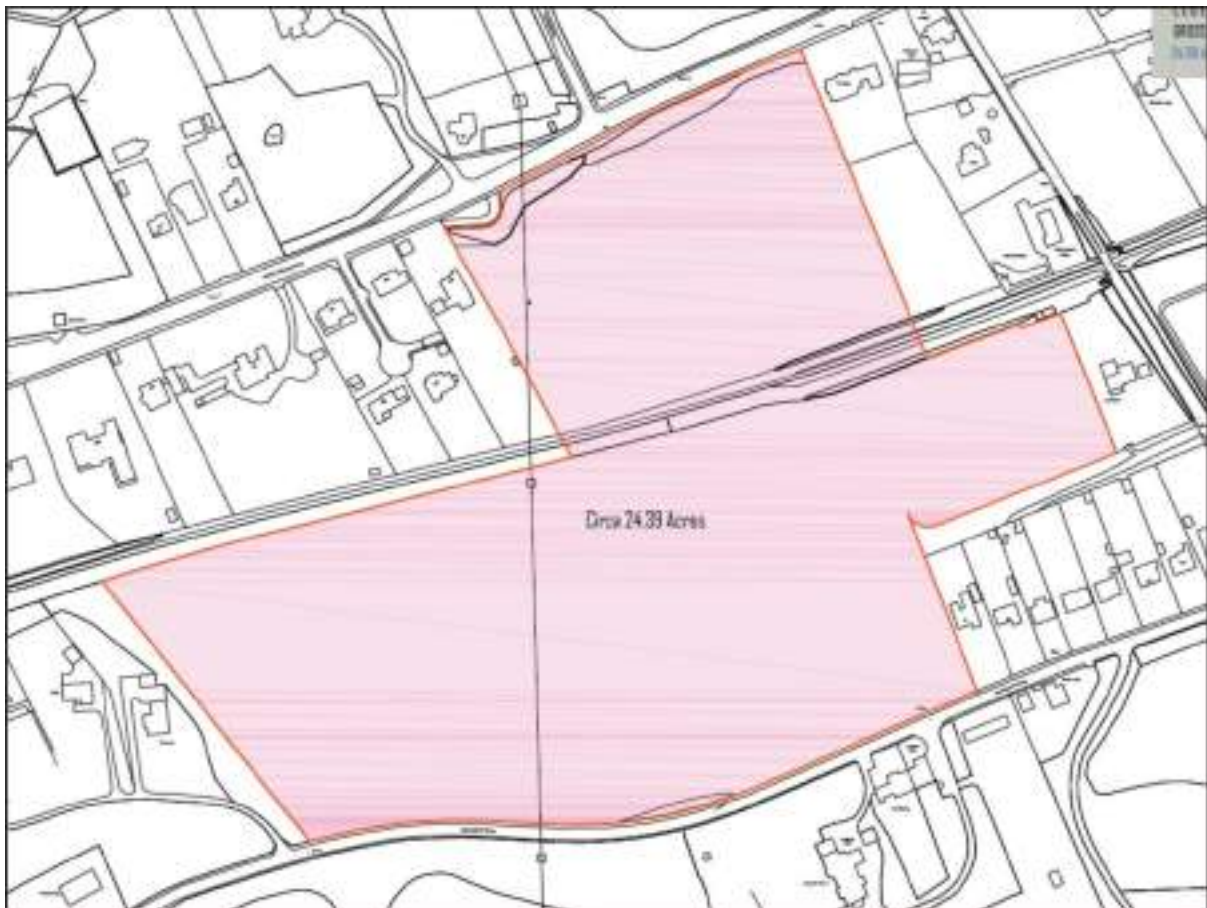
Illus 2 Site plan showing proposed development (*copyright* Fitzgerald Associates)

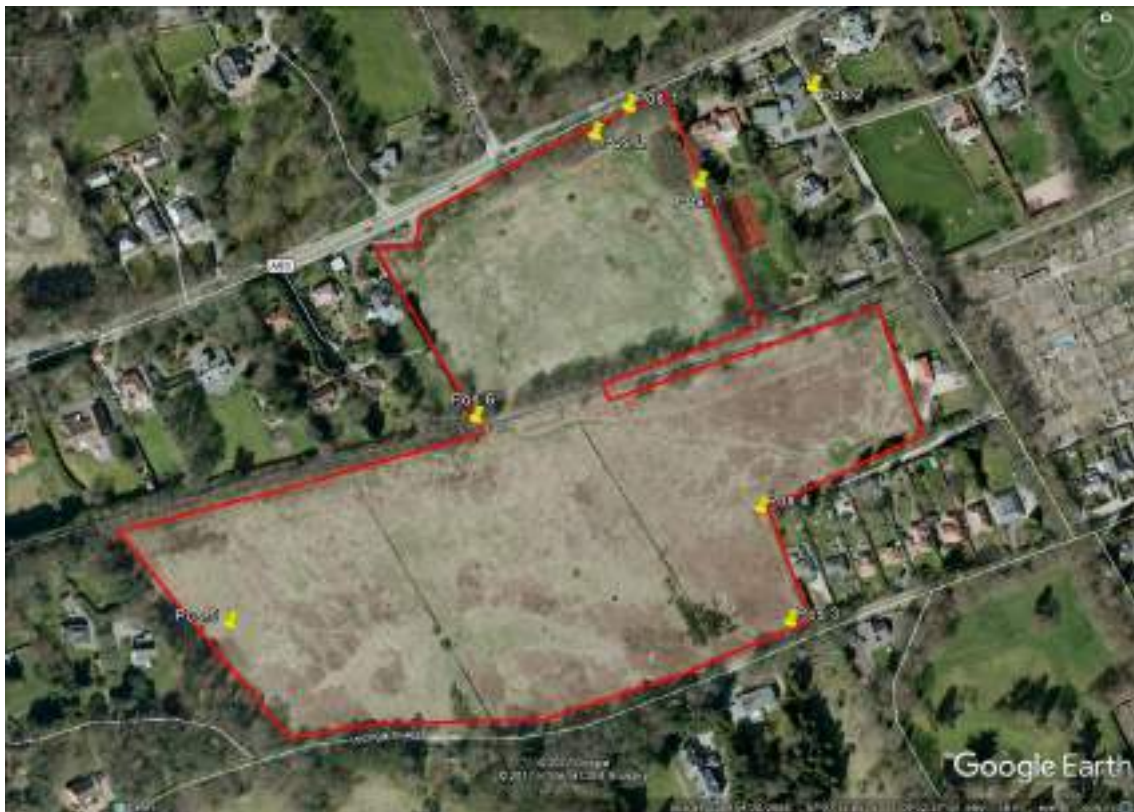
An aerial view of the site and the approximate site boundary is shown in Figure 1.

Figure 1 Aerial view of site (courtesy of Google Earth Pro)

The measurement positions are shown in Figure 1 and are described Table 2.

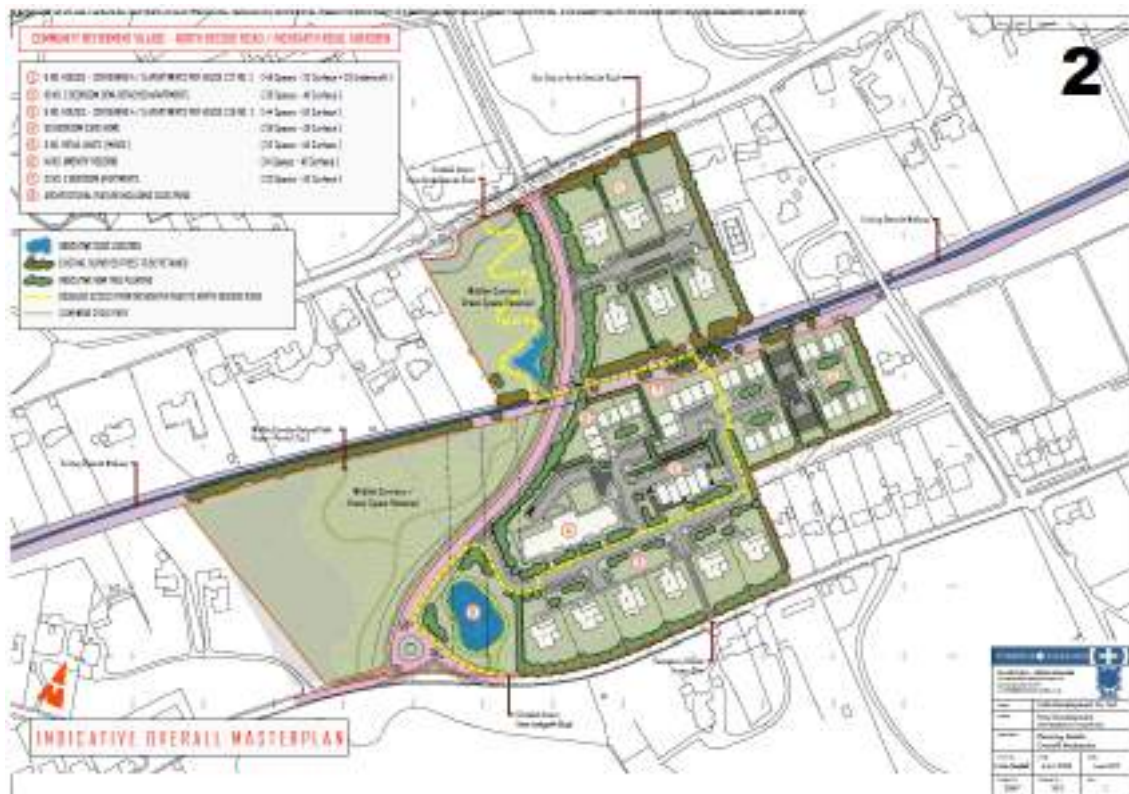
The proposed site plan is given in Figure 2.

Figure 2 Proposed site plan

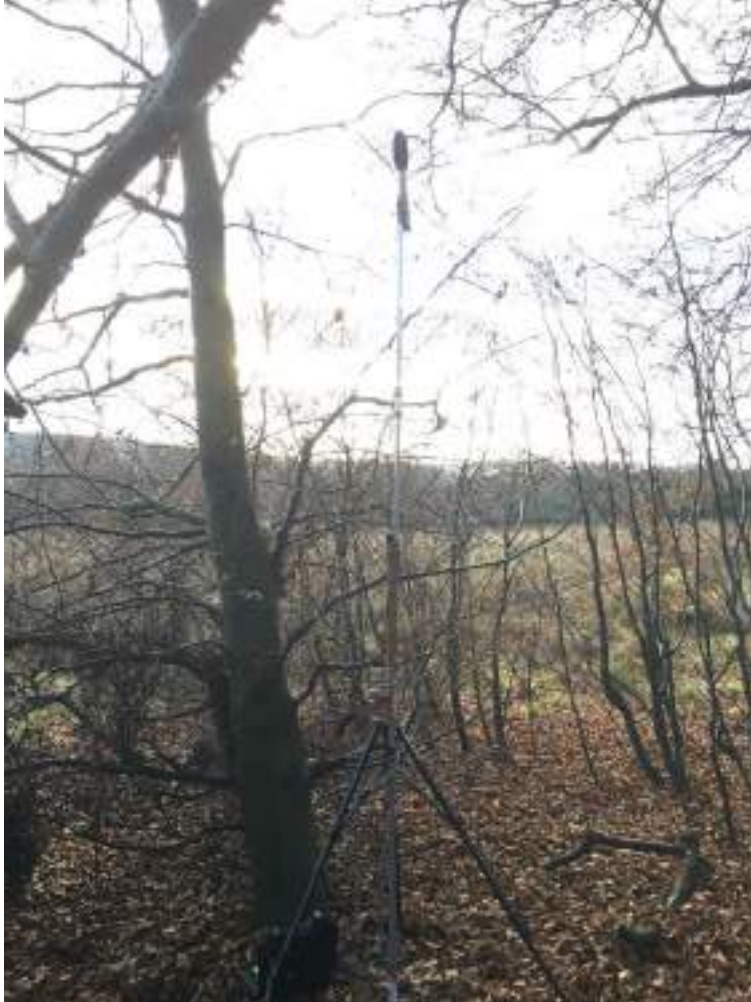
The microphone was attached to a pole which was elevated approximately 4 m above the local ground level. Although elevated, the microphone was still partially screened from North Deeside Road by the existing stone wall on the north boundary.

A photograph of the unattended noise monitoring equipment is shown in Figure 3.

Figure 3 Unattended noise monitoring equipment

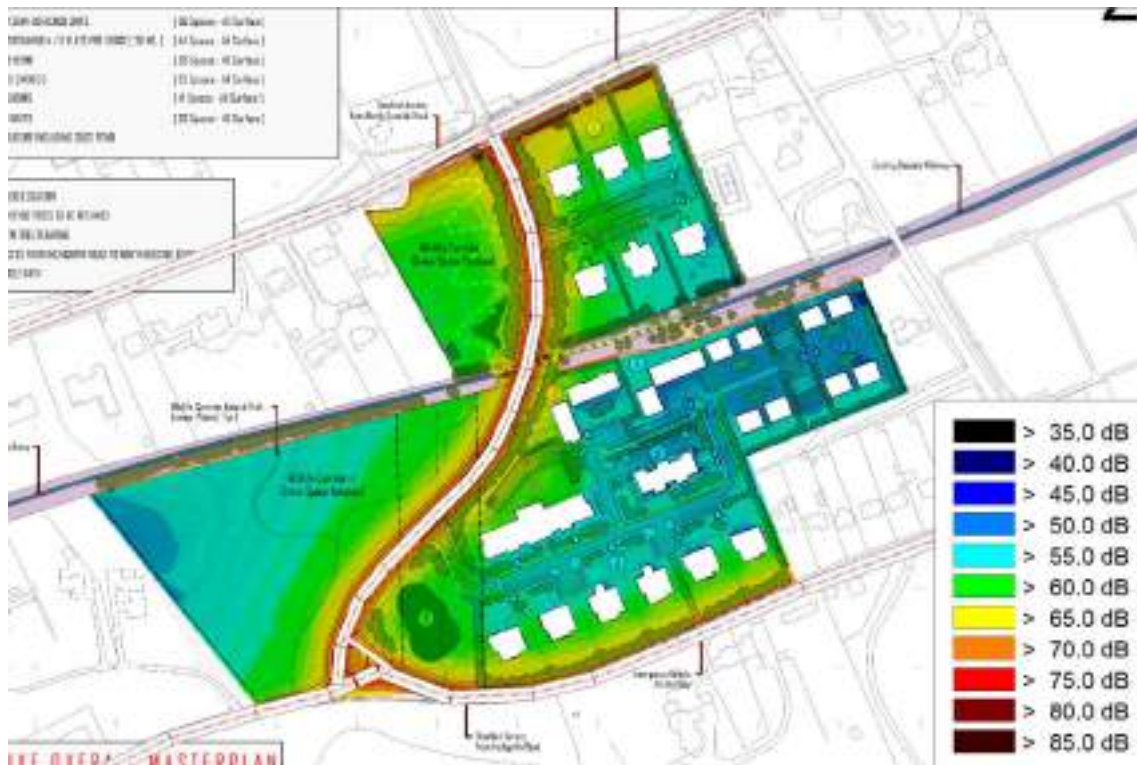
Figure 4 Noise map of the proposed site

The predicted external noise levels are shown in the form of a noise map in Figure 4. The results are presented in terms of the average daytime ($L_{Aeq,16h}$) noise levels. The night-time noise levels are expected to be around 7 – 8 dB lower than the predicted daytime levels. This is based on the results of the noise survey, and guidance given in the DEFRA publication, *Method for converting the UK road traffic noise index $L_{A10,18h}$ to the EU noise indices for road noise mapping*.

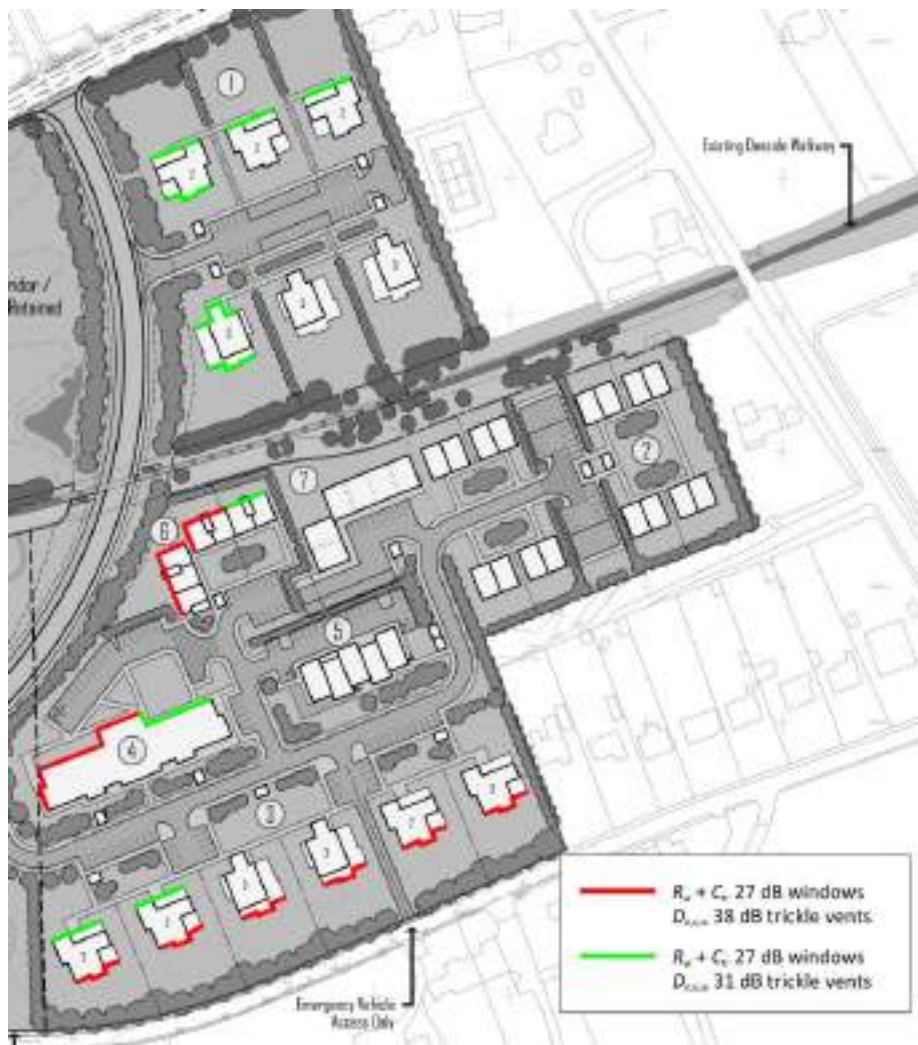
- Windows to the facades highlighted in Figure 5 should have a minimum sound insulation performance of R_w+C_{tr} 27 dB. Trickle ventilators to the same facades should have a minimum sound insulation performance as shown in Figure 5 when in the open position.

Figure 5 Facade sound insulation mark-up

- Windows to noise-sensitive living accommodation should be avoided on the facades directly facing the new relief road
- Windows to the facades highlighted in Figure 5 should have a minimum sound insulation performance of R_w+C_{tr} 27 dB. This performance will be capable of being achieved with double-glazed windows comprising 6 mm glass, 16 mm cavity and 6 mm glass. Trickle ventilators to the same facades should have a minimum sound insulation performance of $D_{n,e,w}$ 31 dB when in the open position

For all other facades, standard double glazed windows and standard trickle ventilators will be acceptable.

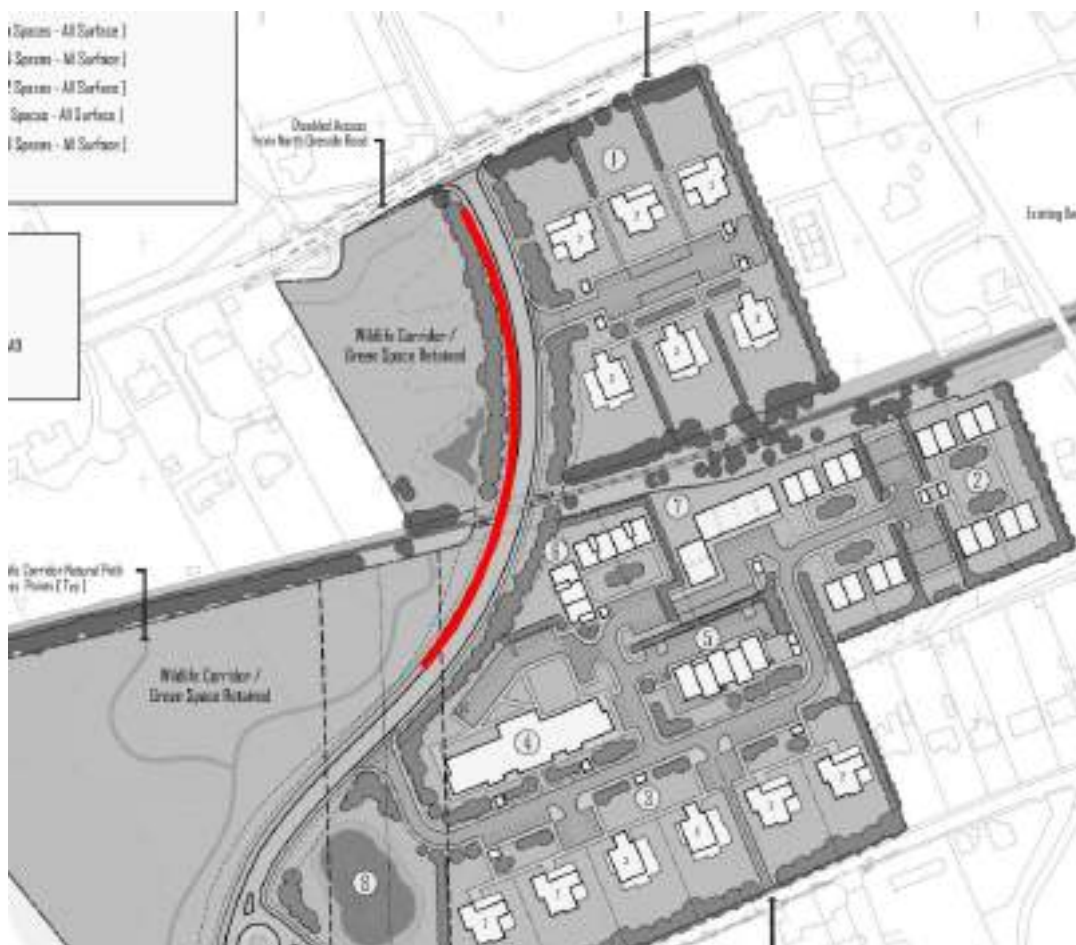
Figure 6 Indicative location of noise barrier to the new relief road

The approximate extent of the noise barrier is shown in Figure 6.

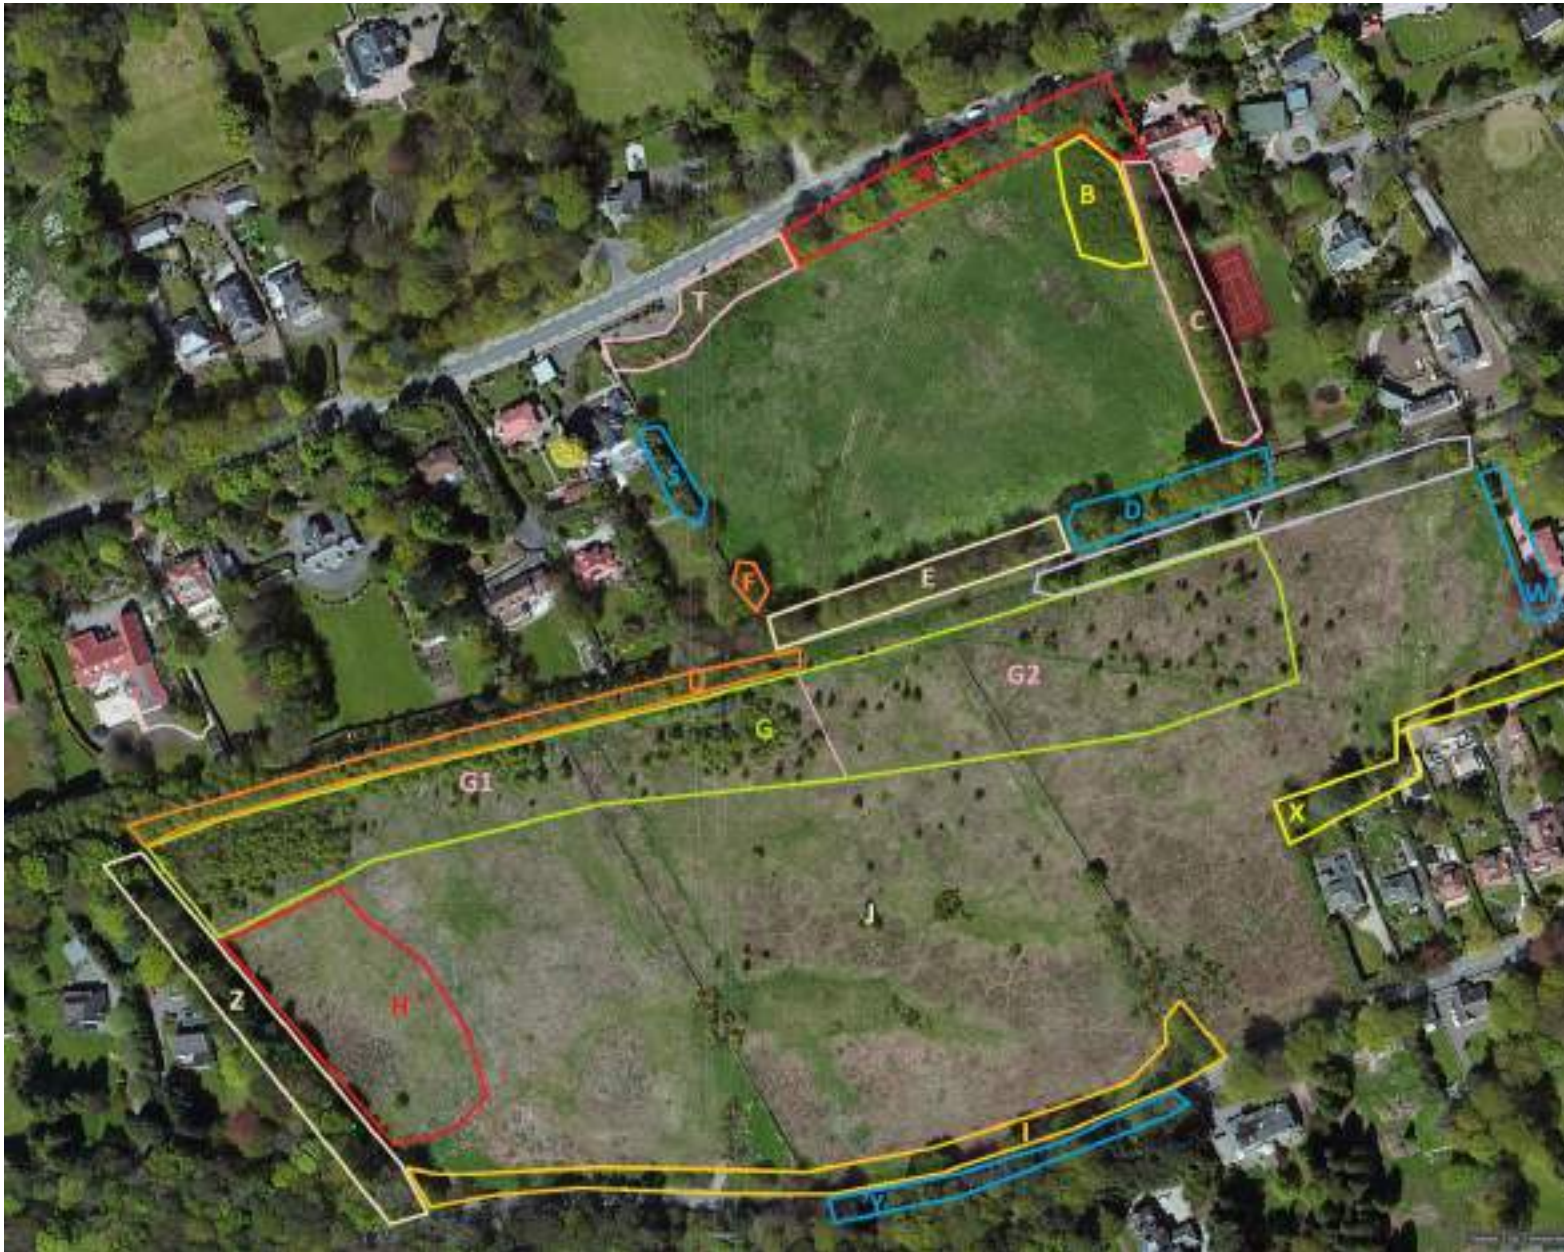
Tree grouping is taken directly from the tree assessment (report IRC-1708-TR). The trees on the site have been grouped into eleven areas (labelled A – J) for ease of description. Group G has been separated into two halves to clarify the description of the management. The trees on the edge of the site have been grouped into eight groups (labelled S – Z). These tree groupings will be used to describe line-of-sight implications and alterations from the baseline.

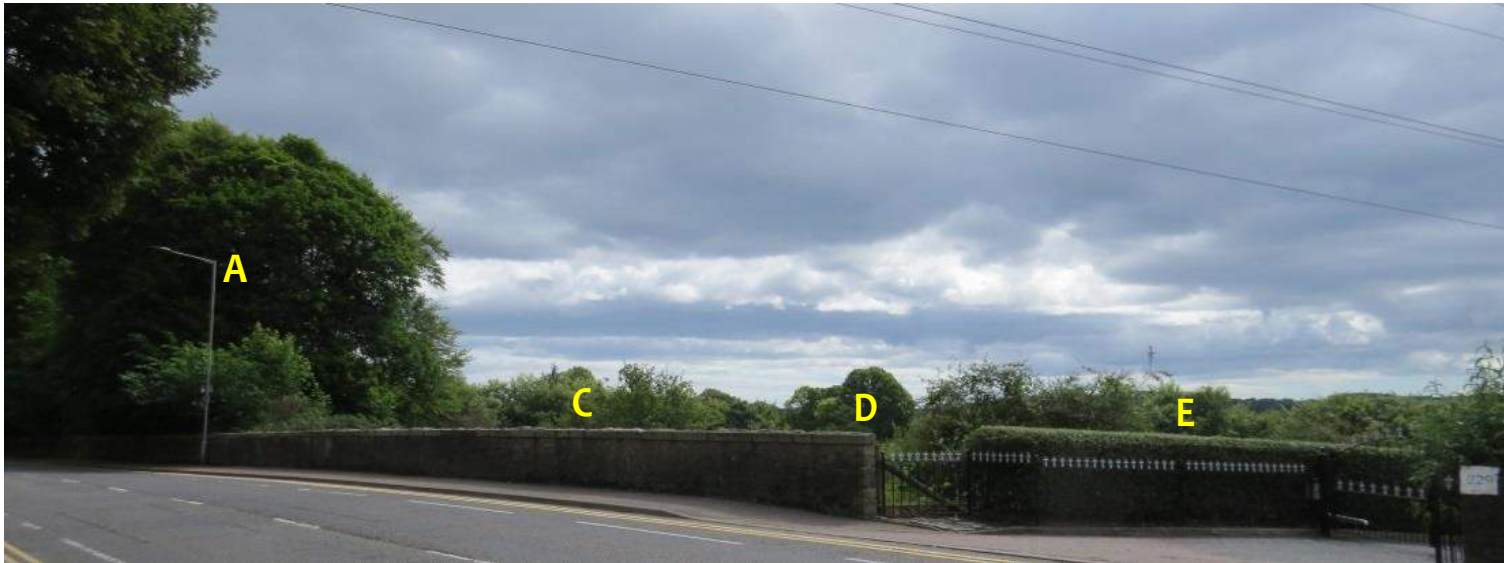
Photo 1:
North Deeside Road, view southeast, over area of public open space. The houses will be constructed on lower ground at the centre of photo. Roofs will be briefly visible as cars go to the east. This view will be screened by new tree and shrub planting.

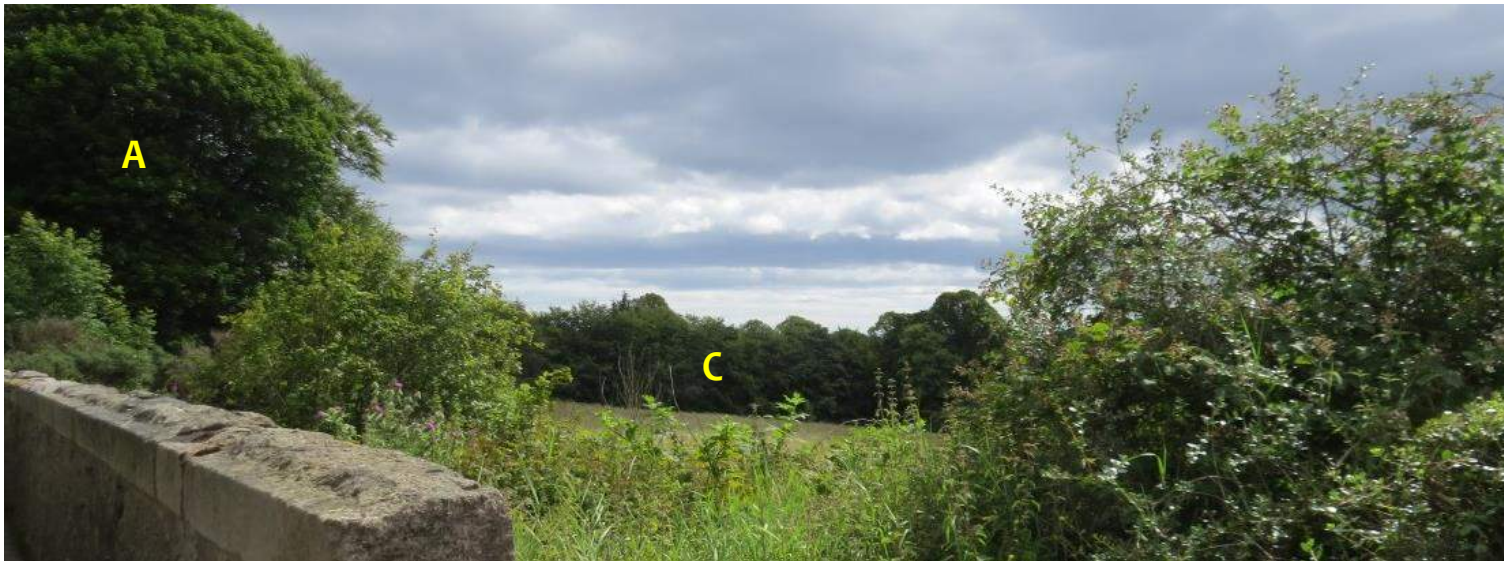
Photo 1a:
Photo from position 1, adjacent to fence and wall on south side of North Deeside Road. The proposed footpath will enter the site from this position. The ground falls away toward the Deeside Way. View of proposed houses and noise barrier on the western side of the road will be limited and eventually obscured by new tree and shrub planting in the area. Tree belt A is on left of photo and beech hedge C can be seen at the centre of the photo.

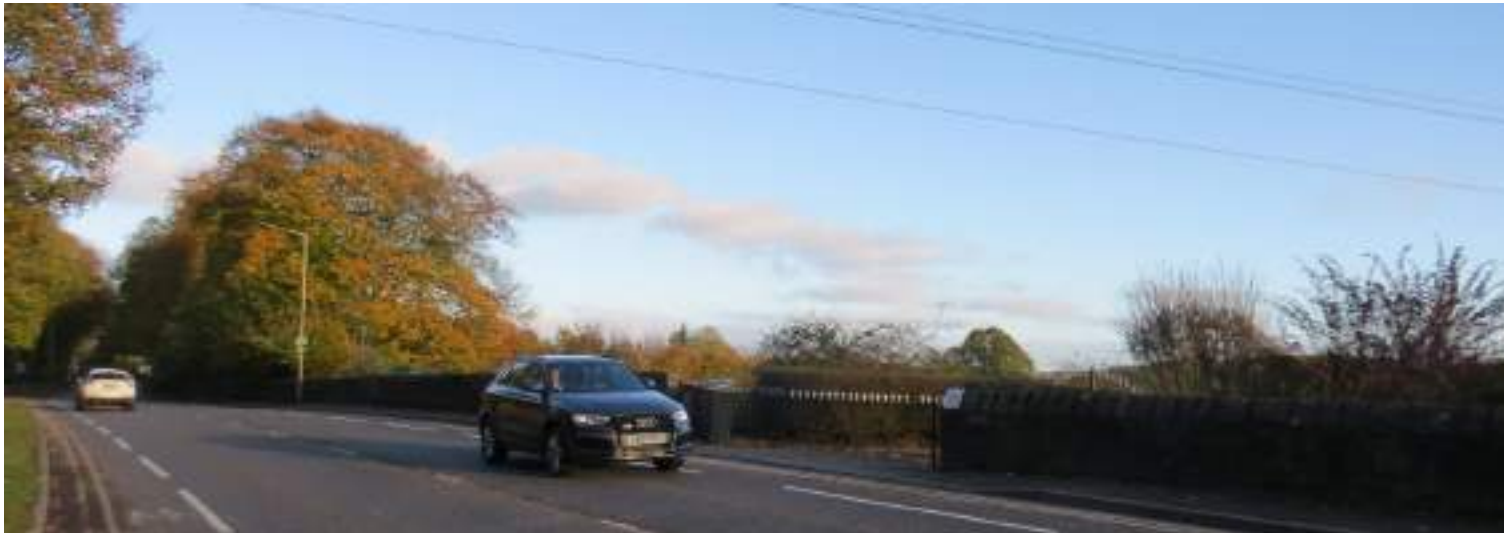
Photo 1b:
View during November to show limited view into proposed development. In future the trees on the left of the photo will blend in with the wildlife corridor planting which will extend to the right, increasing the woodland in the area and will screen views towards the new access road.

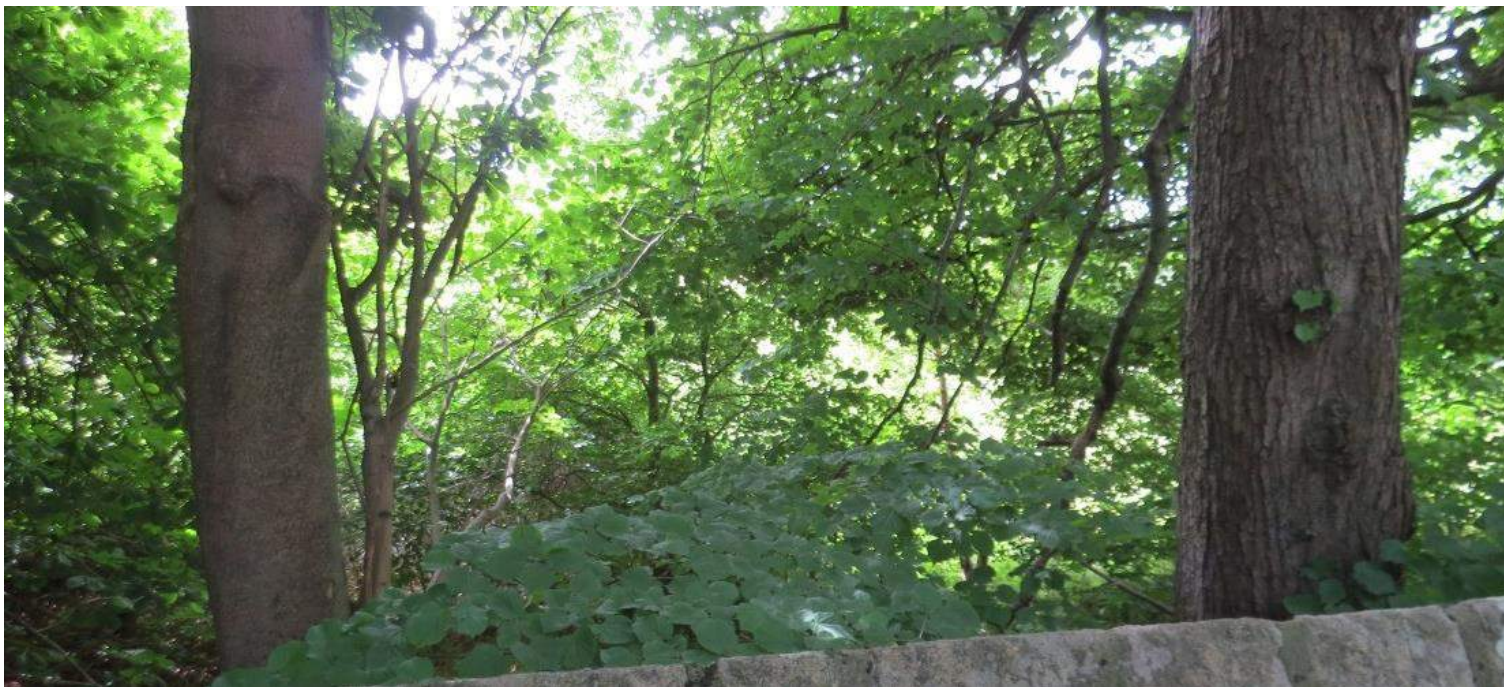
Photo 2:
View south through tree belt A along North Deeside road. Views of proposed houses will be screened and limited. Further planting will reduce these views during the winter months.

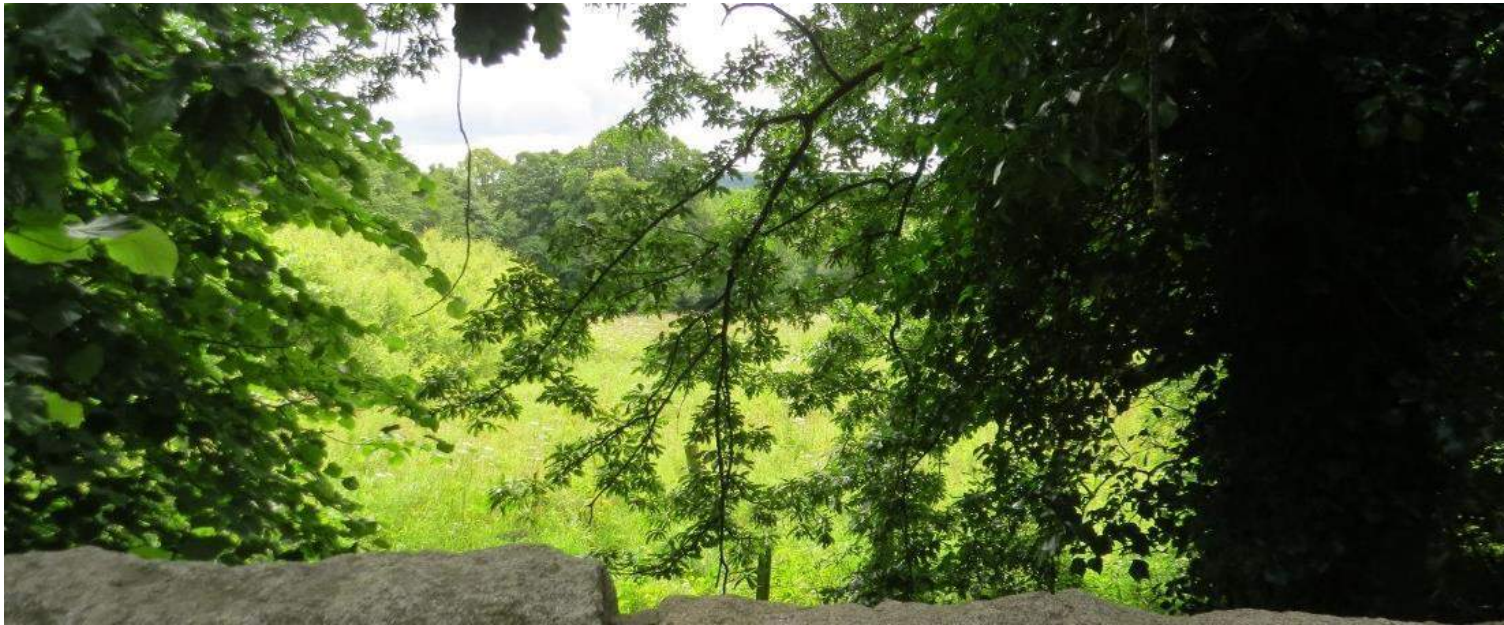
Photo 3:
View towards proposed house positions through tree belt A. Ground contours are reduced as ground falls towards the Deeside Way. Houses are at a lower contour and views into the site are limited. The houses will not be on the skyline but at a lower level, seen against the backdrop of trees. This tree screen is to be thickened by new planting which will widen the tree belt and reduce views during the winter months.

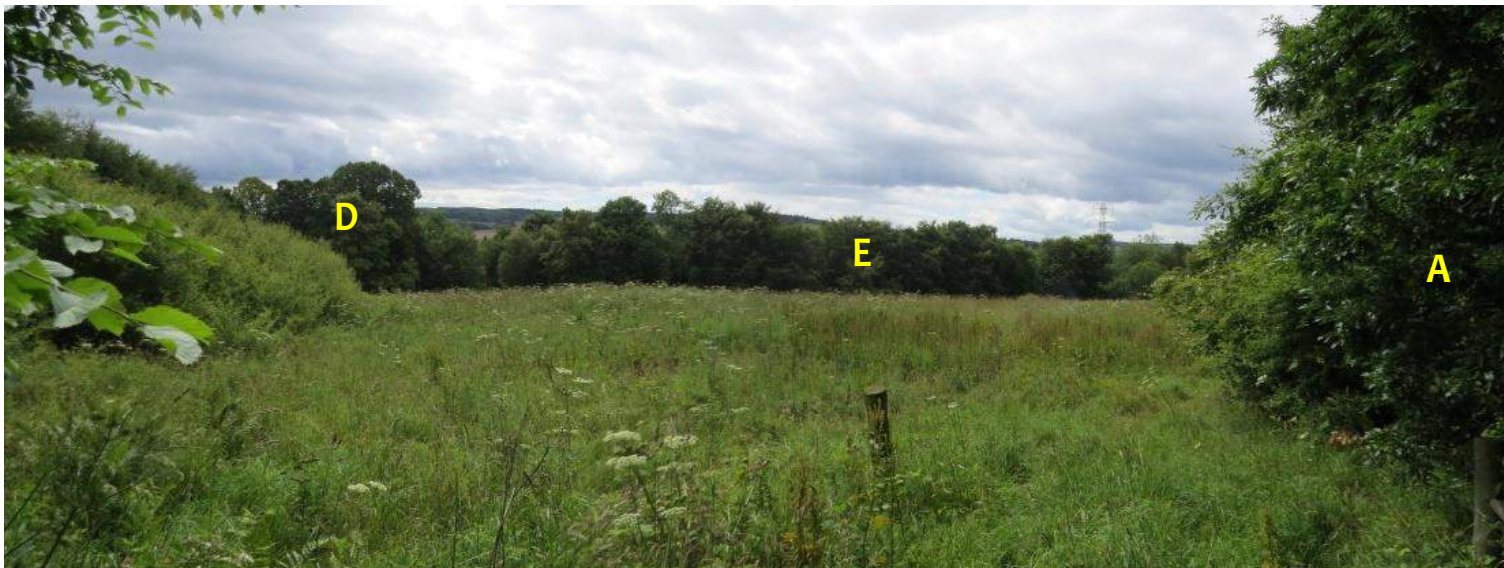
Photo 4:
View from existing field entrance into north field. Beech hedge (trees) (area E) on the north side of Deeside Way are seen across the middle of the photo. Houses in this view will be 7m high and due to the cut and fill operation, will be on a lower contour and less visible against the backdrop of trees. Tree area D is seen on the centre left of this photo.

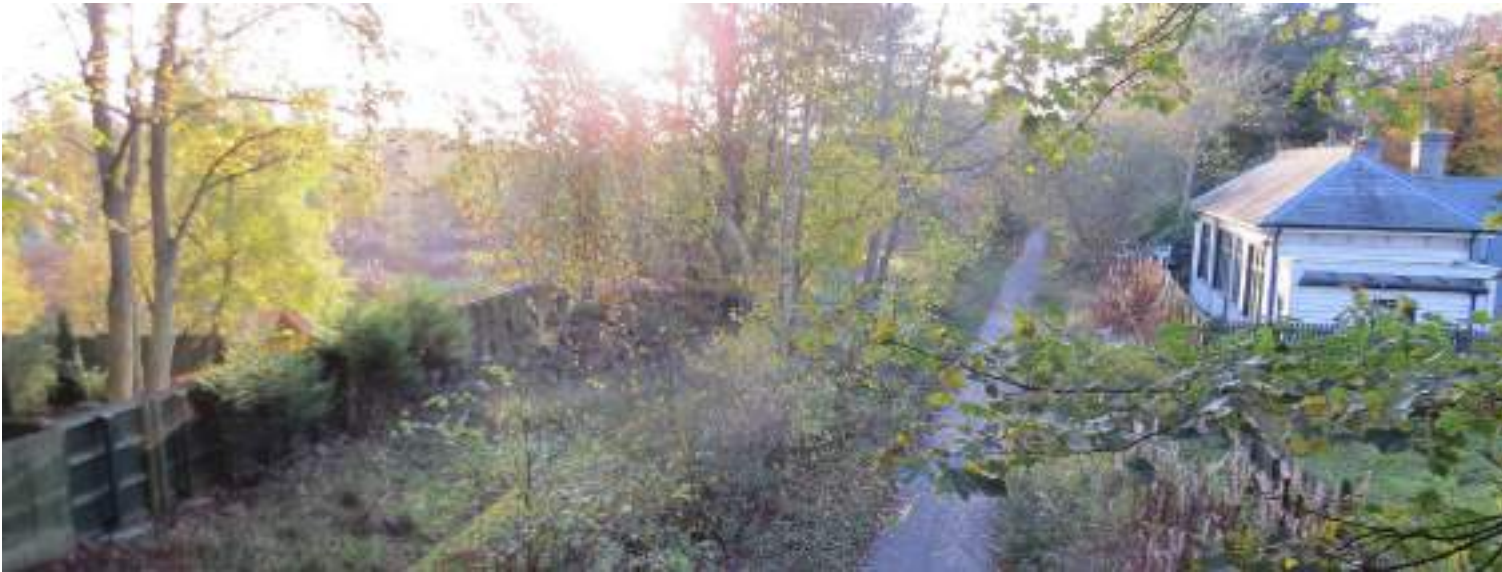
Photo 5:
View from bridge on Pitfodels Station Road. Deciduous sycamore trees screen views from the bridge and Station Road. One gap into the proposed development area is seen in the centre left of photograph.

The views from the Deeside Way (photos 5 – 13) had a level of impact of Moderate Adverse. This is due to the fact that half of the field areas will be changed to buildings and glimpses of parts of this area will be seen from the Deeside Way. The many mature trees surrounding these areas will be retained, limiting views into the development, especially during summer. New tree and shrub planting will reduce this impact in the near future.

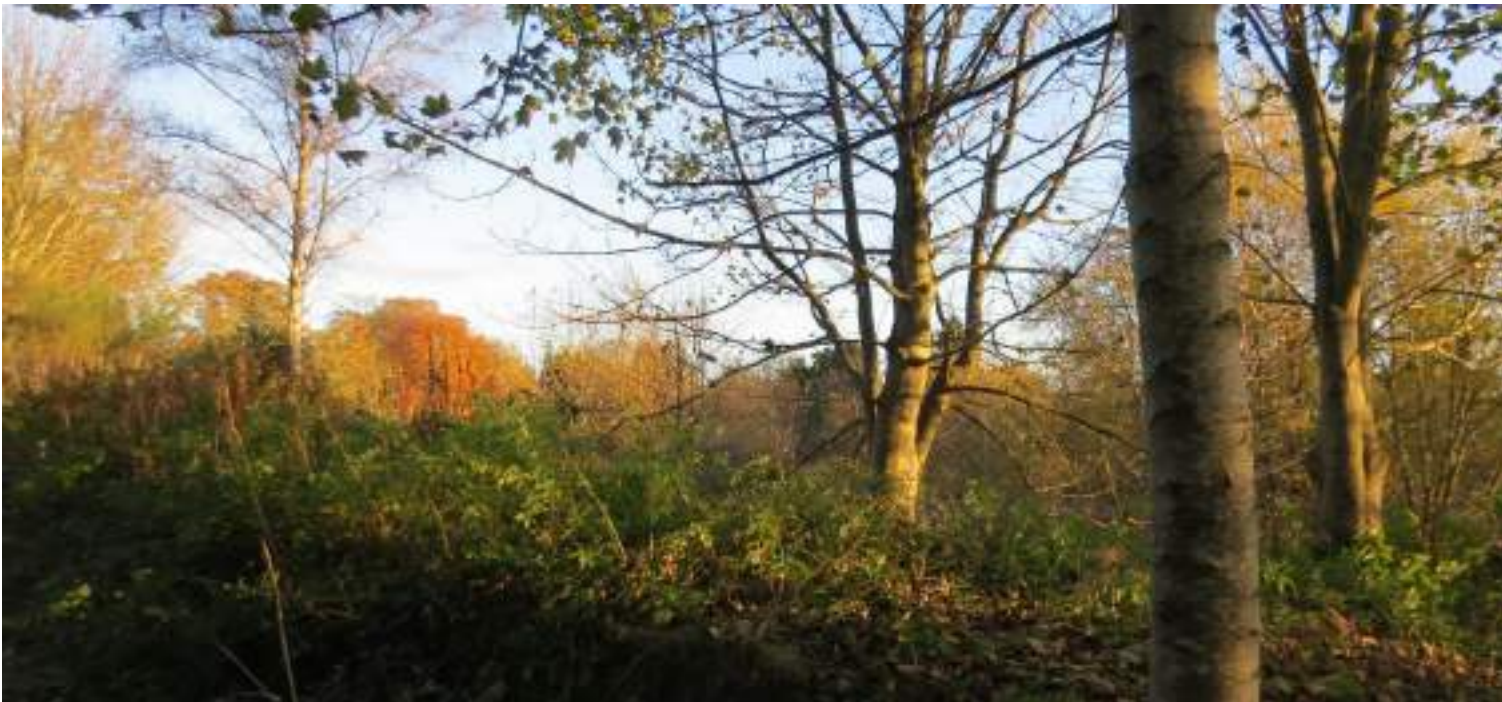
Photo 6:
View east on Deeside Way. The old platform is seen in the foreground. Buildings will be visible in the short term in this area.

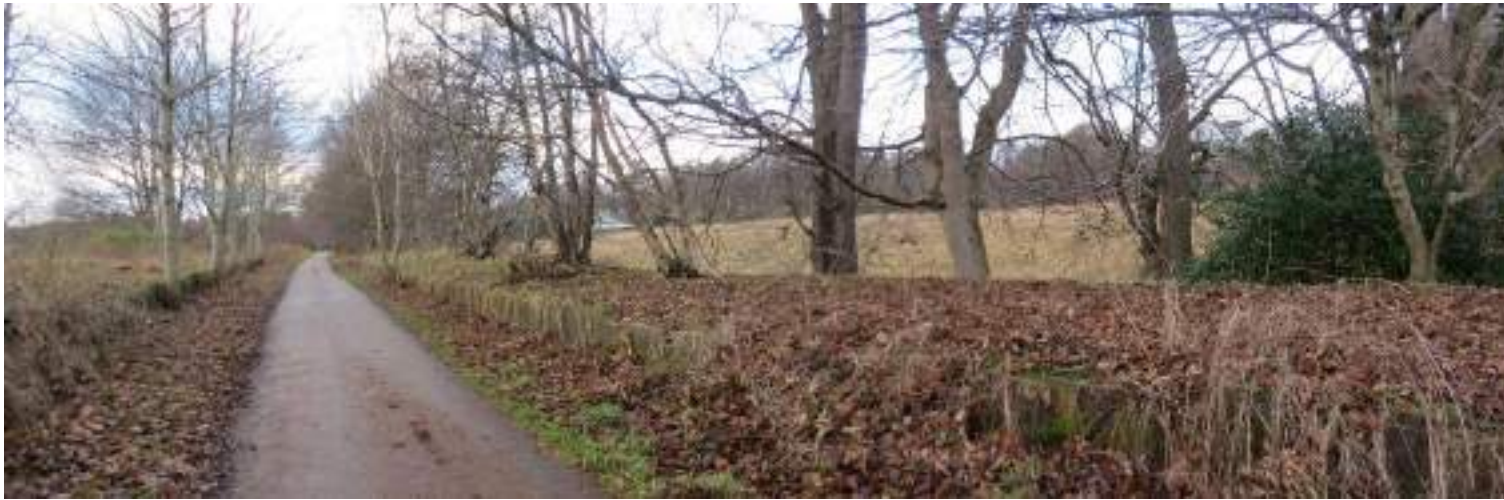
Photo 7:
View southwest along Deeside Way. Mature trees line the north side of the Deeside Way giving views into the proposed development area. These views are greatly reduced during the summer months. The new tree and shrub planting will increase the depth of the tree screen in this area. This will increase screening and reduce impacts.

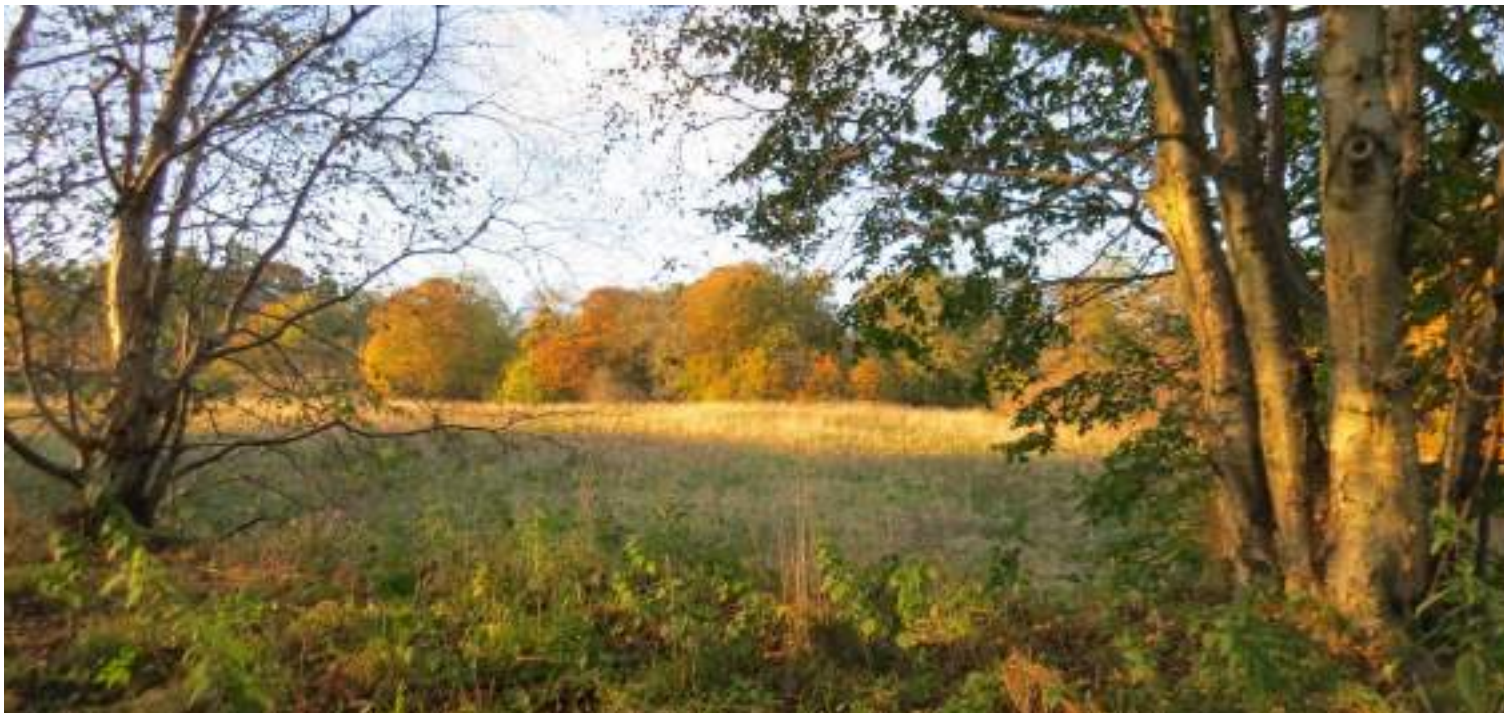
Photo 8:
View northwest from Deeside Way. The open area visible is part of the house development area. The sycamore trees in the foreground and birch on the left are growing on the old platform area. The new trees and shrubs planted as part of the development proposals will reduce views into this area.

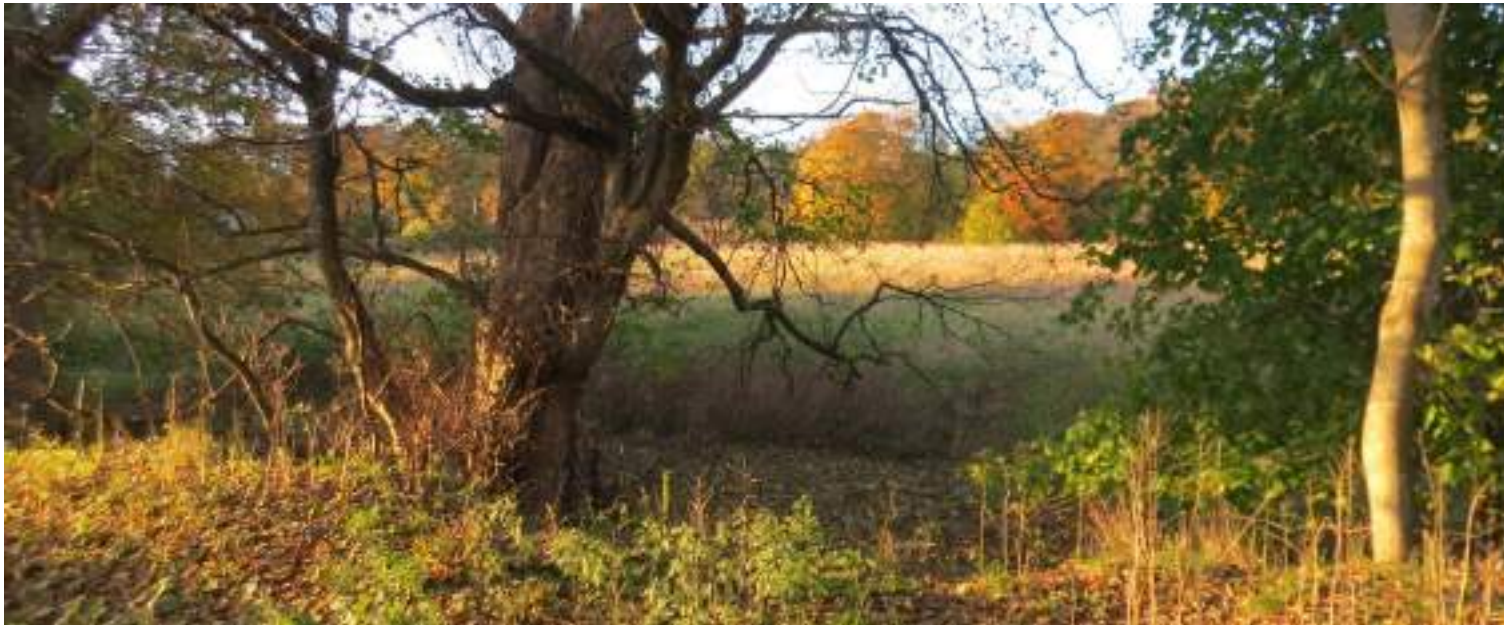
Photo 9:
View northwest from Deeside Way. A view from further southwest on the Deeside Way. Views of the proposed development will be seen in the winter, but are obscured in summer by trees. Proposed new planting will reduced visibility further.

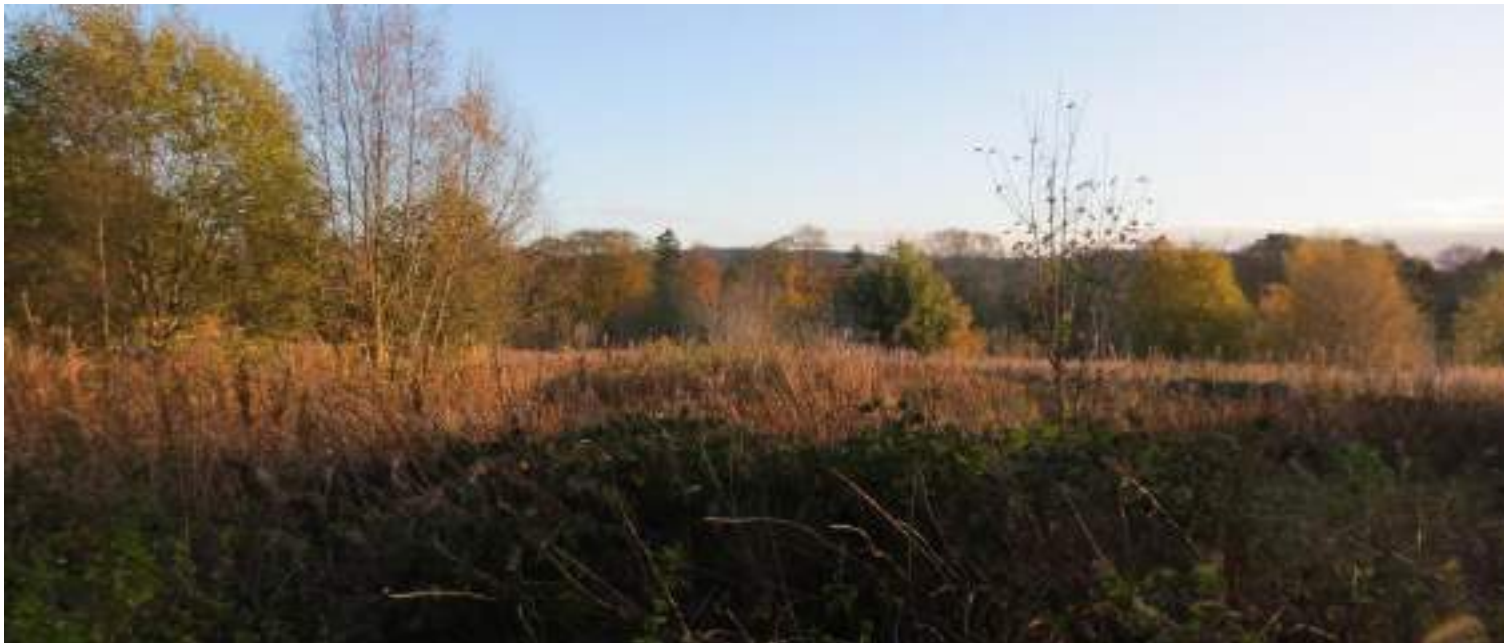
Photo 10:
View south from Deeside Way. The new buildings will be seen from this area. New tree and shrub planting will reduce this view.

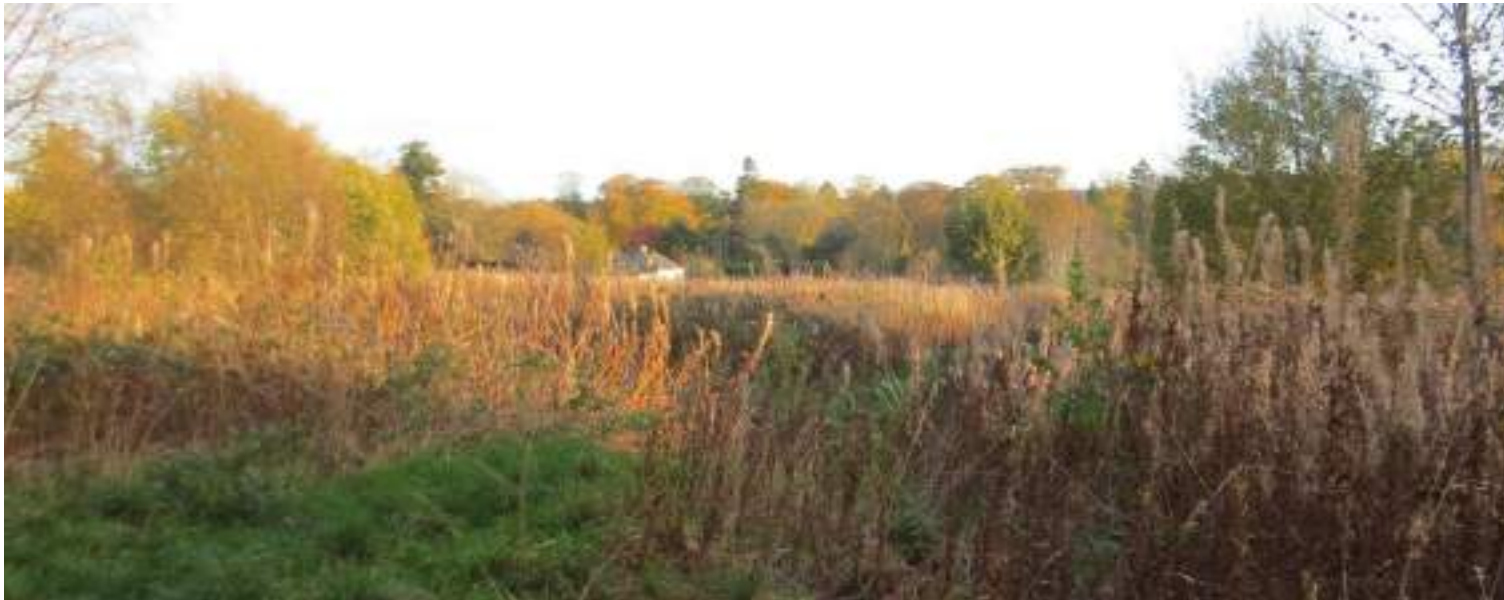
Photo 11:
View southeast from Deeside Way. This view is open at present. In the future the new relief road from north to southwest will remove all views as it crosses the Deeside Way at (4.7m) and effectively removes views of the proposals.
