Appendix 1

Historical Mapping & Photography included:

9 North Deeside Road, Bieldside, ABERDEEN, AB15 9AD

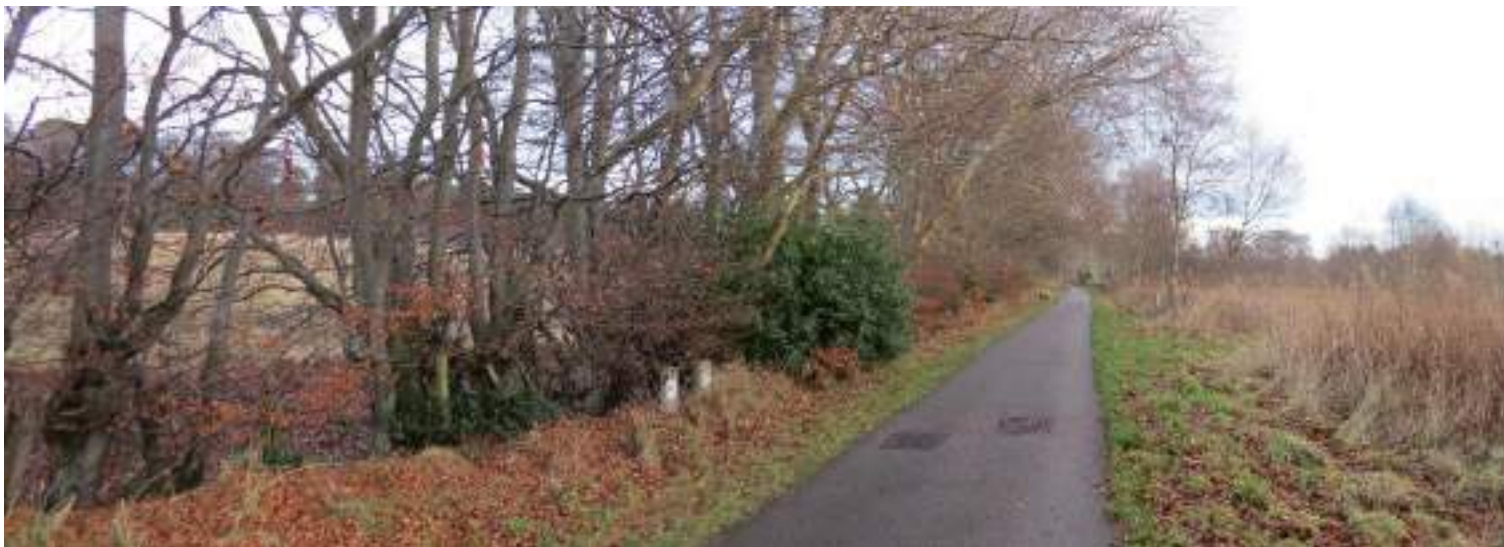
Photo 12:
View northeast along Deeside Way. The beech hedge (Area E), on the left, will be felled to allow the elevated relief road to cross the Deeside Way in this area.

The views from the Deeside Way (photos 5 – 13) had a level of impact of Moderate Adverse. This is due to the fact that half of the field areas will be changed to buildings and glimpses of parts of this area will be seen from the Deeside Way. The many mature trees surrounding these areas will be retained, limiting views into the development, especially during summer. New tree and shrub planting will reduce this impact in the near future.

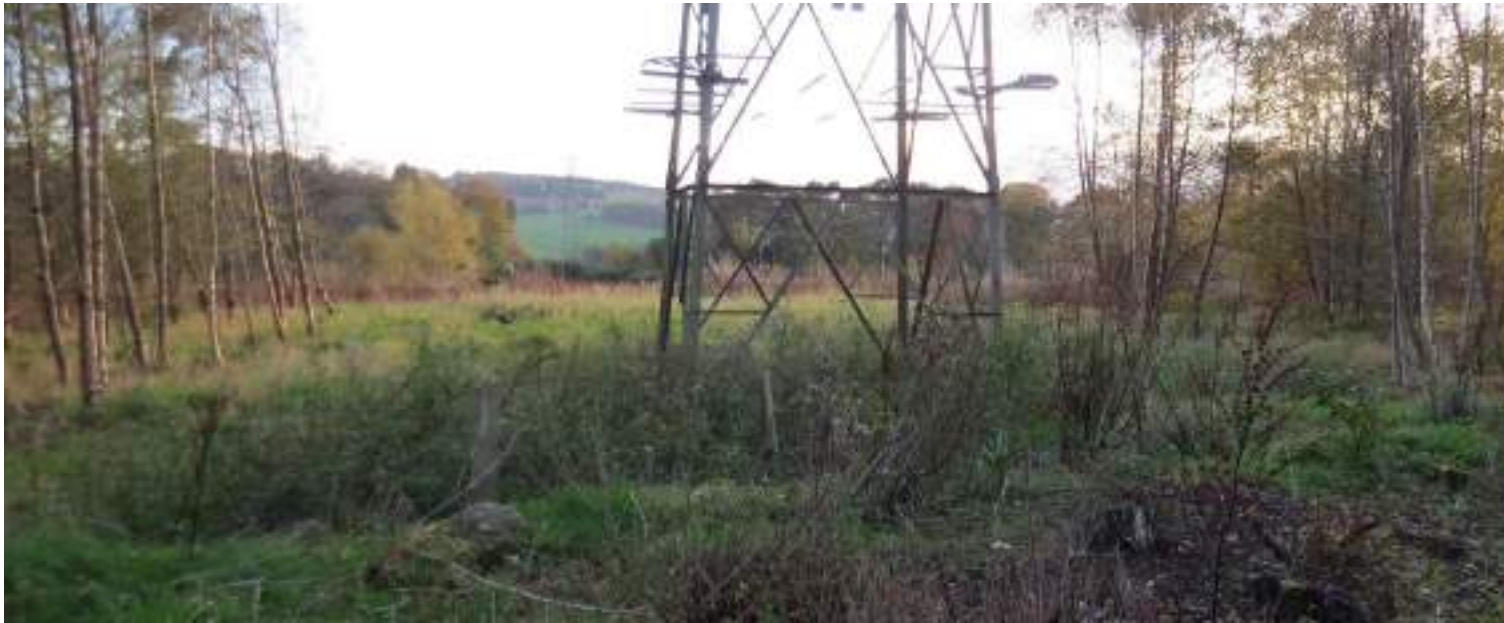
Photo 13:
View south from Deeside Way into amenity area and wildlife corridor. The pylon wayleave is in the area that is to be amenity open space and will be retained as a wildlife corridor. New tree planting will connect the tree belts to the south (Inchgarth Road) with tree belts along the Deeside Way.

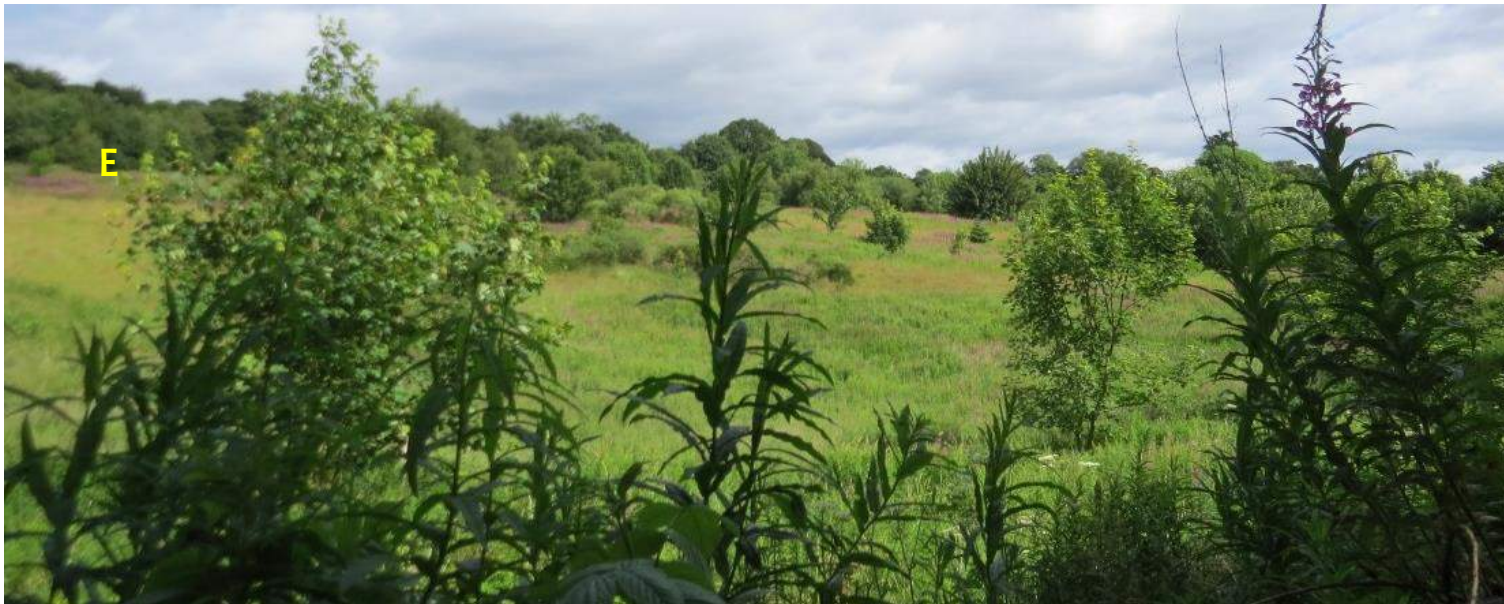
Photo 14:
View from Inchgarth Road into site across area of retained public open space. New road and houses will be constructed to the right. Public open space will be central and extending to the left. New tree planting in this public open space, and along Inchgarth Road, will further restrict and screen views into the area.

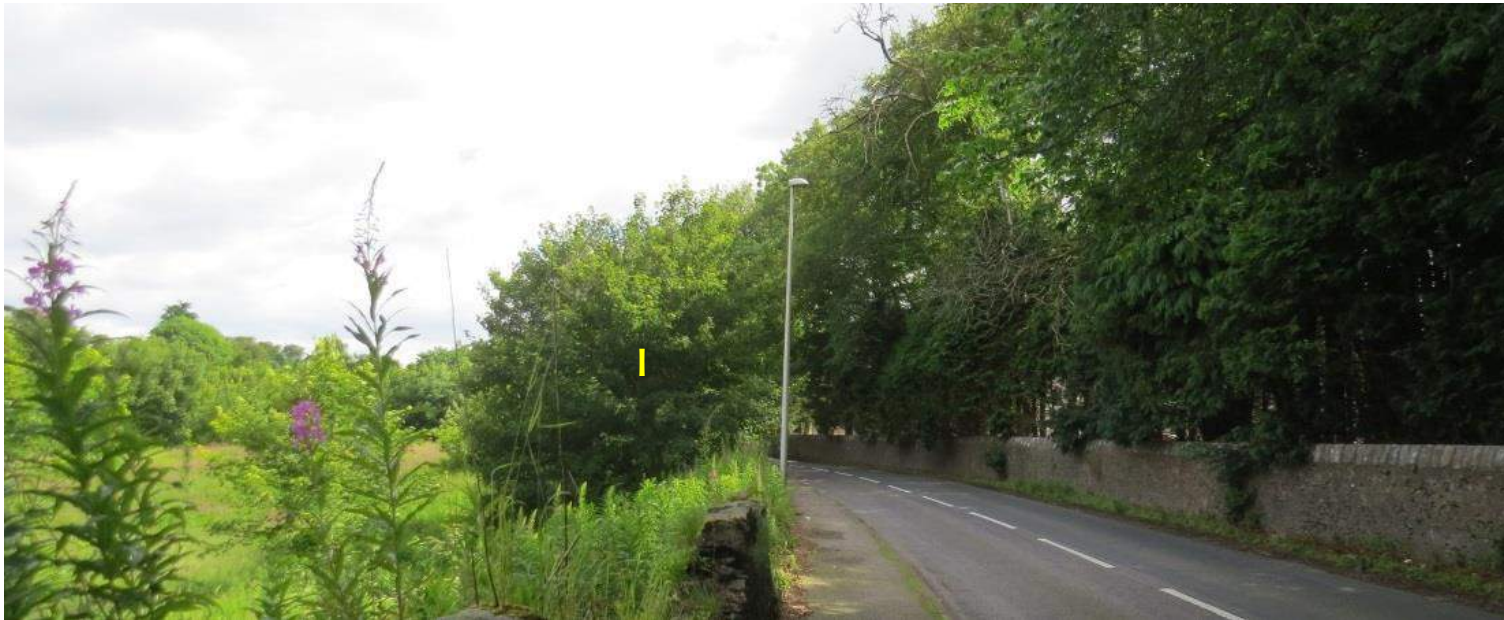
Photo 14a:
View east along Inchgarth Road from position 6. Mature deciduous and evergreen trees on south side of Inchgarth Road screen the proposed development from views from and to the River Dee SAC. Trees within the proposed development area, along Inchgarth Road, will be felled and replaced with screening trees and shrubs, on contoured mounds at a higher level.

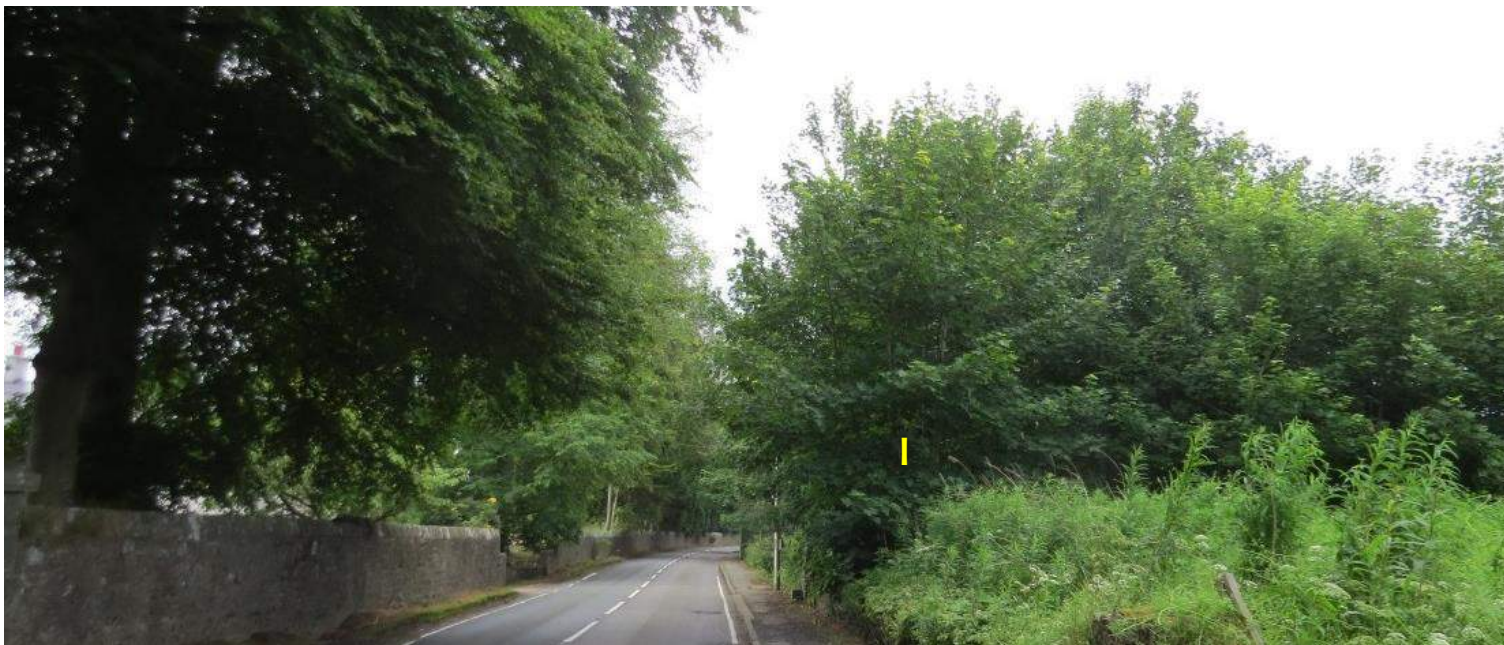
Photo 15:
View west along Inchgarth Road. Mature trees to the south screen the proposals as in Photo 6a. Sycamore trees on north side of Inchgarth Road will be felled and new trees and shrubs planted to screen the proposed development. This photo shows the screening that will be achieved using tree and shrub planting.

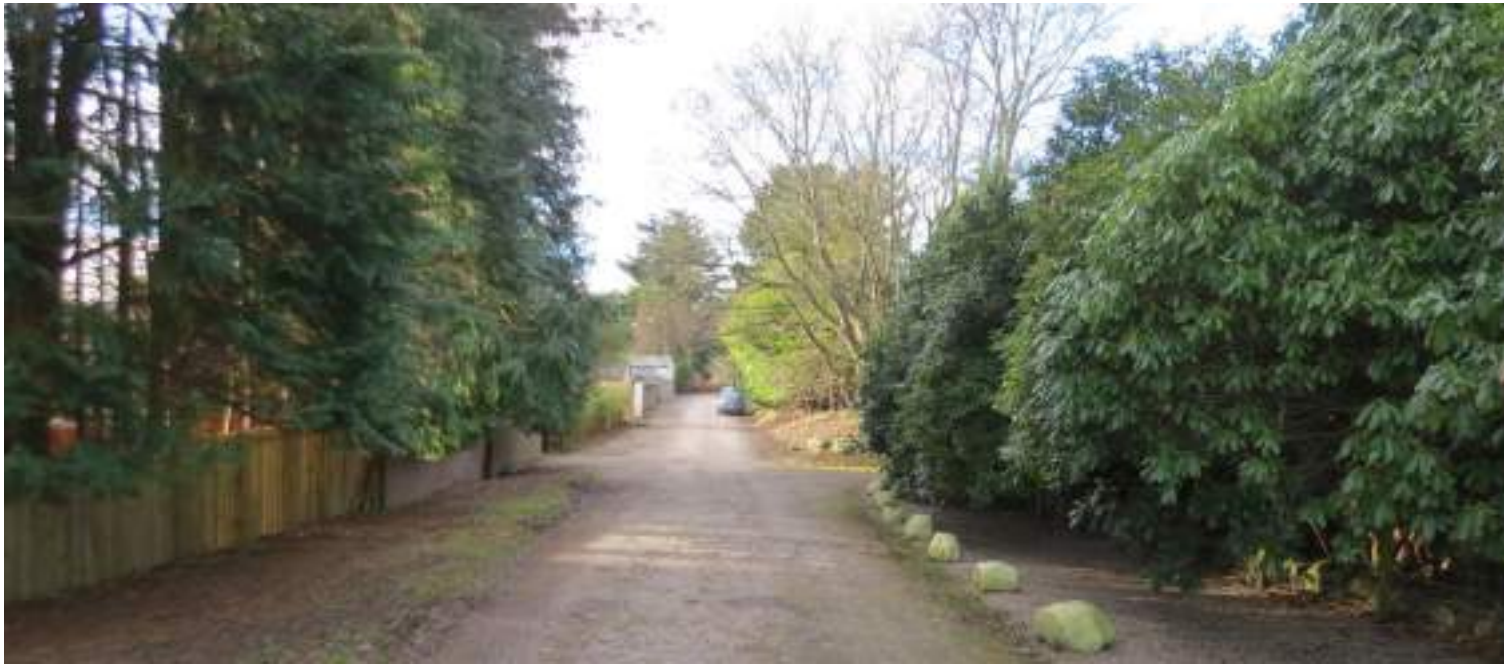
Photo 16:
View west towards proposal along access track from Pitfodels Station Road. Views into proposed development screened by trees and large shrubs.

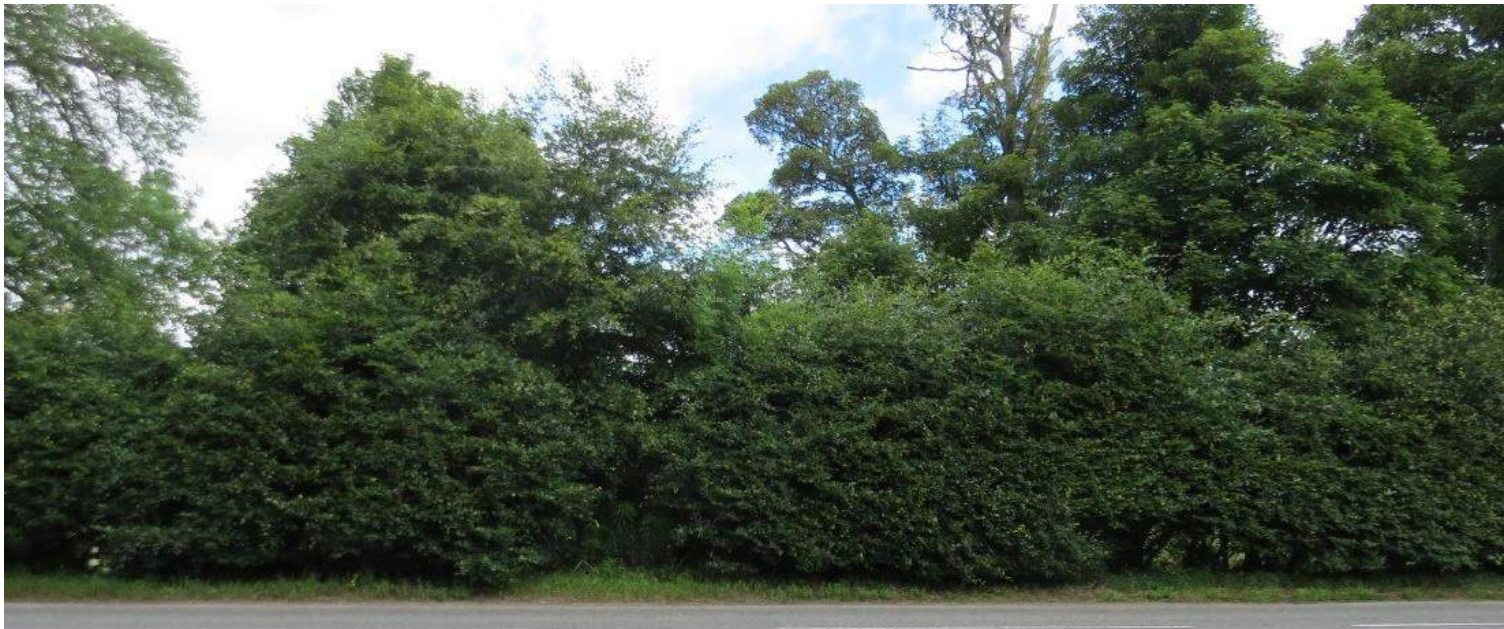
Photo 17:
View across South Deeside Road. Trees and hedging along the South Deeside Road, (B9077) prevent views across to the proposed development. Trees along the South Deeside Road screen the area. Further trees to the north (adjacent to Inchgarth reservoir) also screen the proposals.

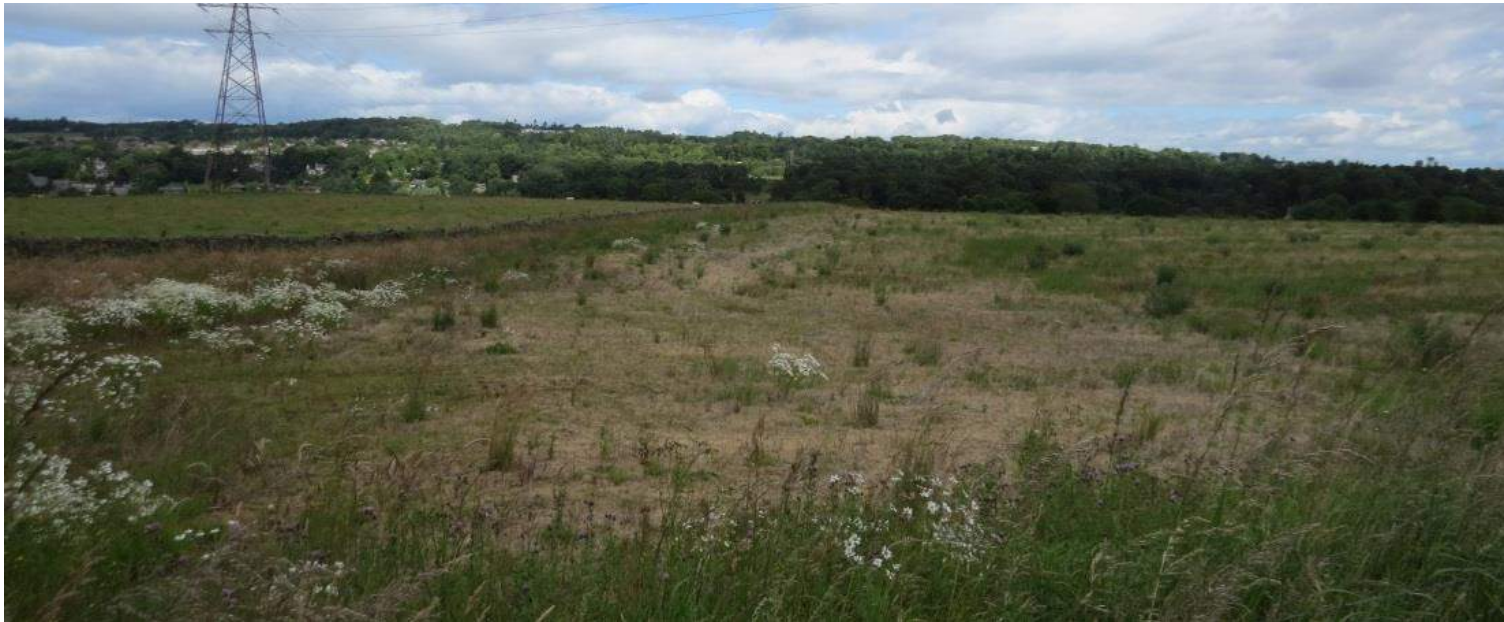
Photo 18:
View from Craighead Road. The fields of the proposed development are distant and screened by mature trees.

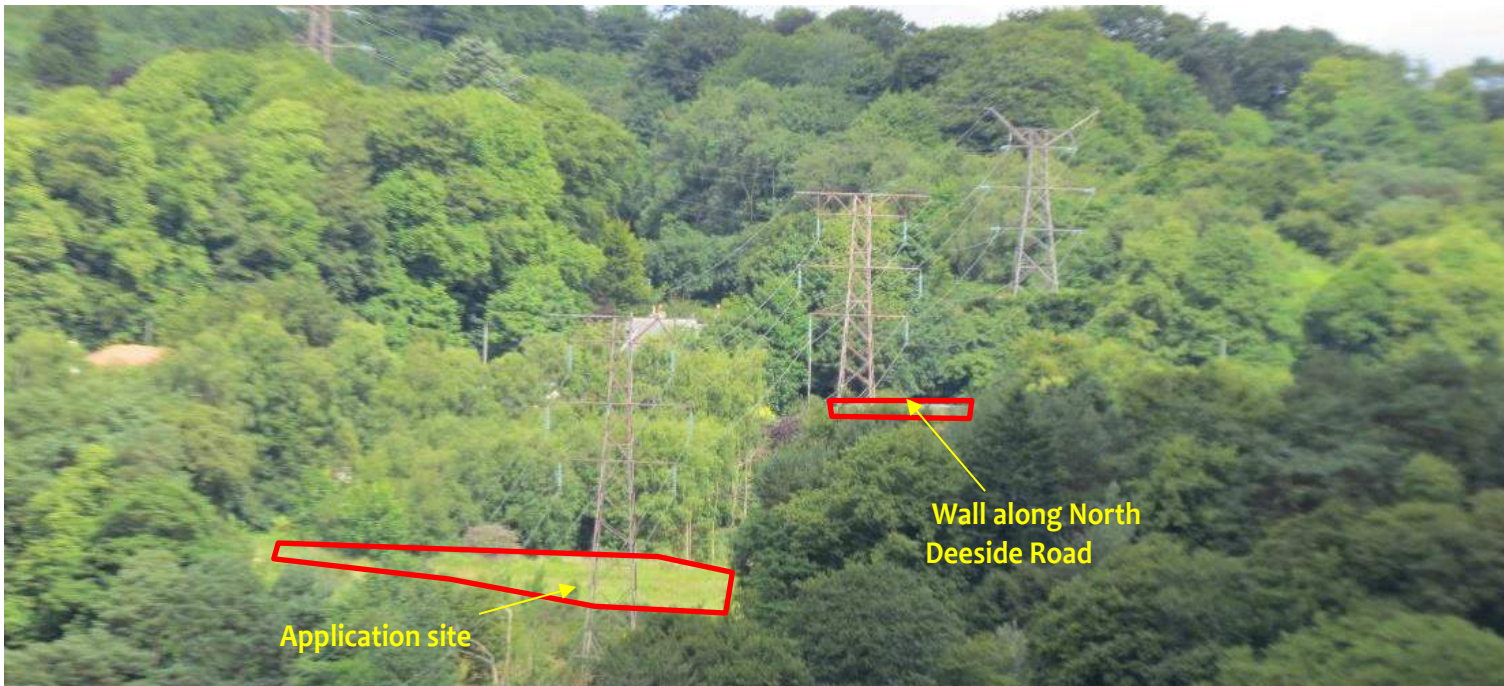
Photo 18a:
Close up of Photo 9. Proposed development screened by mature trees of ancient woodland along Inchgarth Road and also the proposals are set against the backdrop of trees on the north side of the proposals, the woodland area of Cults and Pitfodels. Small areas of the development can be seen. These areas will be part of the open space/wildlife corridors designed into the west area of the site.

The construction phase will require the felling of a number of trees, especially for the link road. Views from the South Deeside Road will not be opened up by this tree felling as they will remain interrupted by trees on different contours in other areas. This can be seen in photos 18a and 19a. The roundabout which connects the link road with Inchgarth Road will not be visible from the south. South of Inchgarth Road and north of the River Dee there is an area of raised elevation woodland, this topography conceals views of the southwest of the site from the south.

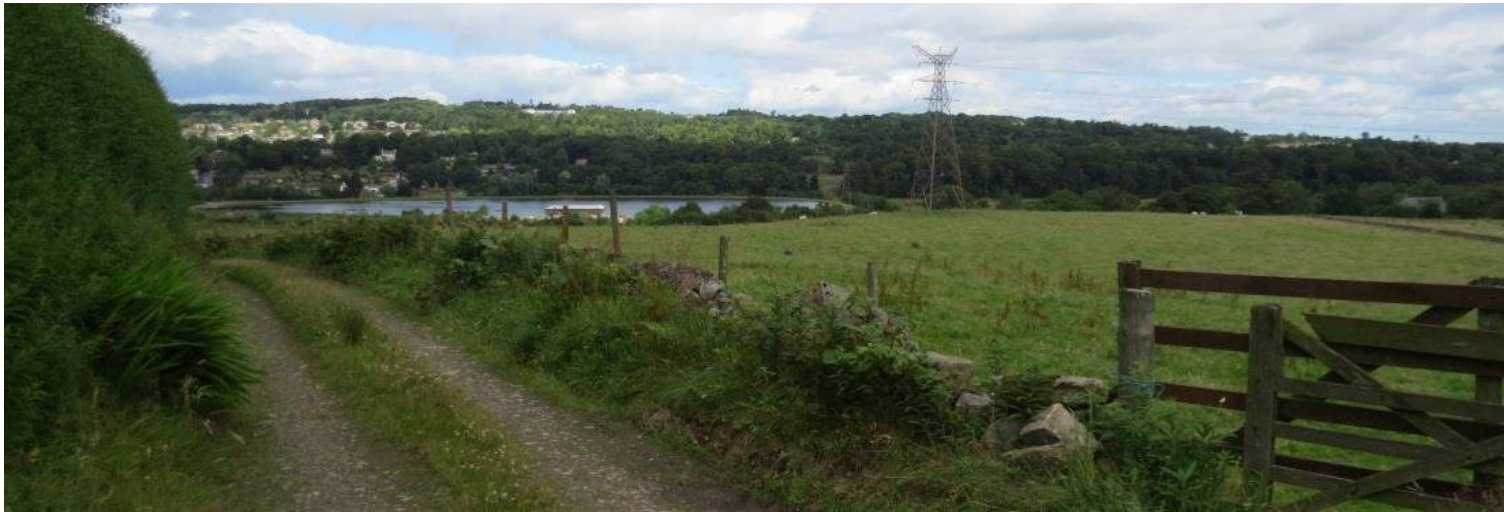
Photo 19:
View from across access road down to Easter Ardoe. View of site restricted to glimpses caused by pylon wayleave.

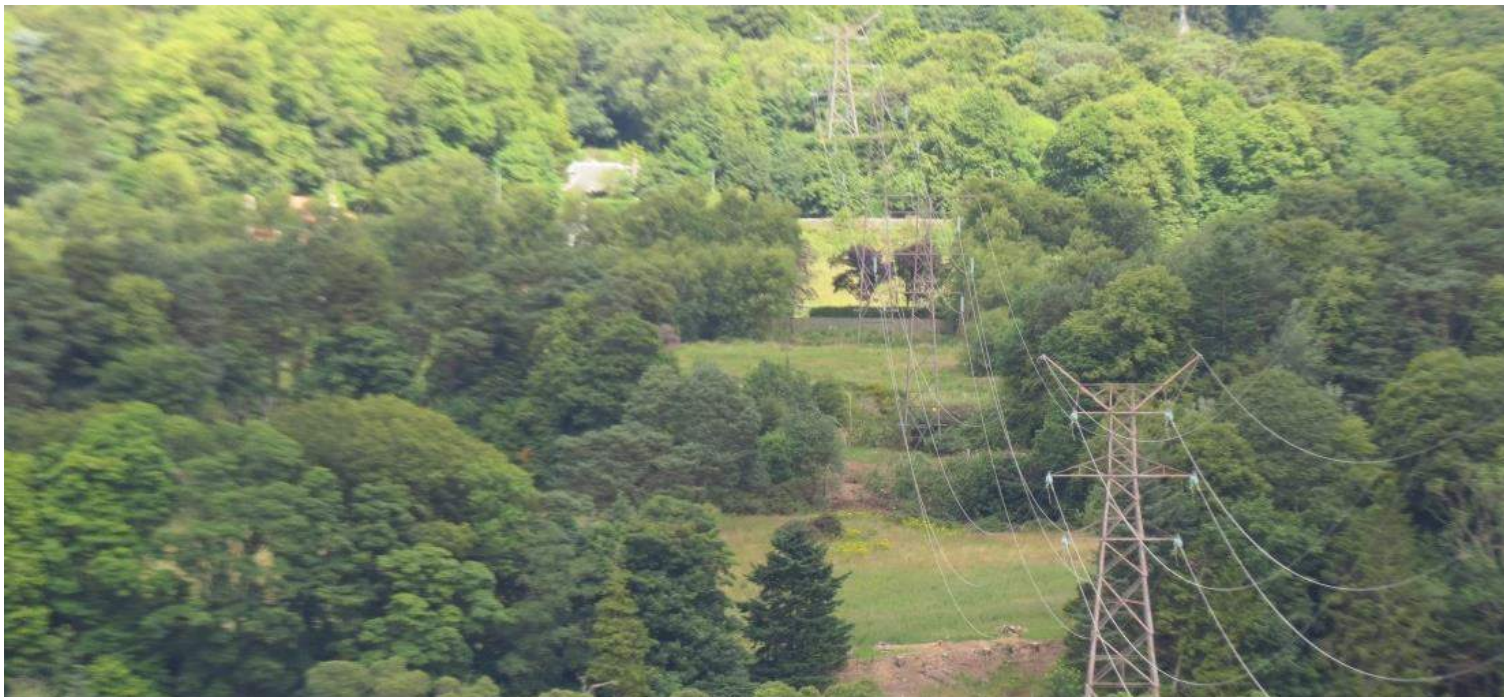
Photo 19a:
Close up of photo 10. View of application site. The only views are along the pylon wayleave. The views of the site are mainly prevented by the mature trees in the ancient woodland along Inchgarth Road. From these areas of Deeside, the application site is distant with many areas with limited views to the application site. The open areas of the site seen in this photograph are retained as open areas with new tree planting forming wildlife corridors.

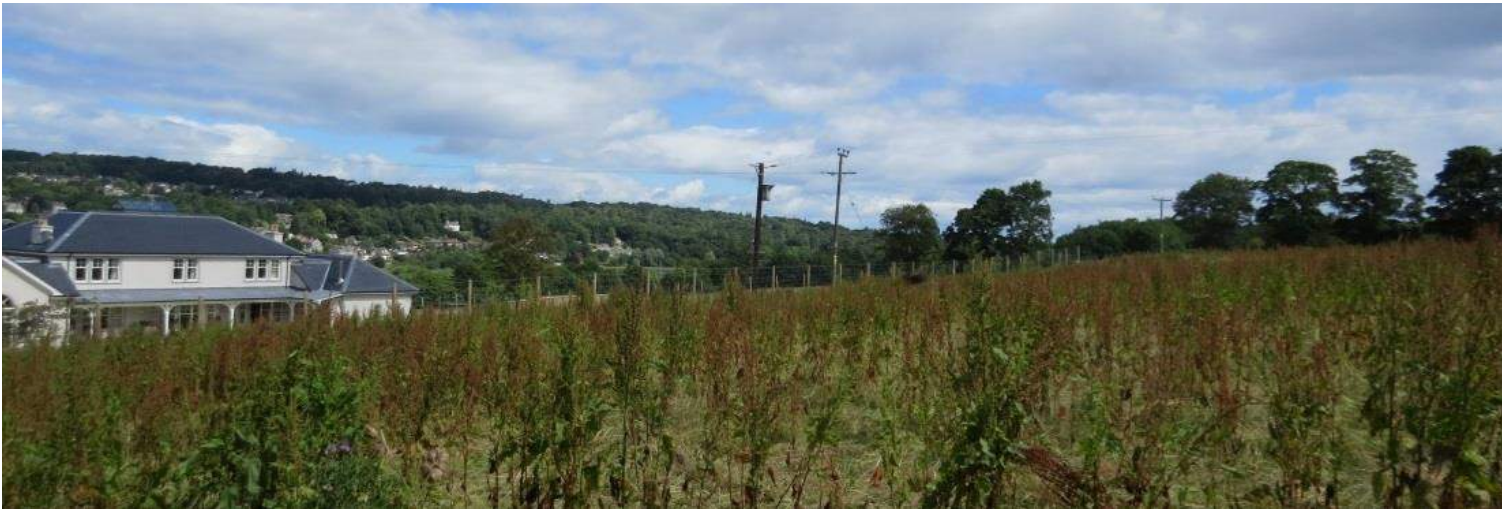
Photo 20:
View northeast from above Mid Ardoe. There is no view of the application site from this area. It is screened by mature deciduous and coniferous trees on various levels of the north Deeside bank.

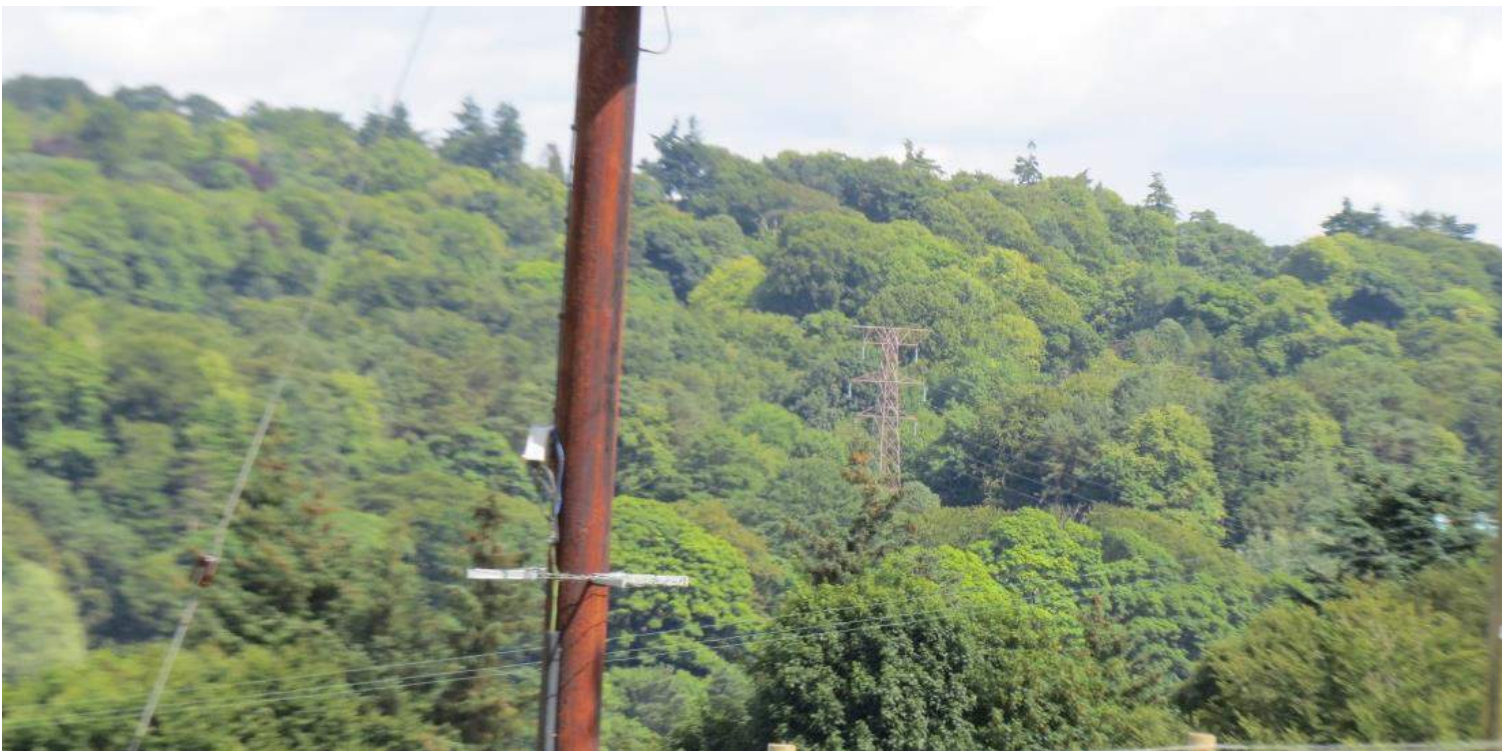
Photo 20a:
Close up of Photo 11 showing no views of the site. The site is screened by mature trees from all areas.

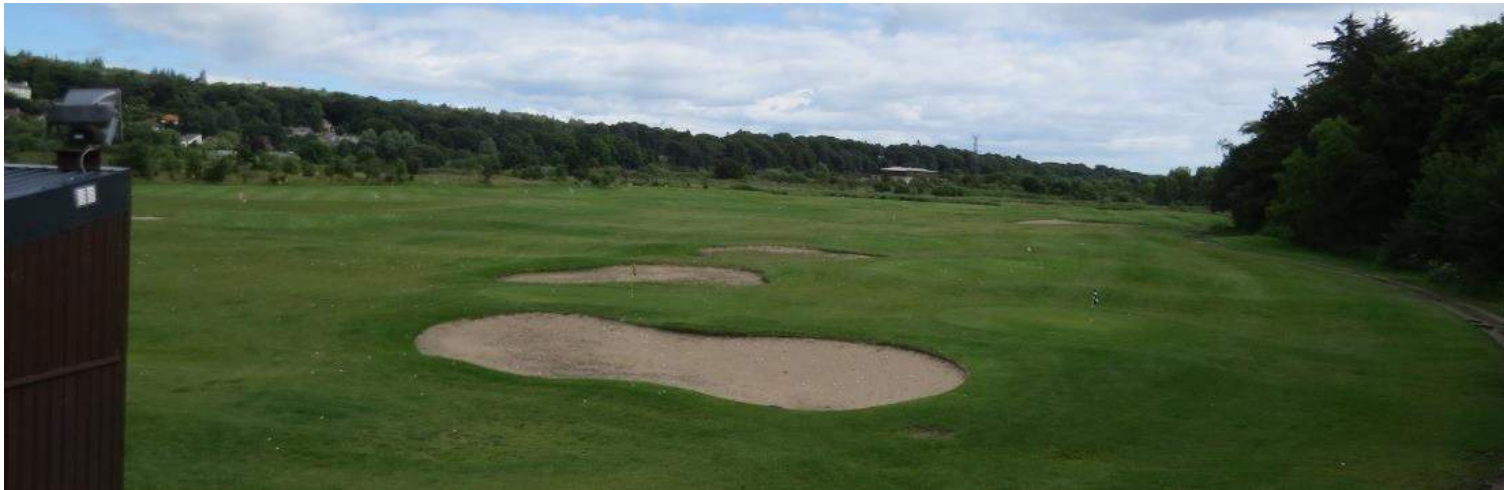
Photo 21:
View northeast from Aspire golf range.
Application site is screened by woodlands and tall trees. There are no views of the application site from the golf driving range.

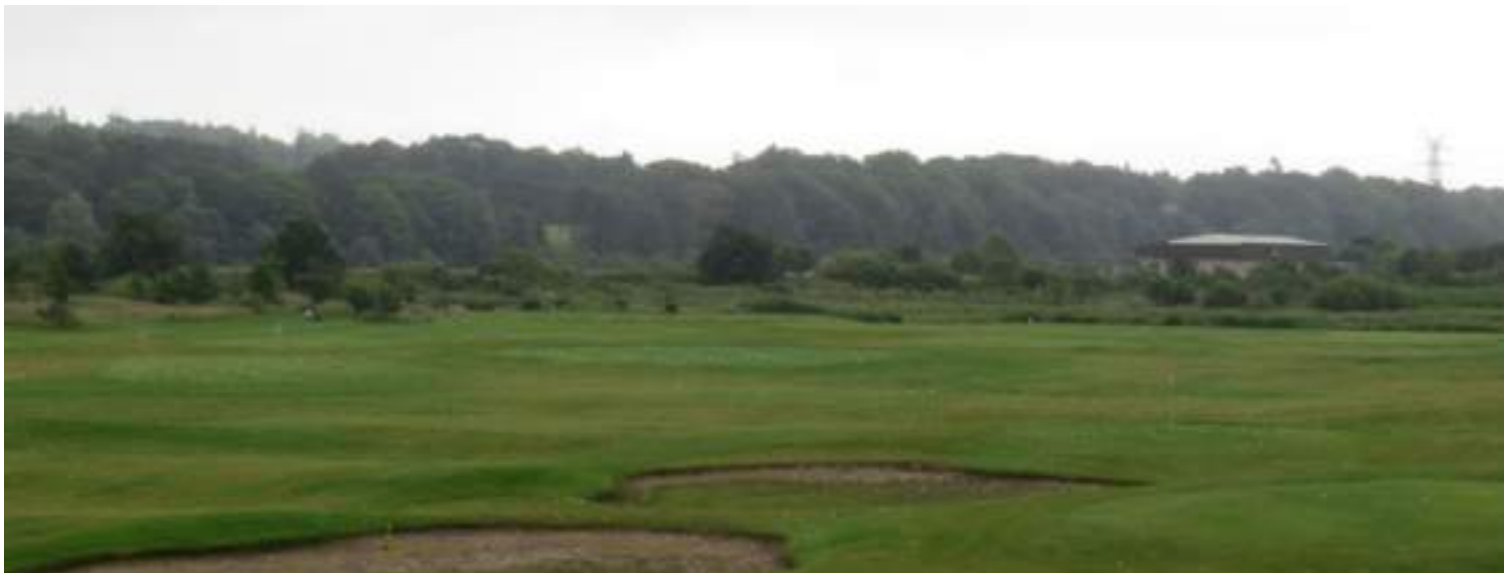
Photo 21a:
Close up of photo 12, mature trees and woodland showing no views into the application site area.

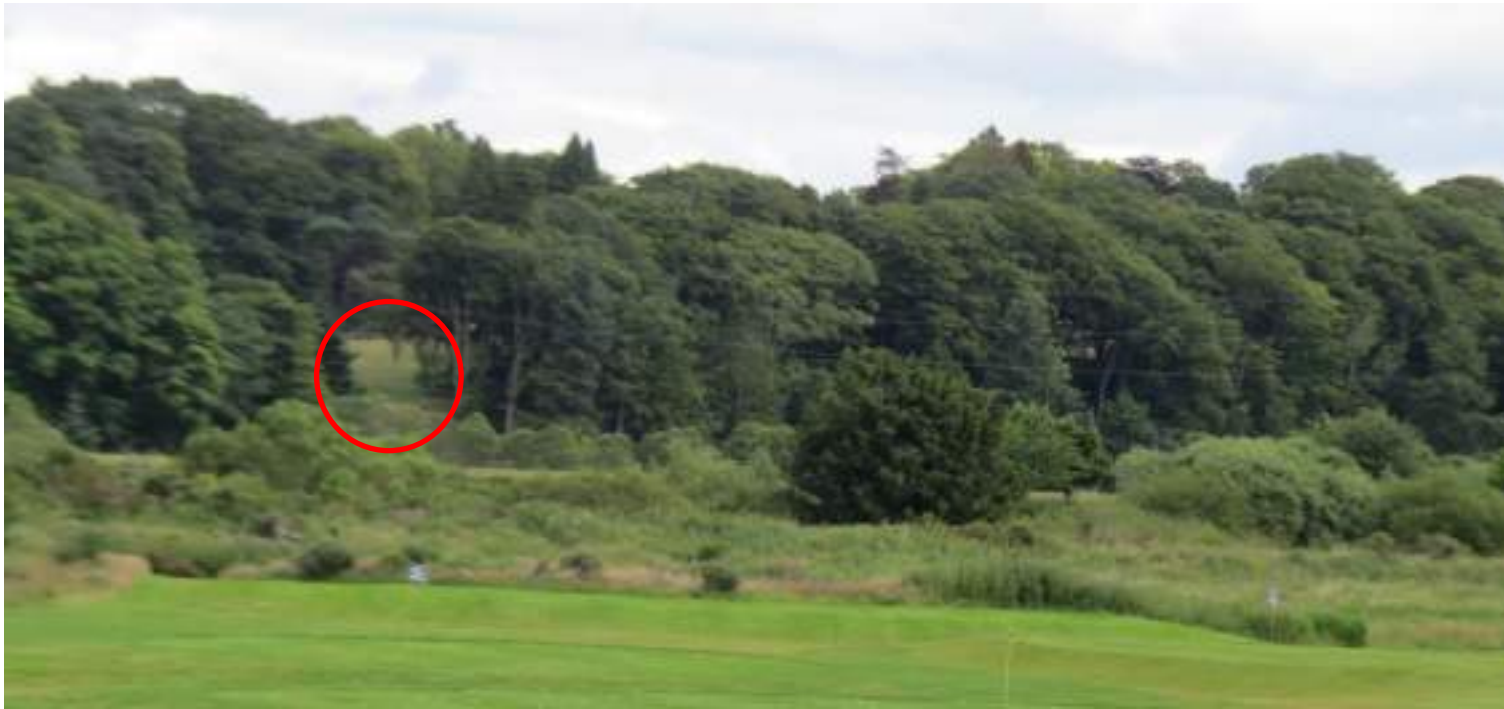
Photo 21b:
Further close up of Photo 12 showing mature trees along the north bank of the River Dee and other mature trees along Inchgarth Road. The field seen centre left (circled) to the west of Inchgarth House is a grass field to the south of Inchgarth Road, not the application site.
