BERRYDEN CORRIDOR IMPROVEMENT PROJECT
HERITAGE STATEMENT

Prepared by Georgina Allison RIBA RIAS
On behalf of HFM Architects

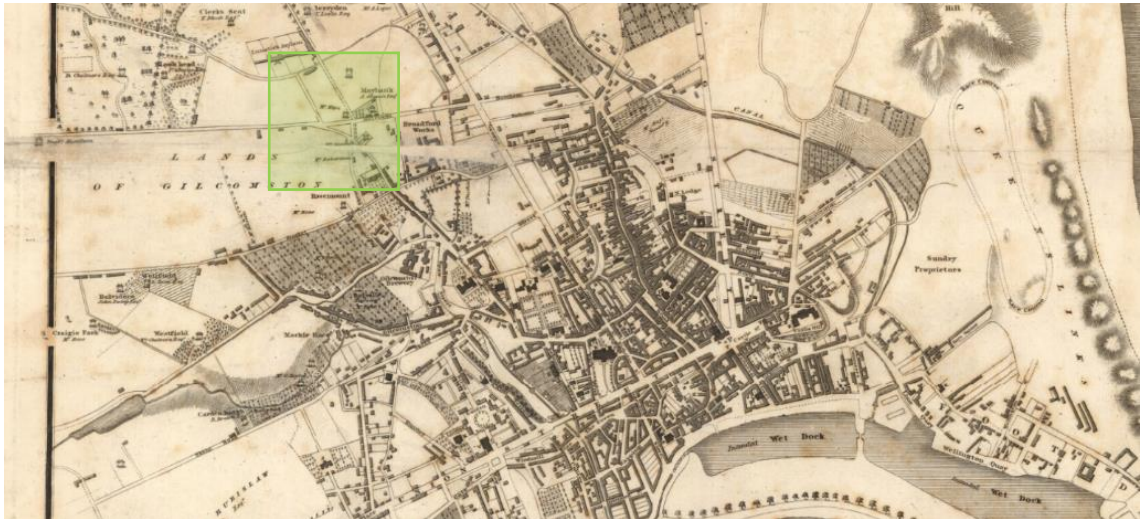
Fig.2: Woods Town Plan of Aberdeen, 1828. Reproduced with the permission of the National Library of Scotland

Between these two maps being drawn up, Aberdeen had gone through fundamental changes. The re-planning of the city centre with the new classical Union Street being taken through the medieval heart of the city.

Berryden Road is shown as a relatively minor road in comparison with the parallel George Street. To the west is the Asylum and the grounds of several suburban villas- the Asylum is already showing as having a hard edge to the road and the main building is present. To the east, the eponymous Berryden House is shown, sitting back from the road.

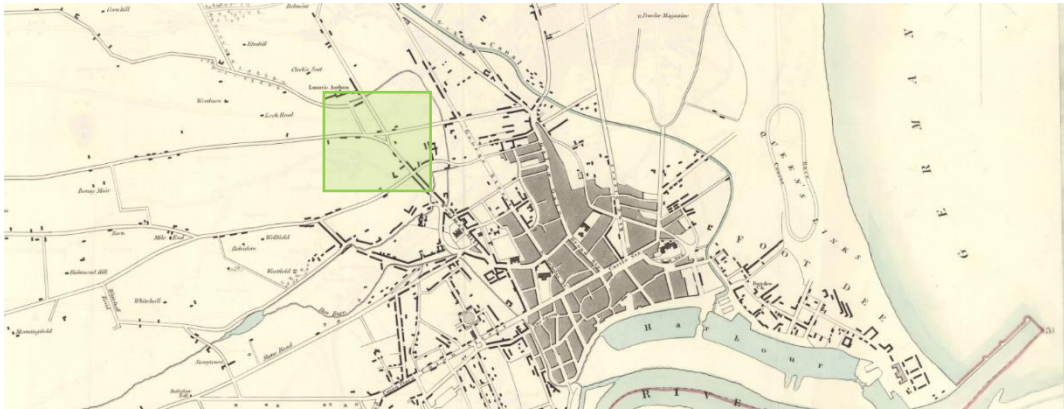
Fig. 3: Town Plan of Aberdeen, 1832. Reproduced with the permission of the National Library of Scotland

This map shows little change in development from the earlier Woods map but does highlight how the main road north west was formed with the now Rosemount Terrace curving and being part of the way west rather than North via Berryden. The first house in Caroline Place (no.5/6, built 1828) is not yet shown.

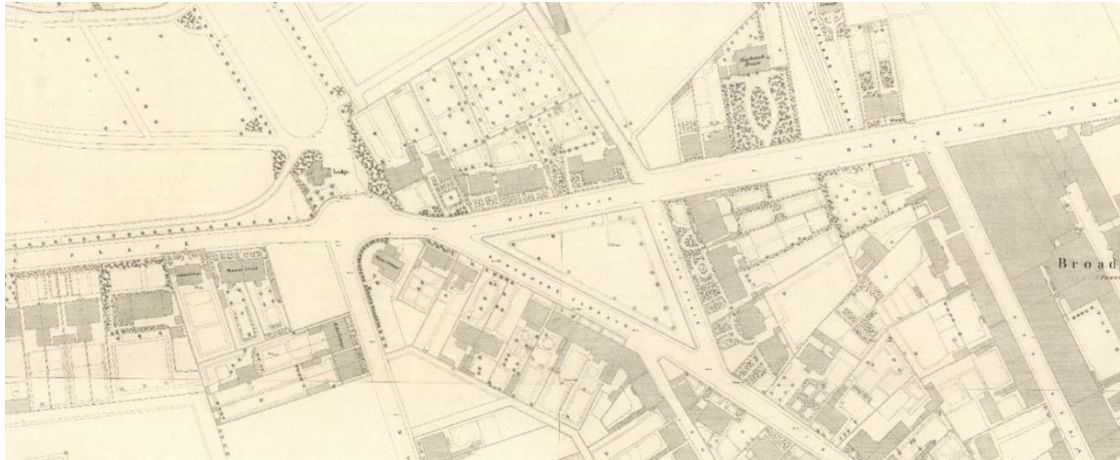
Fig. 5: First Edition OS- 25" town plan version. Reproduced with the permission of the National Library of Scotland

By this point the Rosemount Viaduct had been built, as had the railway. These changes destroyed the “Rotten Holes”⁵ of the Gilcomiston Steps, which further separated Caroline Place from the east of the town, and reinforced the industrial usage of the area to the south and east.

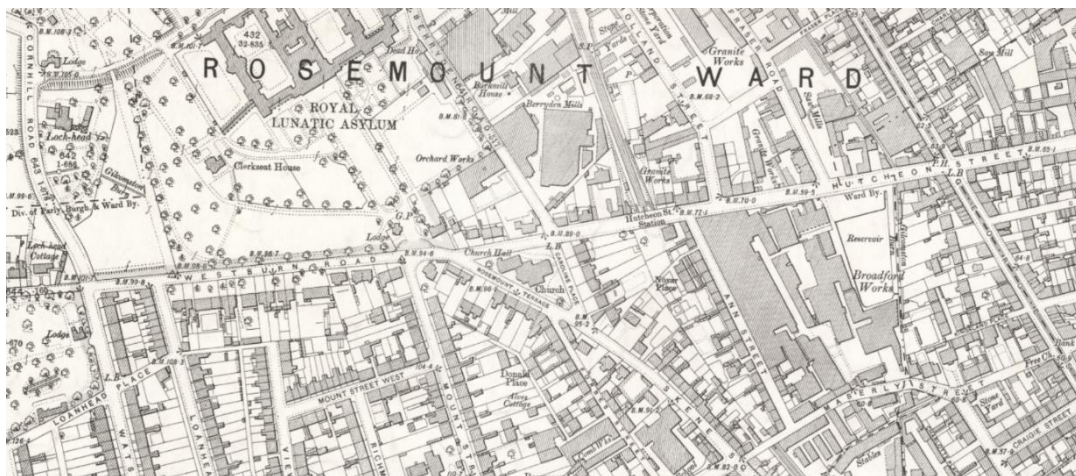
Fig. 6: OS – 2nd Edition , 1899. Reproduced with the permission of the National Library of Scotland

It appears that the south end of Berryden Road has been realigned to meet better with Caroline Place. The corner building on Hutcheon Street (no. 168-170) had been developed, and possibly curtailed, as has the wing of the villa to the north west of the junction (replaced later by a tenement).

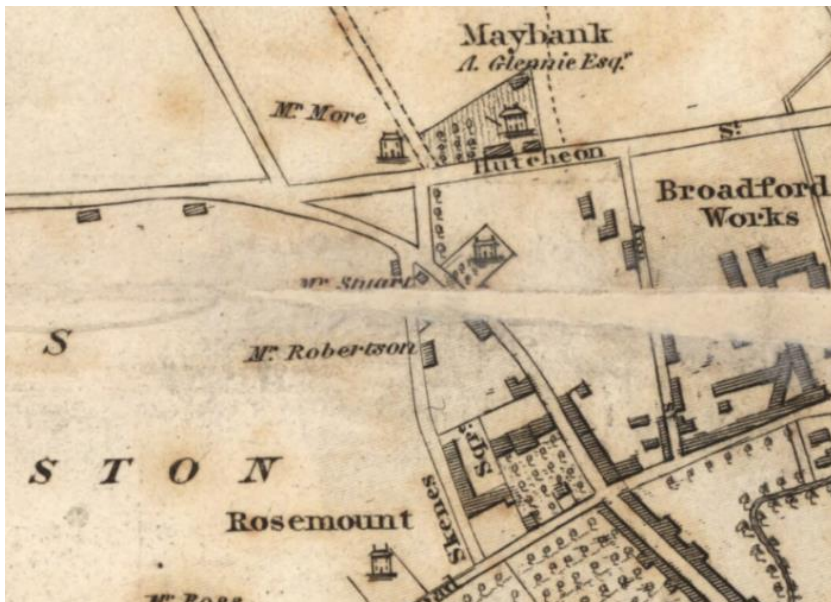
Fig.7: Extract from Woods' Town Plan of Aberdeen, 1828. Reproduced with the permission of the National Library of Scotland

There is only one property shown in James Woods plan in 1828. This clearly shows a building addressing Skene Square, and correlates with a cottage that was situated below No. 1 Caroline Place, now demolished.

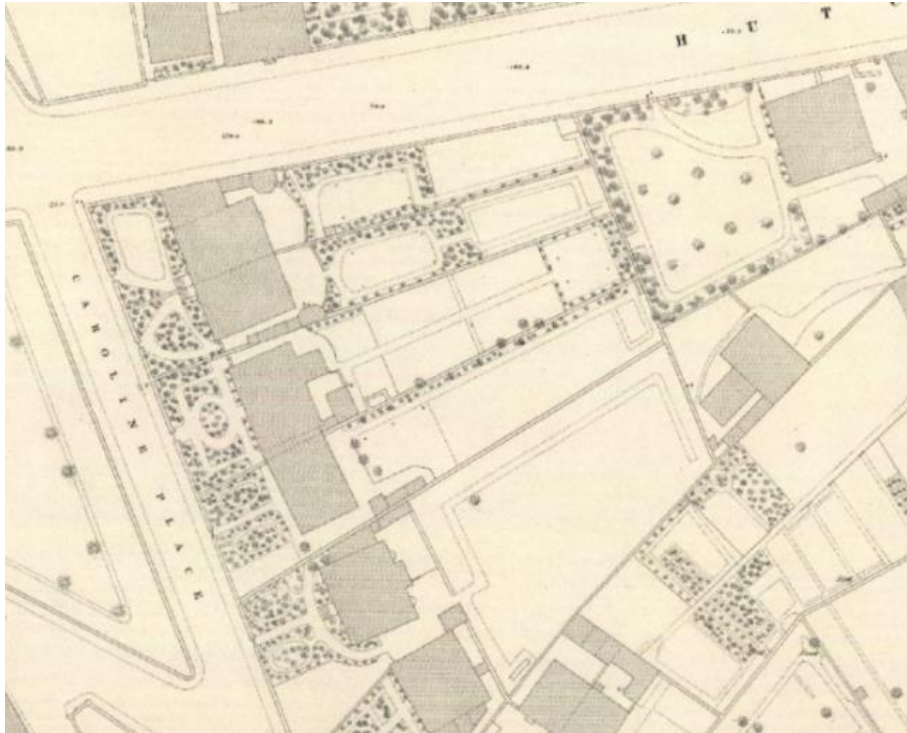
Fig. 8: extract from OS – 1st Edition, 1866 Reproduced with the permission of the National Library of Scotland

The properties to the east (Caroline Place proper) all have much larger front gardens than exist today, and they area shown with decorative planting, paths and boundary walls to front. No. 1-4 have long, narrow rear gardens which are subdivided into distinct sections. Nos. 5 and 6 are paired, with a small wing on to the north shown. Their inhabitants were part of the merchant/ gentry class, with church ministers, clerks and clothiers among them.⁷

The garden island was built upon in when the Rosemount church was built in 1877. This was extended by a church hall in the 1890s.

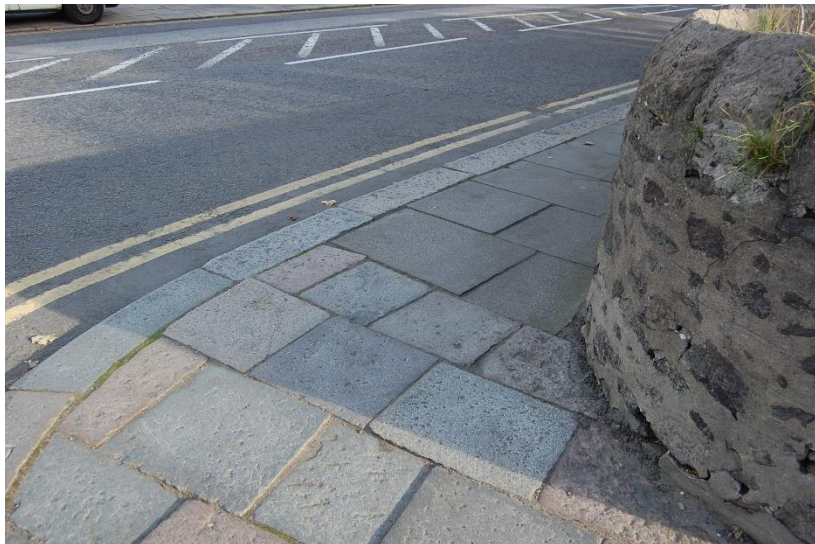
In terms of landscaping, the pavements are generally modern, with some areas of granite kerbstone, and some localised granite paving to primarily the south but also limited areas to the east.

Fig. 10: Granite paving at junction of Rosemount Terrace and Westburn Road

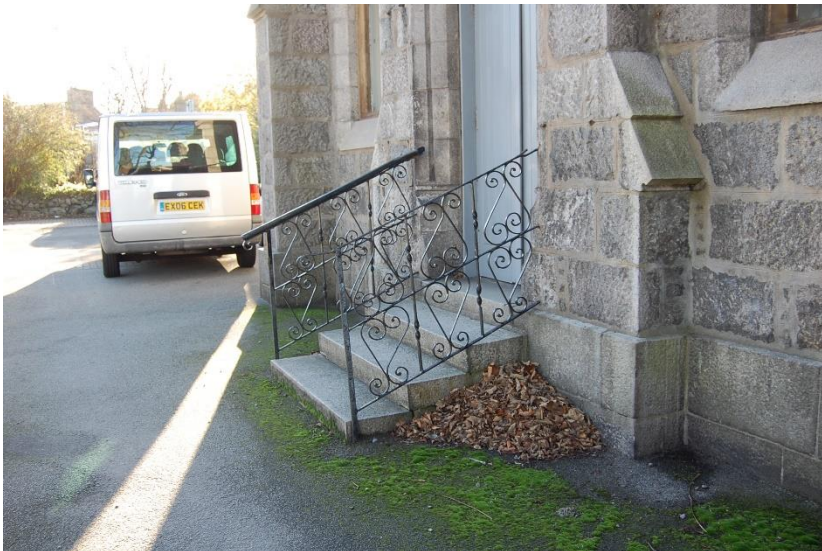
The church is a substantial gothic designed granite building with a cruciform plan, complicated by the partially attached church hall. This leads to a complex building envelope which expands into its island site. The original spire was never built, but the church still has a commanding presence. The moving of the entrance from the east to the south, has reduced the legibility of the building, which relied on landscaping to delineate the primary entrance, which is only moderately successful. The east elevation side doors have been blocked and stairs removed, and the main door relegated to a side entrance, with plain granite steps and modern ironwork balustrade.

Fig. 1: East entrance to church (now side door)

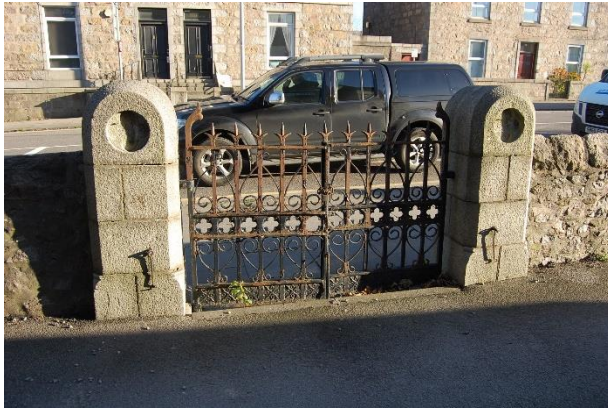
^Fig. 17: East entrance gates to church: these can't be opened owing to change in level behind

Most of the original gates are corroding and some have been bent or distorted (fig. 17).

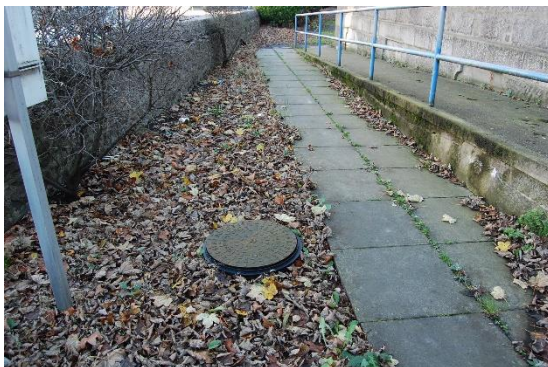
The inner area of the churchyard appears generally modern and utilitarian; with a mix of tarmac to drive and west, gravel and planting to NE car park and grass to NW area (fig 19). There are several entrances to church at various levels, some of which have had steps removed to from car park/ drive and one with a new ramp to north. There are also some level changes in relation to the footway outside, with a drop to the west and a retaining section to the NE corner.

Fig.19: Ramp / wall at Westburn Road

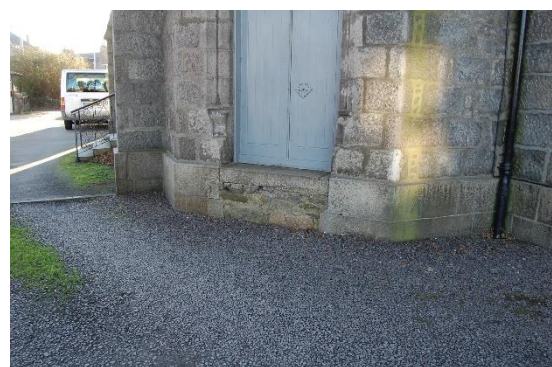
Fig. 20: Surface finishes and lack of steps to east side doors

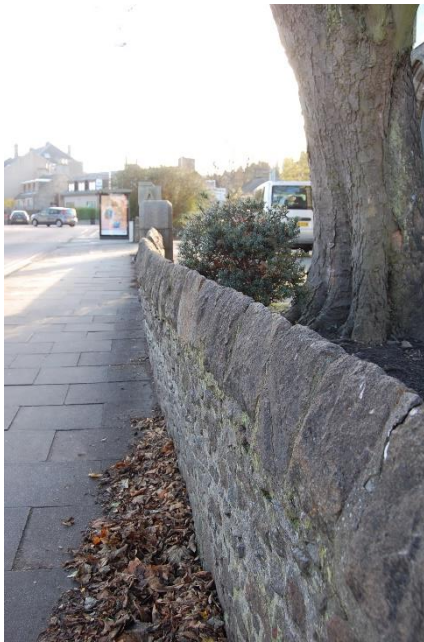
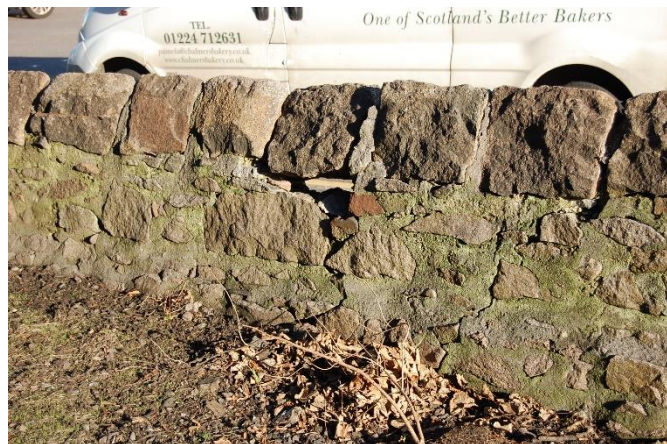
^Fig. 21: cement pointing, missing areas and cracking

The condition of the boundary walls is generally poor. Although the stones appear in reasonable condition, the cementitious pointing is failing in many locations. To the north is a long strip of copes which is offset to the wall below, possibly caused by ground movement/tree root growth at low level.

To the east, a particular area of concern is adjacent to the mature tree which appears to have caused bowing out of the wall, with cracks and significant lateral movement.

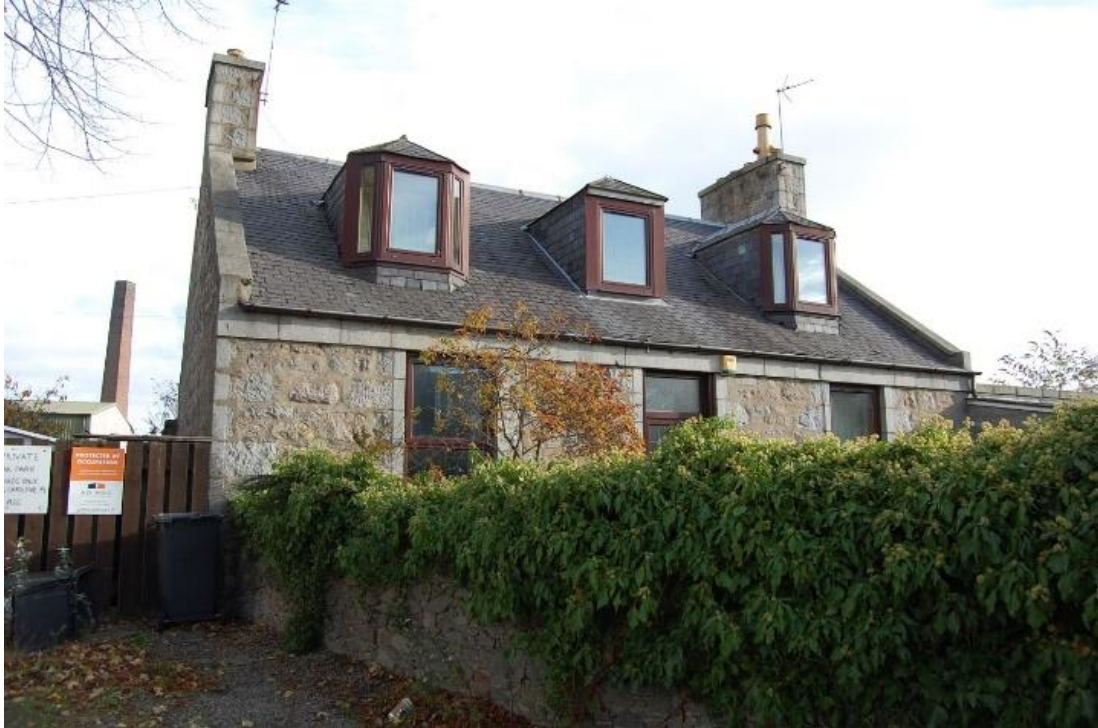
Fig.23: No. 1 Caroline Place

with Spanish slate, and the dormer joinery replaced with UPVC to a modern pattern. The central dormer is smaller than the two flanking ones and may also be a later alteration.

No 1 follows the pattern of typical Aberdeen suburban cottage, with granite walls and pitched slated roofs and front garden addressing street. Some of the exterior character has been lost with replacement UPVC windows, especially at dormers.

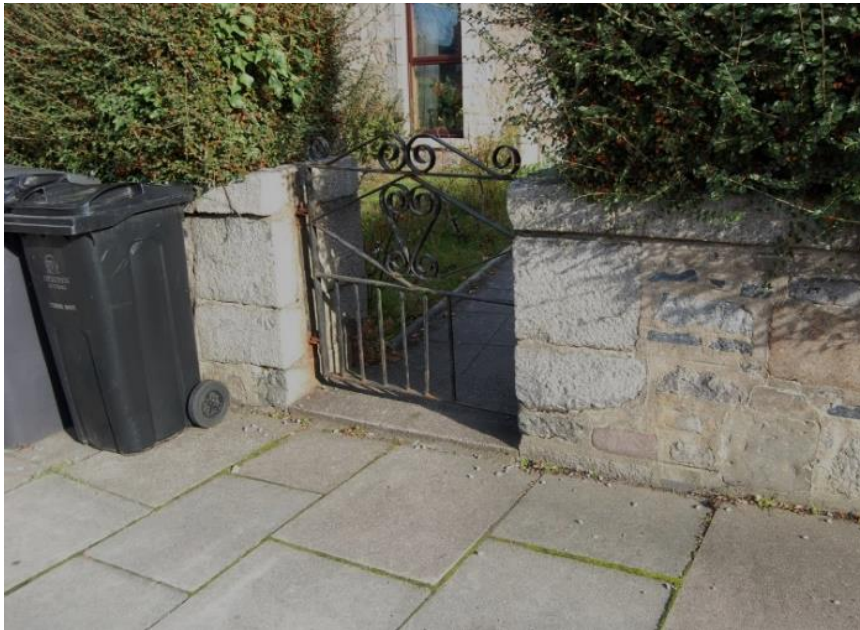
Fig. 24: Front gate and boundary wall, No. 1 Caroline Place.

There is a front and rear garden. The front garden is bounded by mid height rubble granite wall to the side, with taller hedge behind. The wall is of squared dressed stone, with gate piers to central gate (modern metalwork) and hedge behind. There is a bench mark on LH section of wall. The garden is set to lawn, with central path to front entrance door.

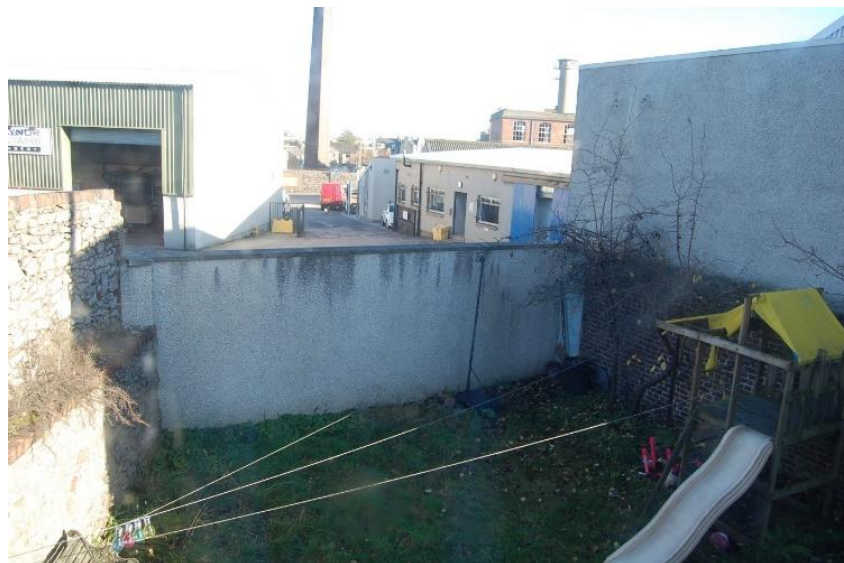
Fig. 25: Rear garden, No. 1 Caroline Place.

The rear garden has a mix of grassed and concrete slab paved areas. It is bounded by high masonry walls: rubble granite with brick dressings to north; hand made bricks to south; and a modern roughcast wall to east, which has curtailed the original extent of the rear garden/ area.

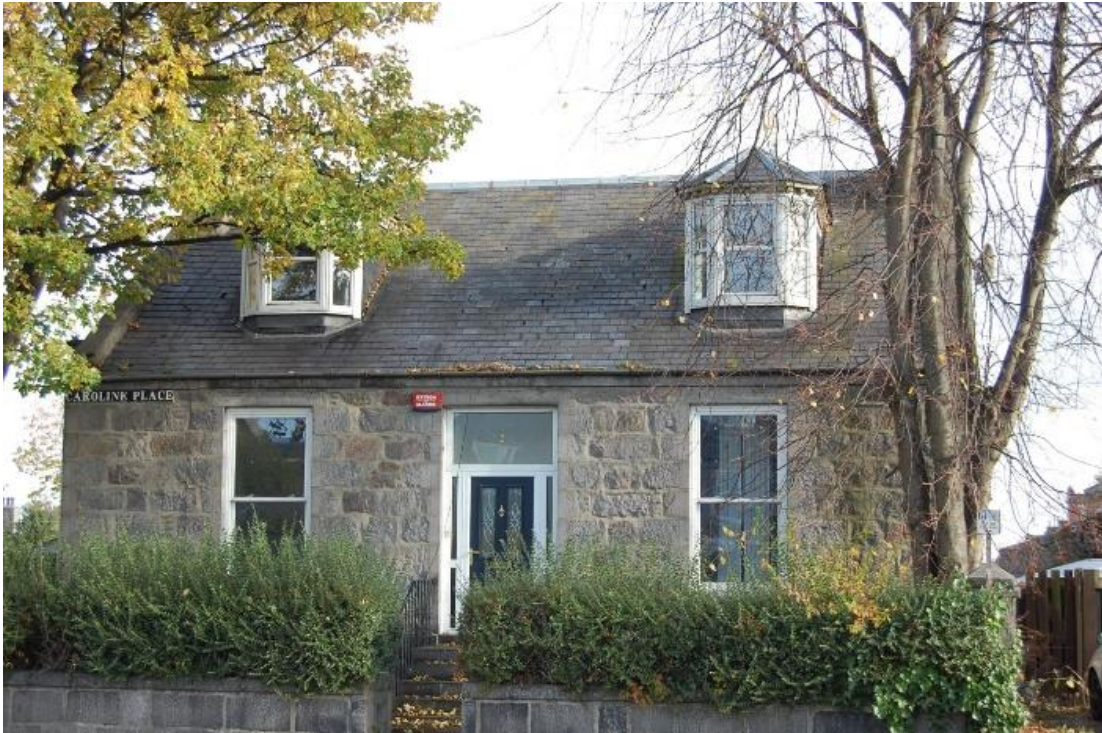
Fig.30: No. 2 Caroline Place

No. 2 Caroline Place is a traditional granite cottage, with one primary entrance floor, a coombed attic floor with dormers, and a lower ground floor. There are two rear extensions: a rendered porch to the back elevation; and a two storey block of modern materials.

No.2 Caroline Place is a detached cottage of one and a half storeys, with basement, of a typical Aberdonian pattern. It has a slated pitched roof, with two hipped, slated dormers to the front attic rooms. Although the dormer window joinery has been replaced, the dentiled cornice remains. A black tile road sign is fixed to front elevation.

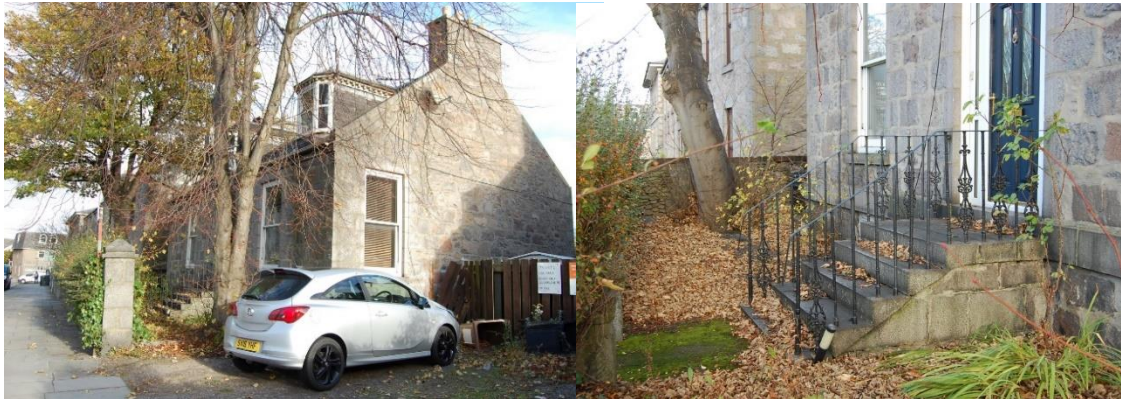
The envelope is of granite masonry, symmetrically laid out, and with flush ashlar dressings to openings, quoins and wall head. The main entrance has steps and railings leading up to it of traditional pattern, but the door itself is modern. All other external joinery has also been replaced. There are two light wells to the front basement rooms.

Figs. 31, 32: Front of No. 2 Caroline Place

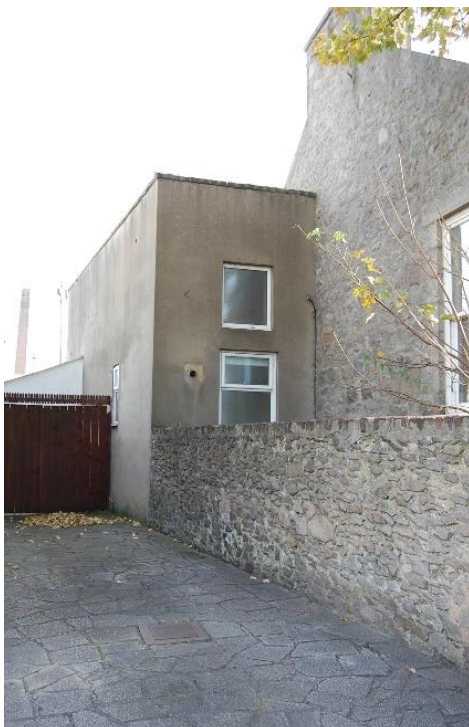
No. 2 does not continue the line of Nos. 3-6, but is set back a little. The side elevation also has a side window to the front room. On the north, a modern extension block sits to the back of the site. This is a cement rendered block of unsympathetic design (fig. 34).

<Fig. 33: North extension block No. 2 Caroline Place

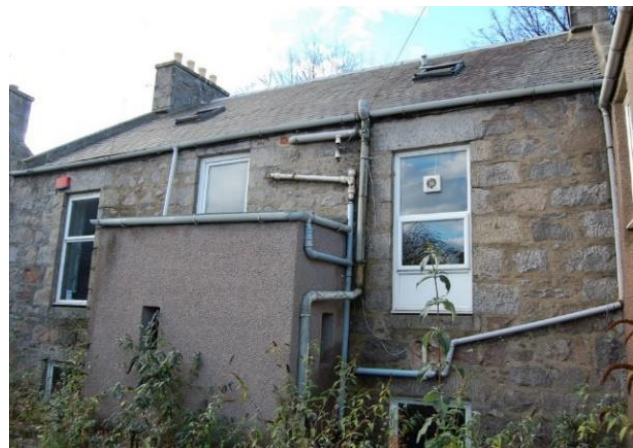
To the rear the original rubble façade is visible, but there has been an accretion of drainage pipes and the rear porch has either been rebuilt on has had a modern cement wet dash applied (fig. 35). Windows are modern.

^Fig. 34: Rear elevation, No. 2 Caroline Place

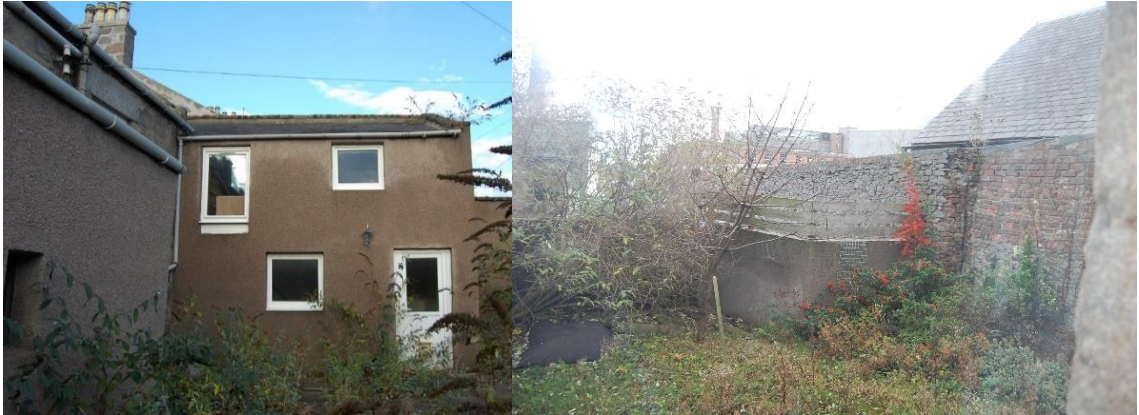
Figs. 35, 36: Rear of No. 2, Caroline Place

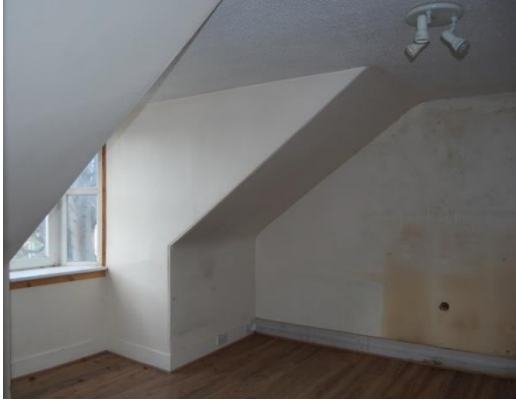
Figs.39, 40: Attic rooms, with water ingress, No. 2 Caroline Place

The building is in moderate condition. There appear to have been localised leaks at windows and flues which have damaged internal finishes. The external masonry has been cement pointed.

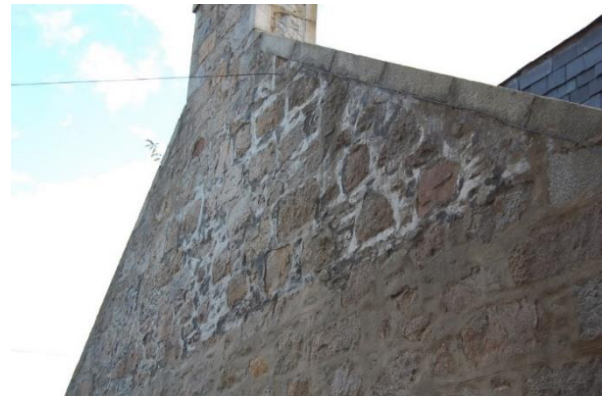
^Fig. 41: cement pointing to gables

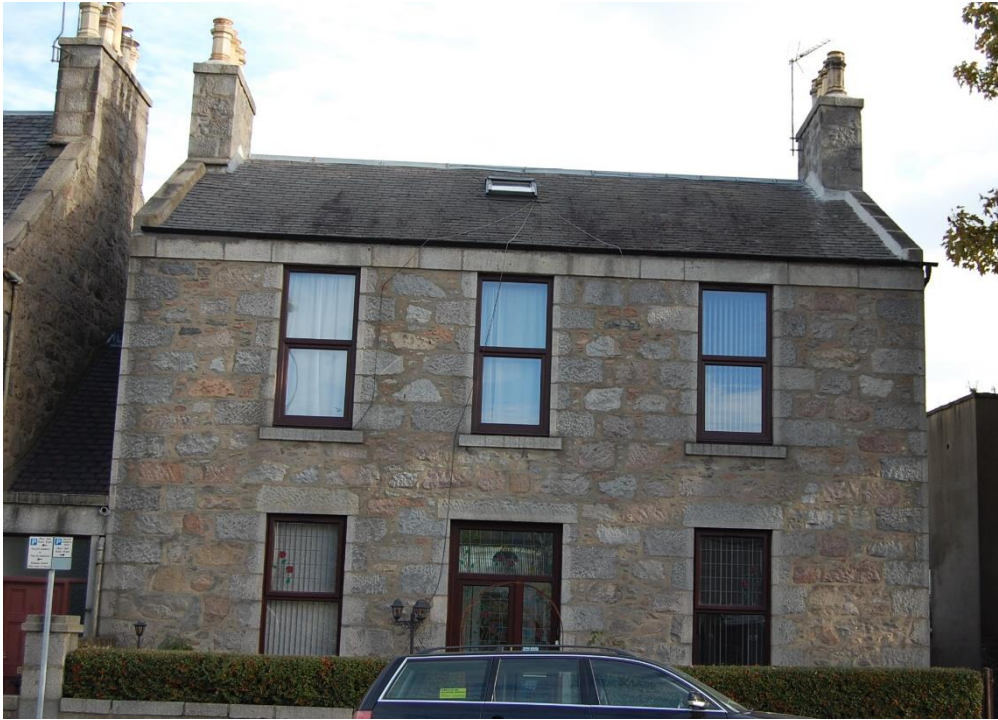
Fig.44: No. 3 Caroline Place

No. 3 Caroline Place is a typical two and half storey suburban cottage, with granite masonry and slated roof.

around a central opening. The current fenestration is modern UPVC wood effect, with a plain double sash appearance. There are no dormers, with a small central rooflight only. Chimney stacks sit in middle of gable with original pots.

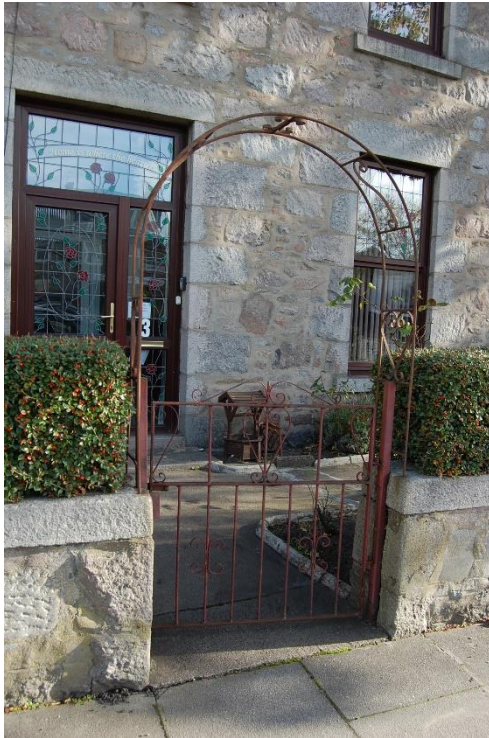
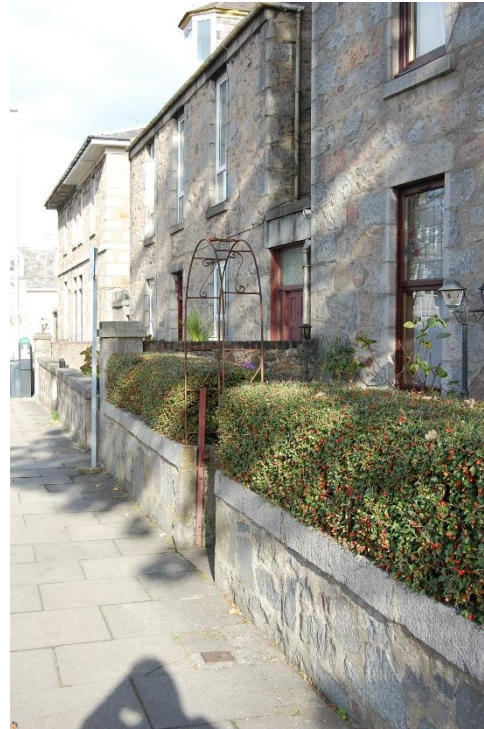
Figs.45, 46: No. 3 Caroline Place, front garden

The garden is bounded by a low level granite wall, with well trimmed hedge behind. A modern metalwork gate sits on the centre axis. A very small garden is laid with path and flower beds to each side.

From cursory external inspection from street, there are no obvious important condition items for No. 3.

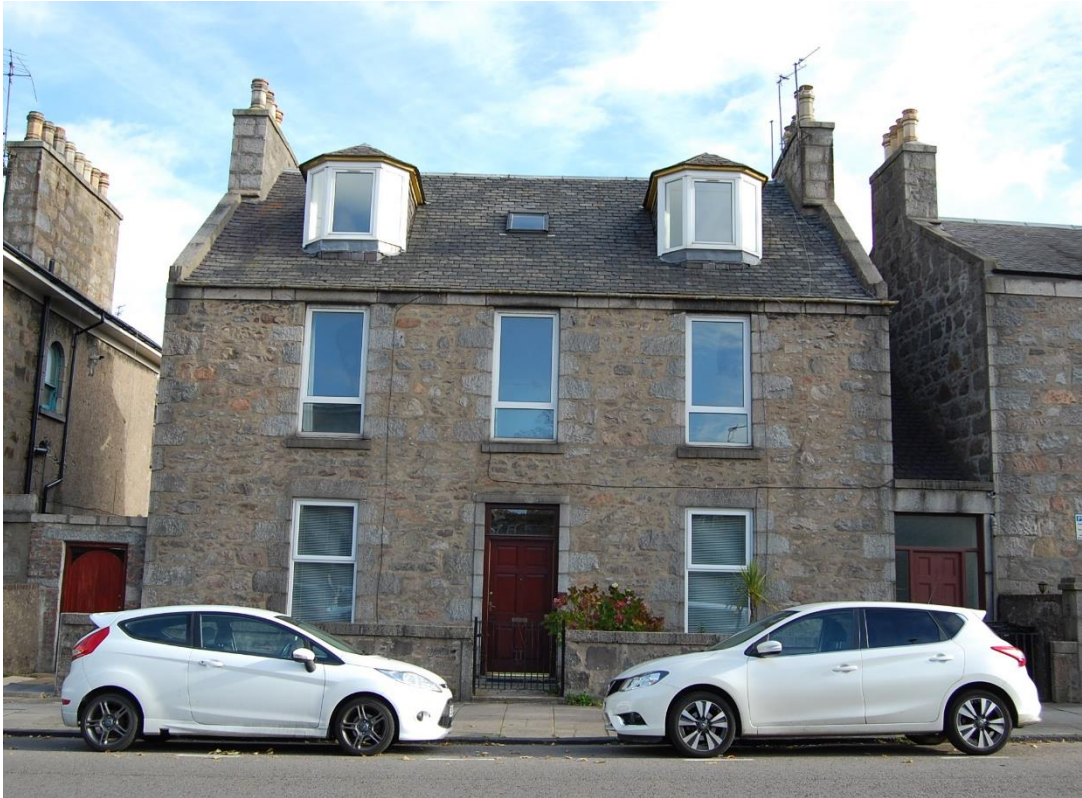
Fig.47: No. 4 Caroline Place

At some point in the recent past, the original joinery has been replaced to external windows and doors, and the front boundary wall moved closer to the building.

The house appears in reasonable condition, although the cement pointing is detrimental to appearance and performance of the house. The cast iron gutter to the front elevation is in need of resetting and decoration.

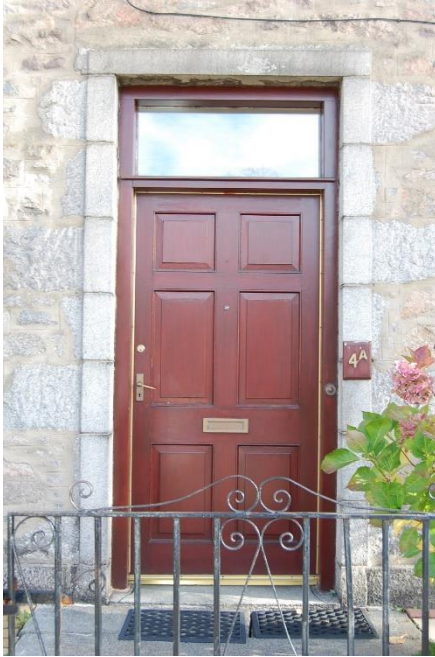
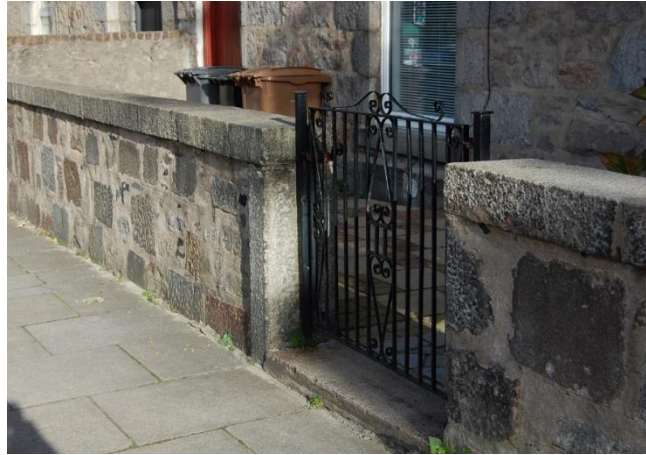
^Fig. 48: No. 4, front Garden

<Fig. 49: No. 4, front gate and door

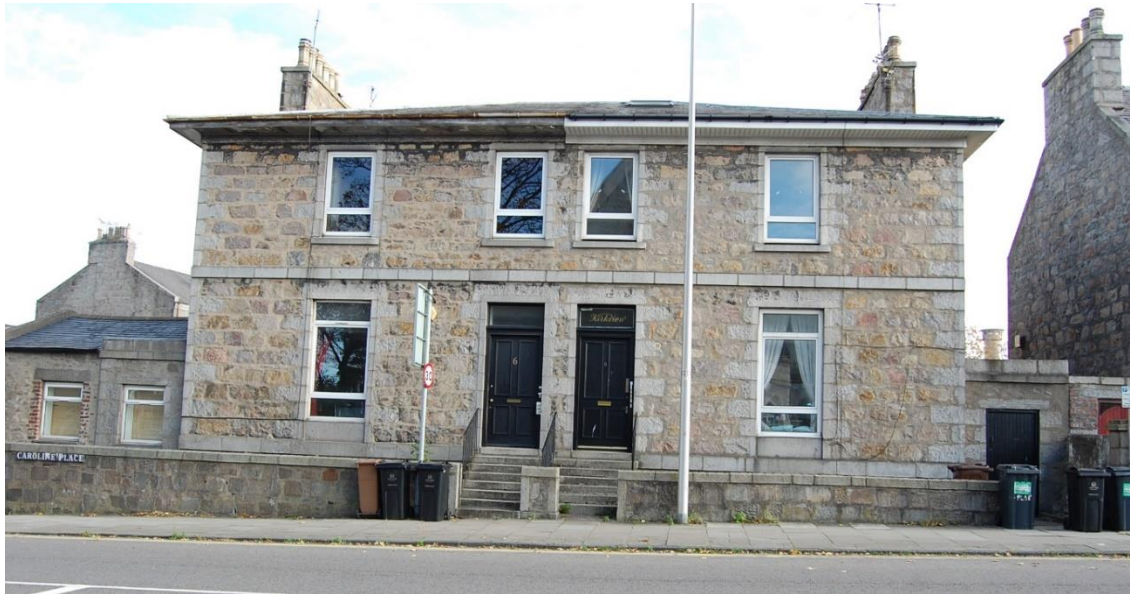
Fig. 50: Nos 5/6 Caroline Place

The front façade of the building is little changed, with the exception of the replacement windows which are unfortunately not to the original pattern and materials, which cannot now be determined. It retains its windows bands and string courses, and the light wells to basement rooms. The varying decorative treatment to both houses has given a patchwork effect, rather than the single villa originally intended.

The house is of characteristic early nineteenth century design, but its deep eaves cornice, overhanging shallow roof are unusual for Aberdeen. The eaves to no. 5 appear to have been replaced with plastic.

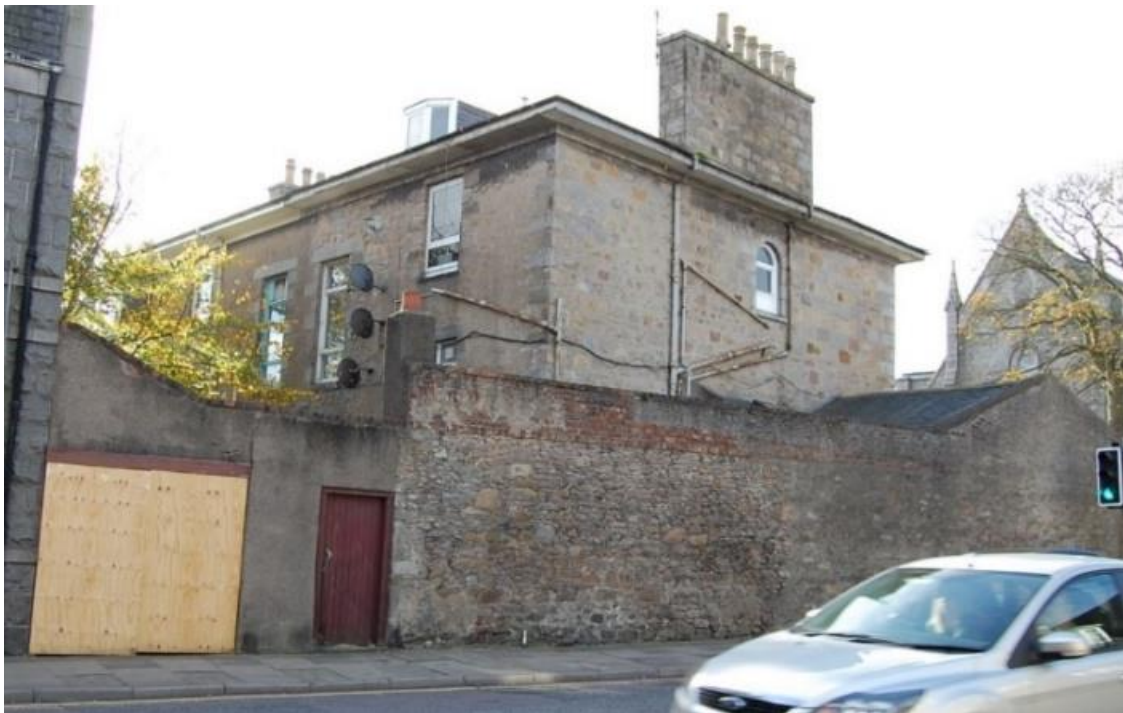
The northern outshot was extended towards Hutcheon Street although the date for this is unclear. The footprint of the building exists in 1866, but is not shown in the second edition OS. Given the change in materials and lack of symmetrical design (to the whole building), it is very unlikely to be original, but likely a rebuilding from late 19th/ early 20th Century, with a further modern garage and garden door fitted to the cement rendered section to east.

Fig. 51: Nos 5/6 Caroline Place, side elevation to Hutcheon Street

The rear elevation has been rendered, likely with cement, which is beginning to fail and again has different decoration to both sides.

The building is in moderate condition but is in need of decoration and some repair of joinery, particularly no. 6. The rear elevation has some failing render, pointing and masonry.

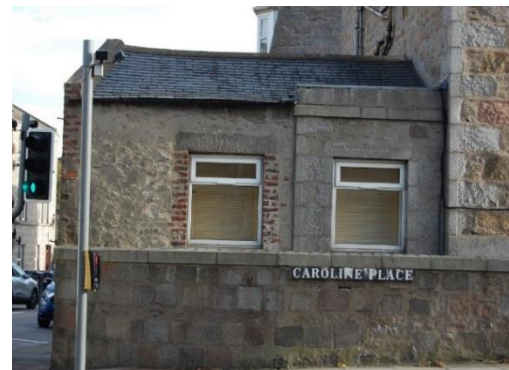
Fig. 52, 53: Nos 5/6 Caroline Place, external details

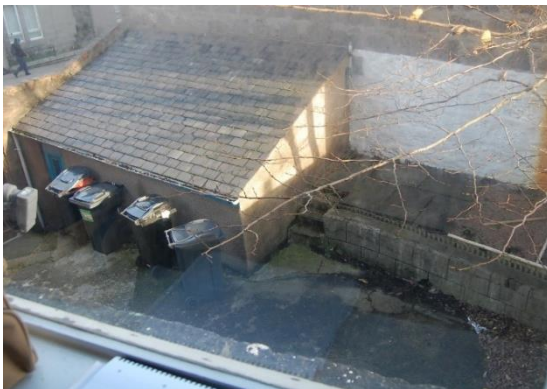
Fig. 54: Rear Garden, Nos 5/6 Caroline Place

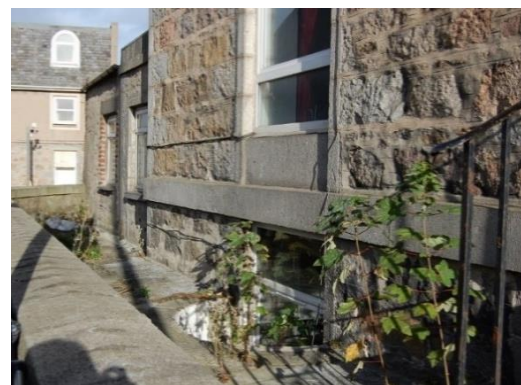
Fig. 55: Front Garden, Nos 5/6 Caroline Place

The front garden is very truncated to that shown on the OS map of 1866. It currently has a low-level rubble granite wall, with chamfered cope and black tile street sign. The space between this and the house is paved, with unguarded oval light wells to basement. The steps to the house are salvaged granite, with modern steel balustrades.

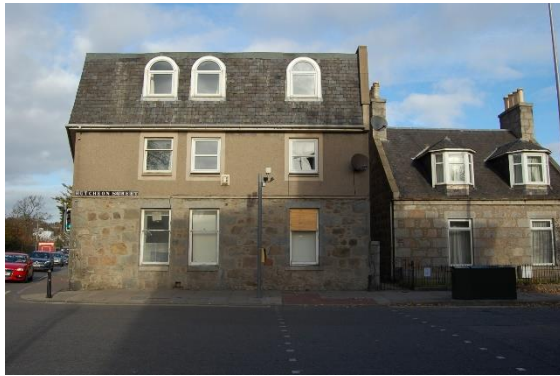
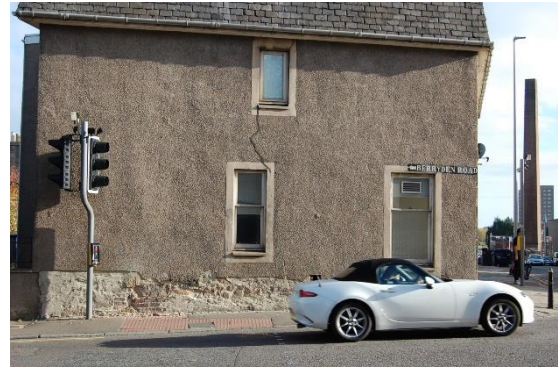
Nos. 168-170 Hutcheon Street sits on the NE corner of the junction of Hutcheon Street and Berryden Road. It is a three storey building, with a granite ground floor to the front, a cement rendered first floor and a slated mansard attic. It is flatted accommodation, although no access was possible to the interior to confirm layouts etc.

Fig.60: Upper flat, No. 165 front elevation

Fig. 61.: Basement flat, No. 165, side elevation to Berryden Road

No access was gained to the interior because of health and safety concerns. The exterior appears in moderate to poor condition, as there are issues with poor quality materials in surfaces and windows reaching the end of their life.

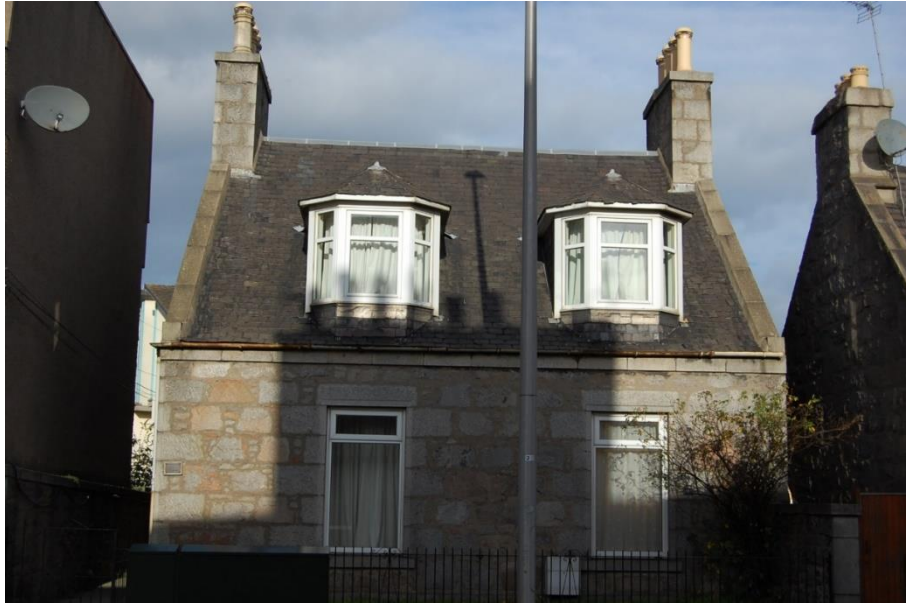
This is a deceptively large one and half storey dwelling, in granite masonry, with slate roof.

Fig. 62: 166 Hutcheon Street, front elevation

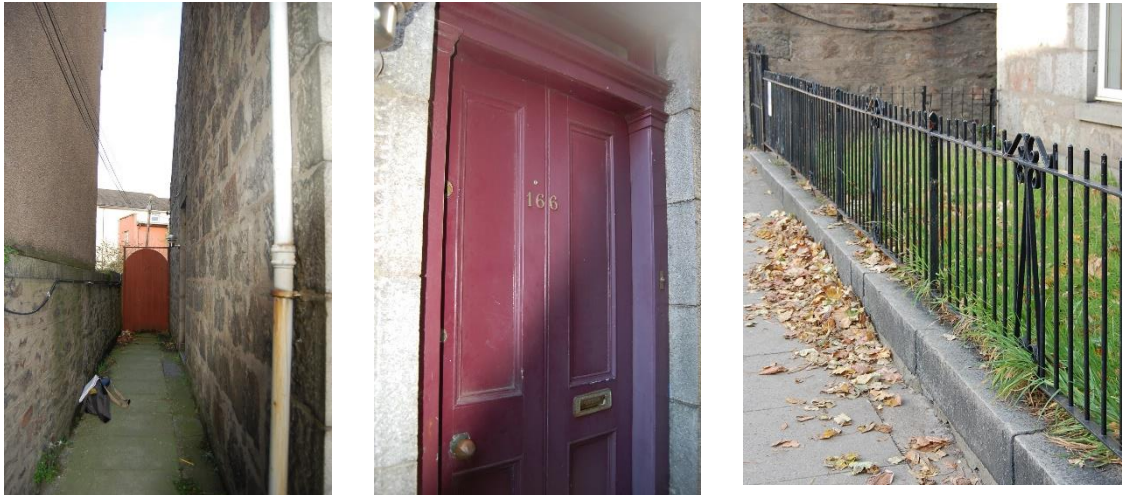
Figs. 64, 65, 66: External Details No. 166 Hutcheon Street.

The front garden is set to lawn, with modern steel railings over a granite cope. The rear garden is grassed and retains sheds similar in footprint to those in 1866. The rear extension has been rebuilt/ rendered over.

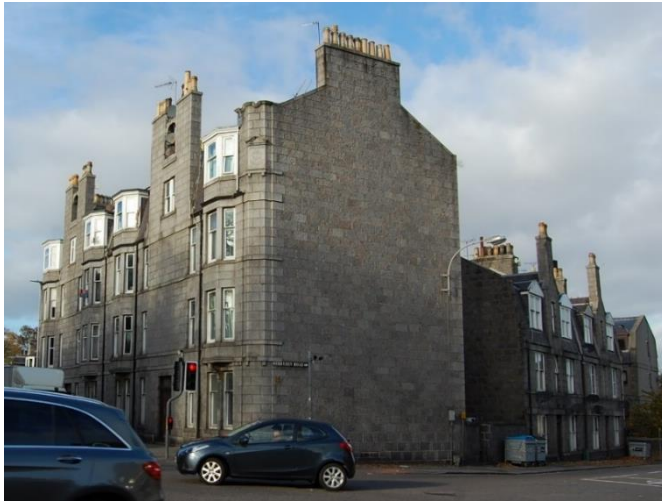
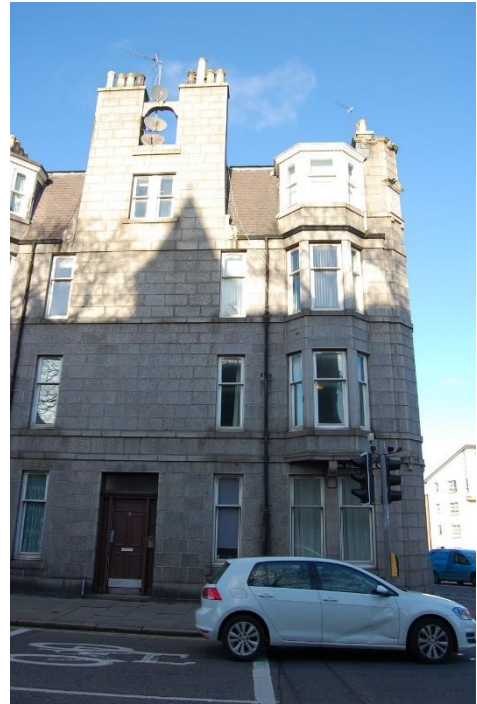
^Fig.69: Tenement to Westburn Road/ Berryden Road

>Fig. 70: Part elevation to Westburn Road showing stonework detailing

The first block (to Westburn Road) has a number of interesting features, including the double chimney stack, strong façade modulation caused by bay windows and wall head bay dormers/ They also have some carved stone detailing, all of which is unusual for the what was low cost housing in a difficult to work granite stone.

Generally in acceptable condition although windows and roofs are in need of redecoration and maintenance. Their character would be considerably enhanced by reinstatement of original paint colours beyond the off white currently in use.

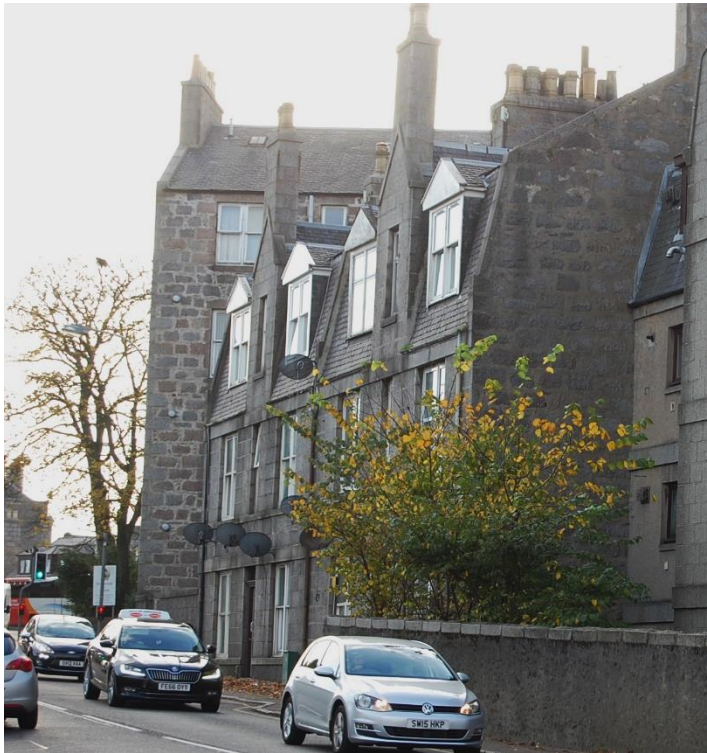
The blank gable to Berryden Road emphasises that this road was of lesser importance, and perhaps allowed the flats to look over the green space to the centre, not the industry to the east. Originally the gable was shown with side windows to rear kitchens in this gable but there is no evidence that these have been subsequently infilled.

Fig. 71: Rear Block, to Berryden Road.

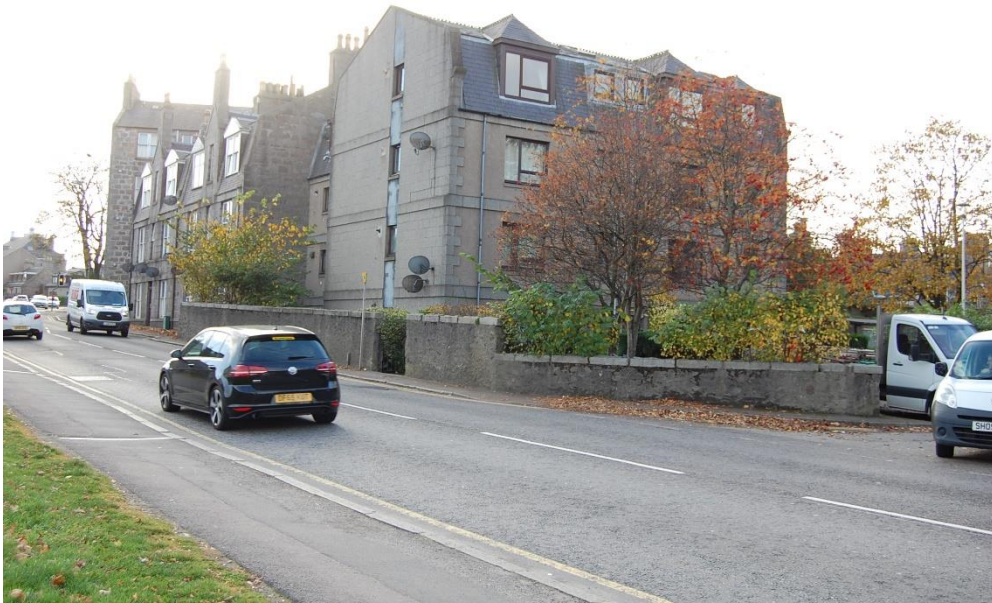
Approaching from the north via Berryden Road the effect is less pronounced. The back block is dwarfed by the modern development adjacent: the grey cement rendered wall of this newer development encroaches on this view, leaving a rather dull and dark impression (fig.73).

Fig.73: Berryden Road, South west: modern rendered wall to recent flatted development

granite rubble work with similar copes. This is likely to date from the late twentieth century housing development (fig. 73, 74).

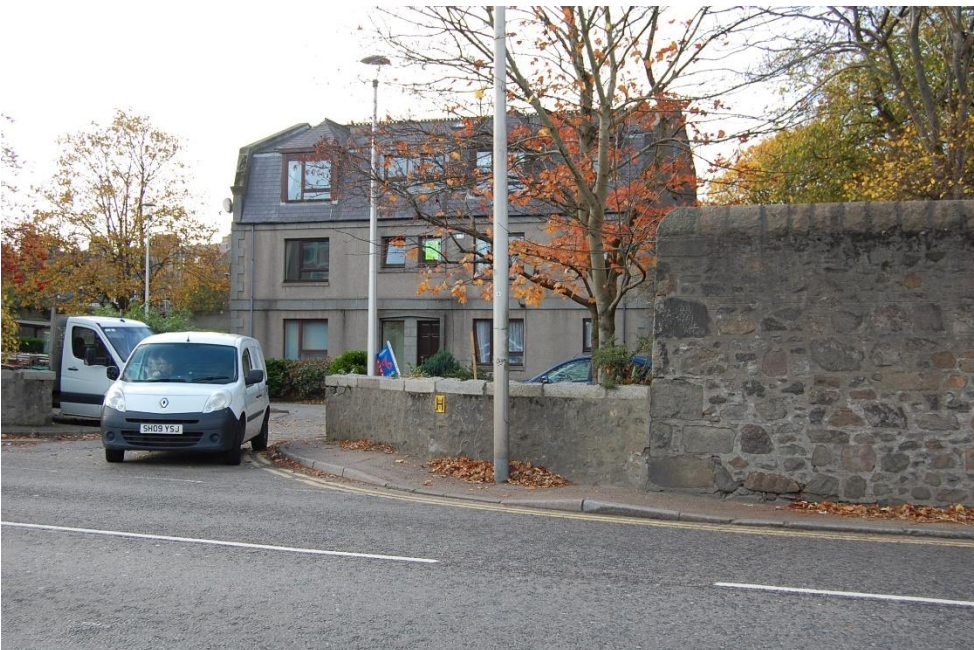
Fig.74: Berryden Road, southern edge of orchard wall to right.

The next section of the wall (which returns around the northern half of this housing plot), is of substantial height, with quoins stone corners and saddle profile copes; all in granite. This is likely to be a part of the original wall to the Asylum. Mature trees sit behind this wall. (fig. 74, 75)
