BERRYDEN CORRIDOR IMPROVEMENT PROJECT
HERITAGE STATEMENT

Prepared by Georgina Allison RIBA RIAS
On behalf of HFM Architects

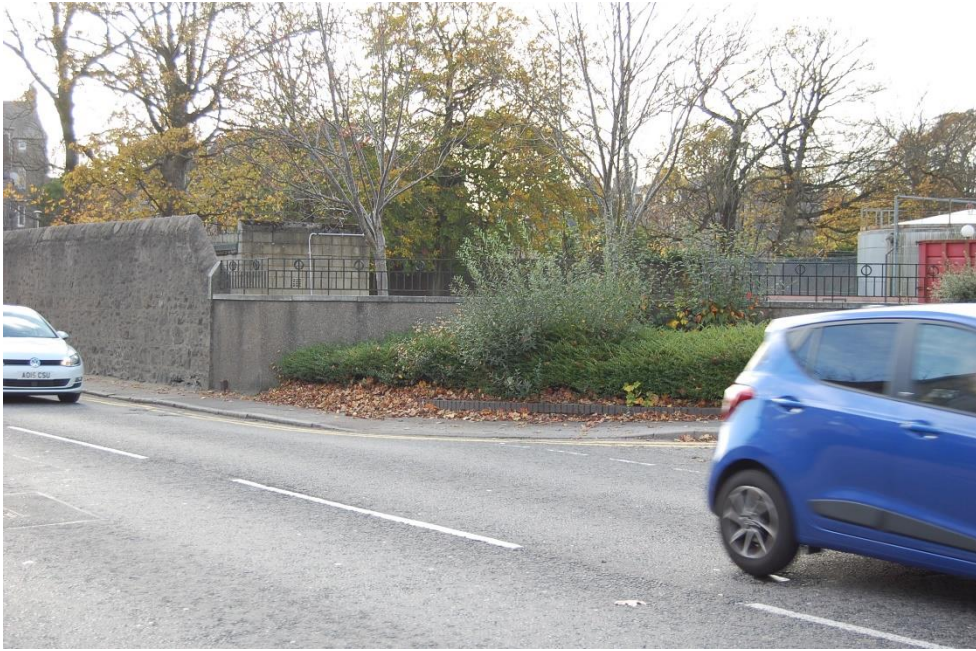
Fig. 75: Berryden Road, northern edge of orchard wall to left, modern swept drive to Cornhill Hospital.

This solid section of wall runs south on to the 'new' entrance to the Cornhill Hospital, where again a swept drive/ entrance has been extended and adapted for vehicular use and to form an entrance to the twentieth century hospital. The wall has been replaced with a cement rendered wall with modern ironwork railings above (fig. 75)

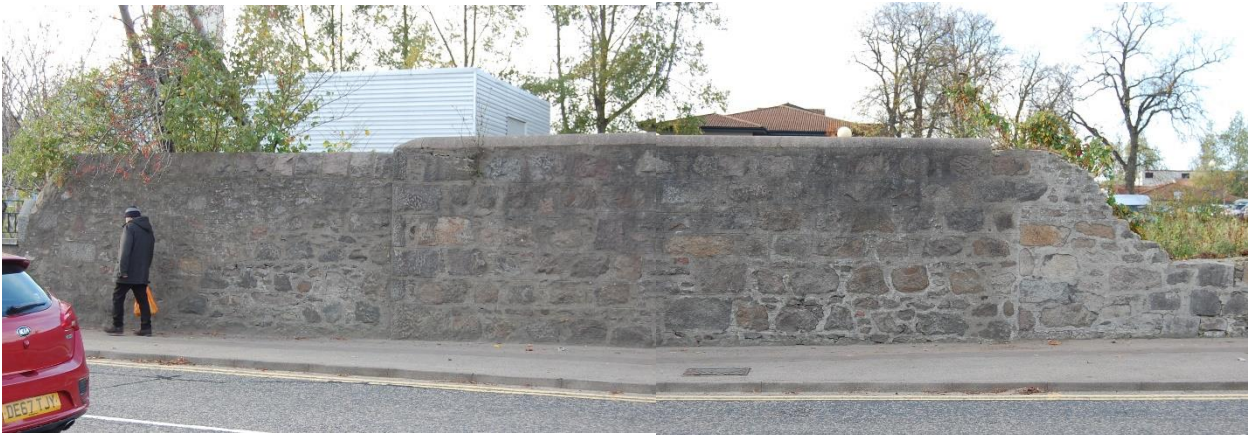
Fig. 76: Last section of Cornhill wall to left then former Asylum boundary wall going northwards, showing various phases of construction

The condition of the walls varies from extremely poor and partially collapsed to moderate. Almost all is granite rubble work, with some later additions, and this rubble work is generally cement pointed, which is not appropriate for historic masonry structures and will exacerbate decay.

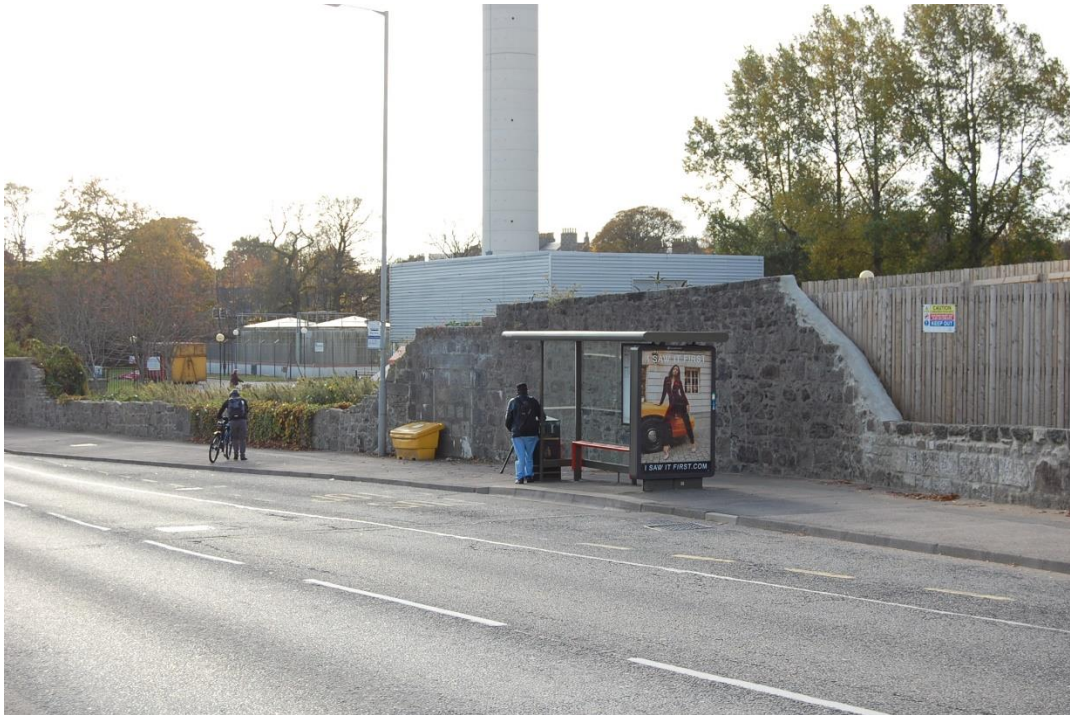
Fig.77: Berryden Road, former Asylum boundary walls, showing remains of wash-house and laundry

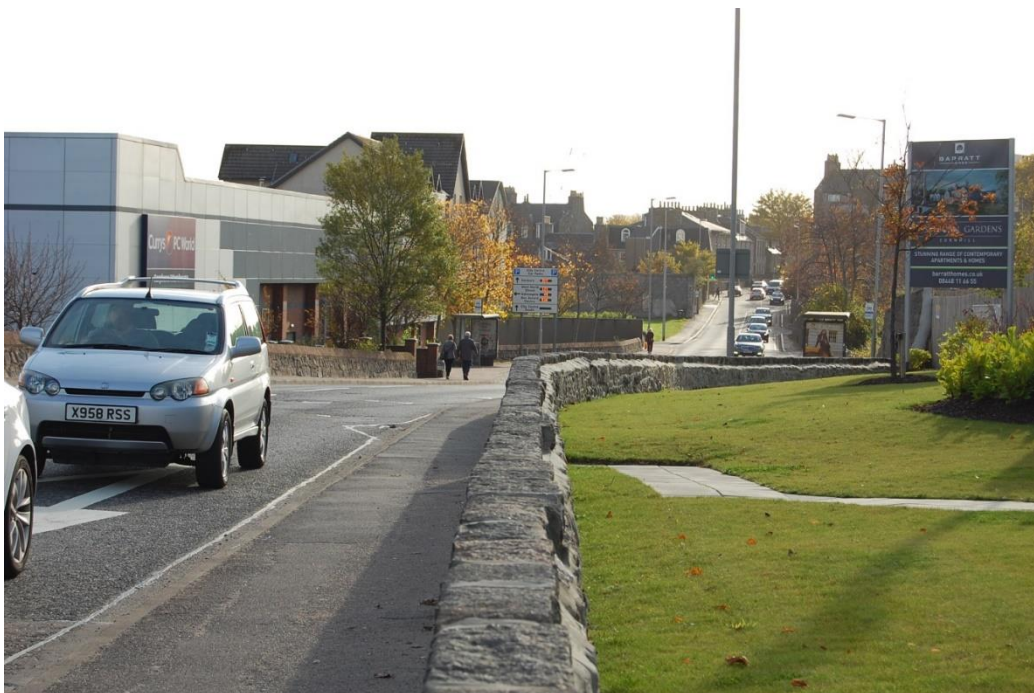
Fig.78: Berryden Road, former Asylum boundary walls to new housing development to west, recently reduced in height and capped.

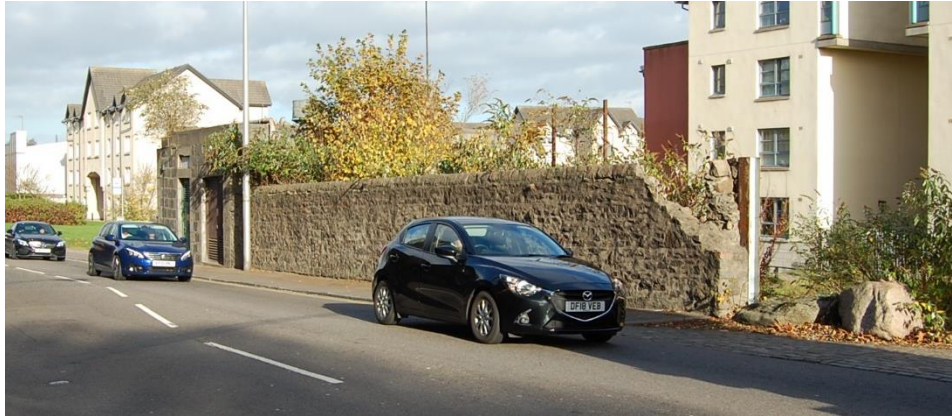
Fig.80: Berryden Road, remains of Industrial Building

The ruins are in moderately poor condition, with eroded joints to upper edges as well as plant growth. Openings have been blocked and metal door in north façade is corroding. The cobbled section is partially complete and overgrown.

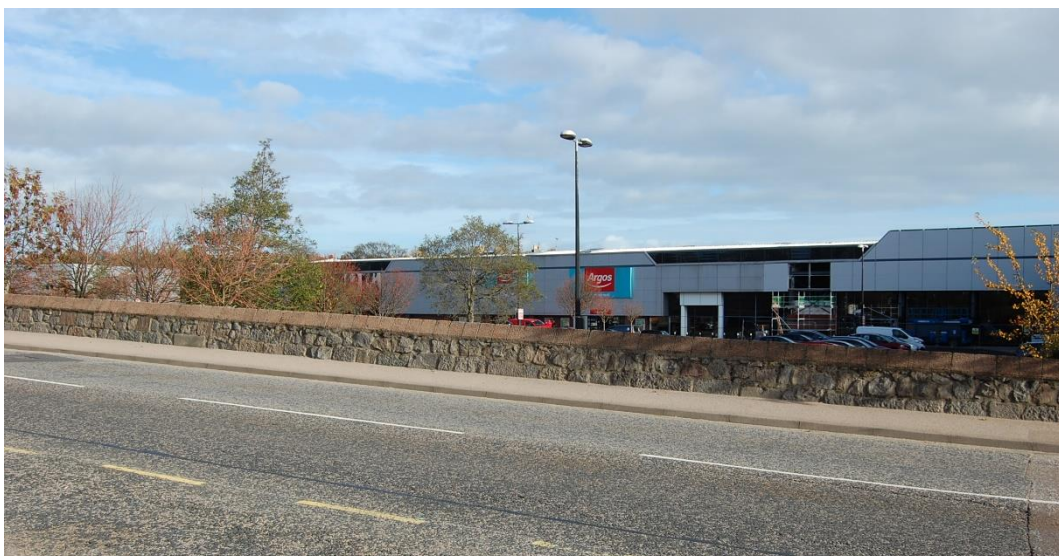
The low level wall to the retail park is c. 600mm high and made of rubble laid granite, with triangular cope of pinkish red granite/reconstituted stone, typical of developments along this road.

Fig.81: Berryden Road, boundary wall to Retail Park

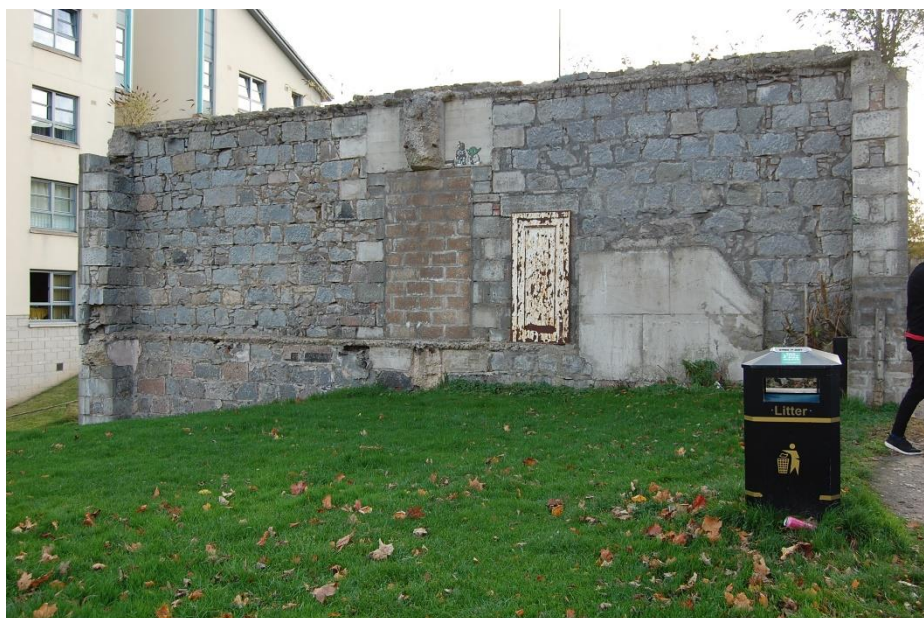
Fig.82: Berryden Road, Former Mill/ sub- station

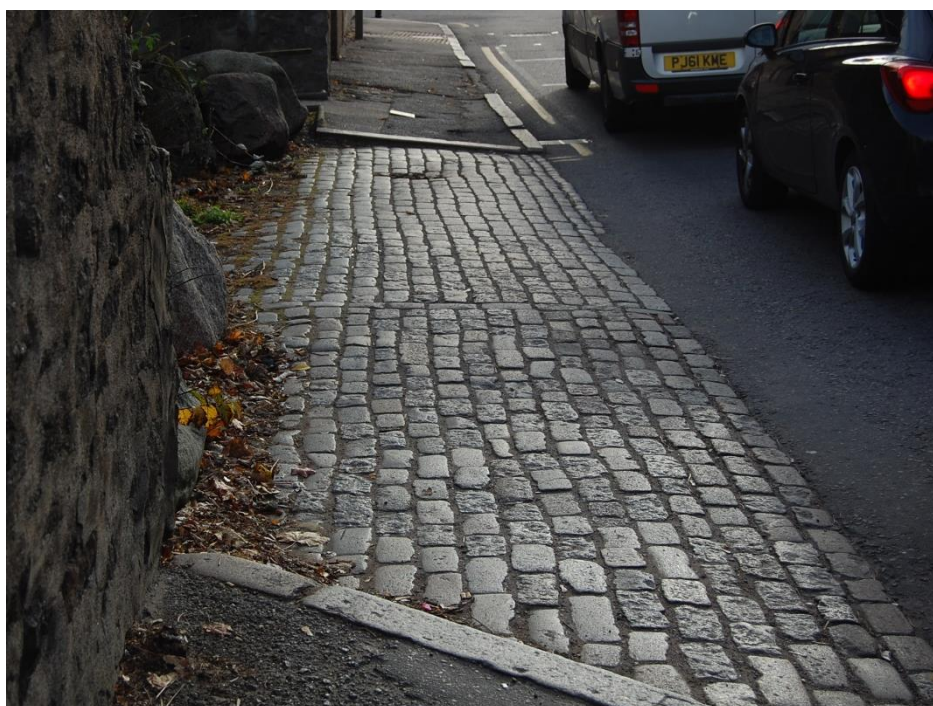
Fig.83: Berryden Road, granite setts and kerbstones to former mill entrance

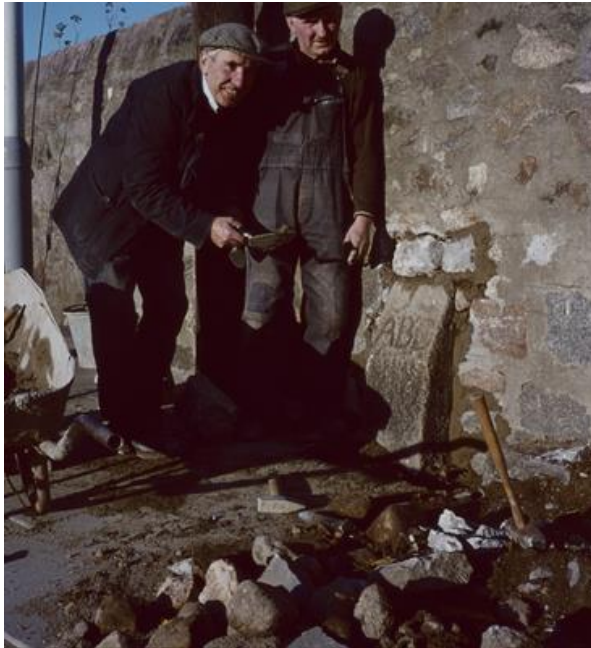
Fig.87 : Stone being reset into wall (photo courtesy of City Archives. c. ACC)

The March stone is in fair condition but had been chipped on upper corner.
