## 2 Survey of granite gables

A photographic survey was made of granite gable walls on a number of mornings following overnight rain to determine the patterns of wetting on their surface relative to weather conditions, façade orientation and façade design details. Weather conditions during the previous night were obtained from the Meteorological Office (Table 2.1).

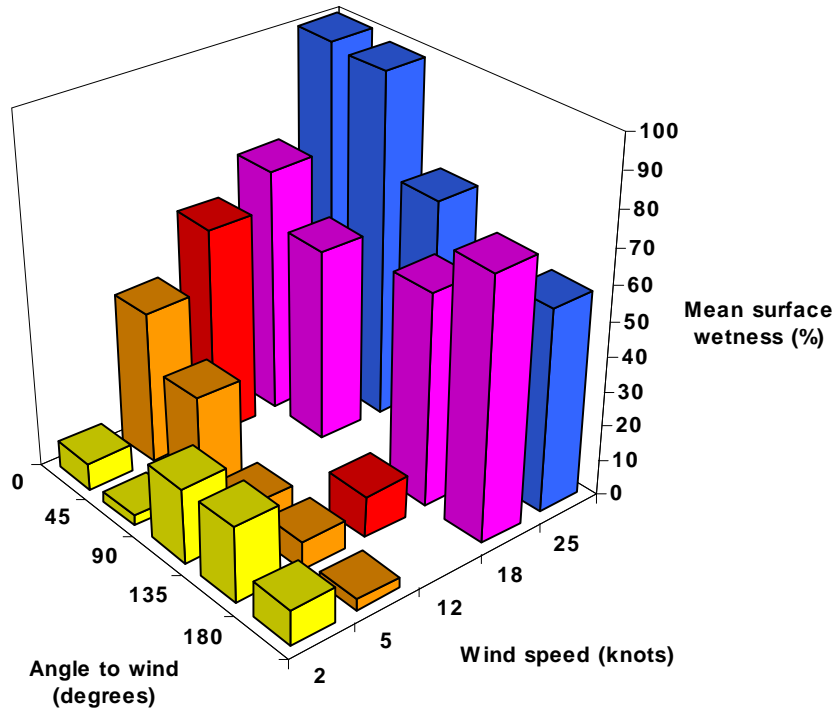
Figure 2.1 Relationship between mean surface wetness of gables (% surface area), wind speed and orientation of gable relative to driving rain.

In any orientation, stronger wind speeds resulted in more surface wetting (Figure 2.1). The duration of rain events clearly also influences the extent of wetness (Figure 2.2) but is a less important control on surface wetness than wind speed. There was a weak correlation between the amount of wetness on gables and the relative direction of wind driven rain during the previous hours (Figures 2.1 & 2.2). Gables that faced into the wind tended to be more wetted although the differences were not so pronounced as might have been expected. Even gables at 180° to wind driven rain can be significantly wetted, especially at higher wind speeds. It is likely that surrounding buildings have a strong influence on local wind direction so that climatic data from a weather station a few miles away (Aberdeen Airport) do not necessarily directly reflect conditions experienced on a building facade.

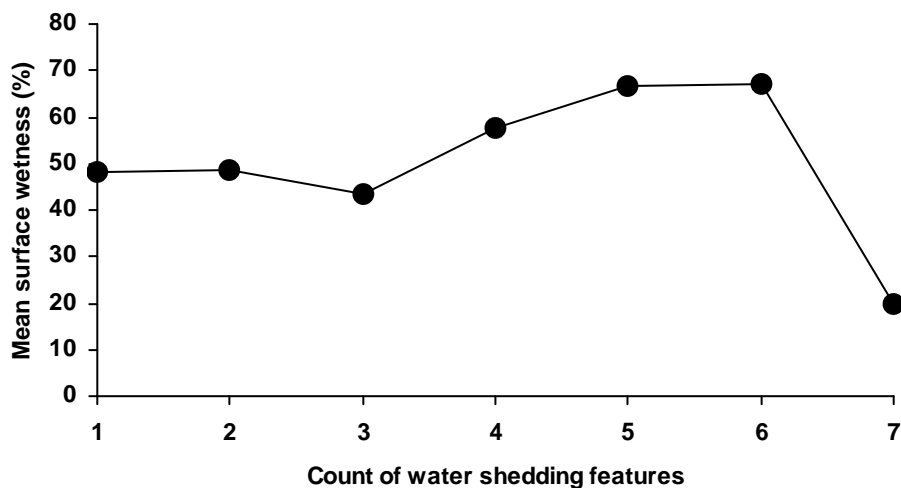
Figure 2.3 The relationship between mean surface wetness and count of detailing features on gable.

Gables with more detailing features showed no evidence of reduced wetting (Figure 2.3). If anything the tendency was for gables with more features to show greater degree of wetting. Features have been “counted” by the simple mechanism of counting 1 for each of the following elements:

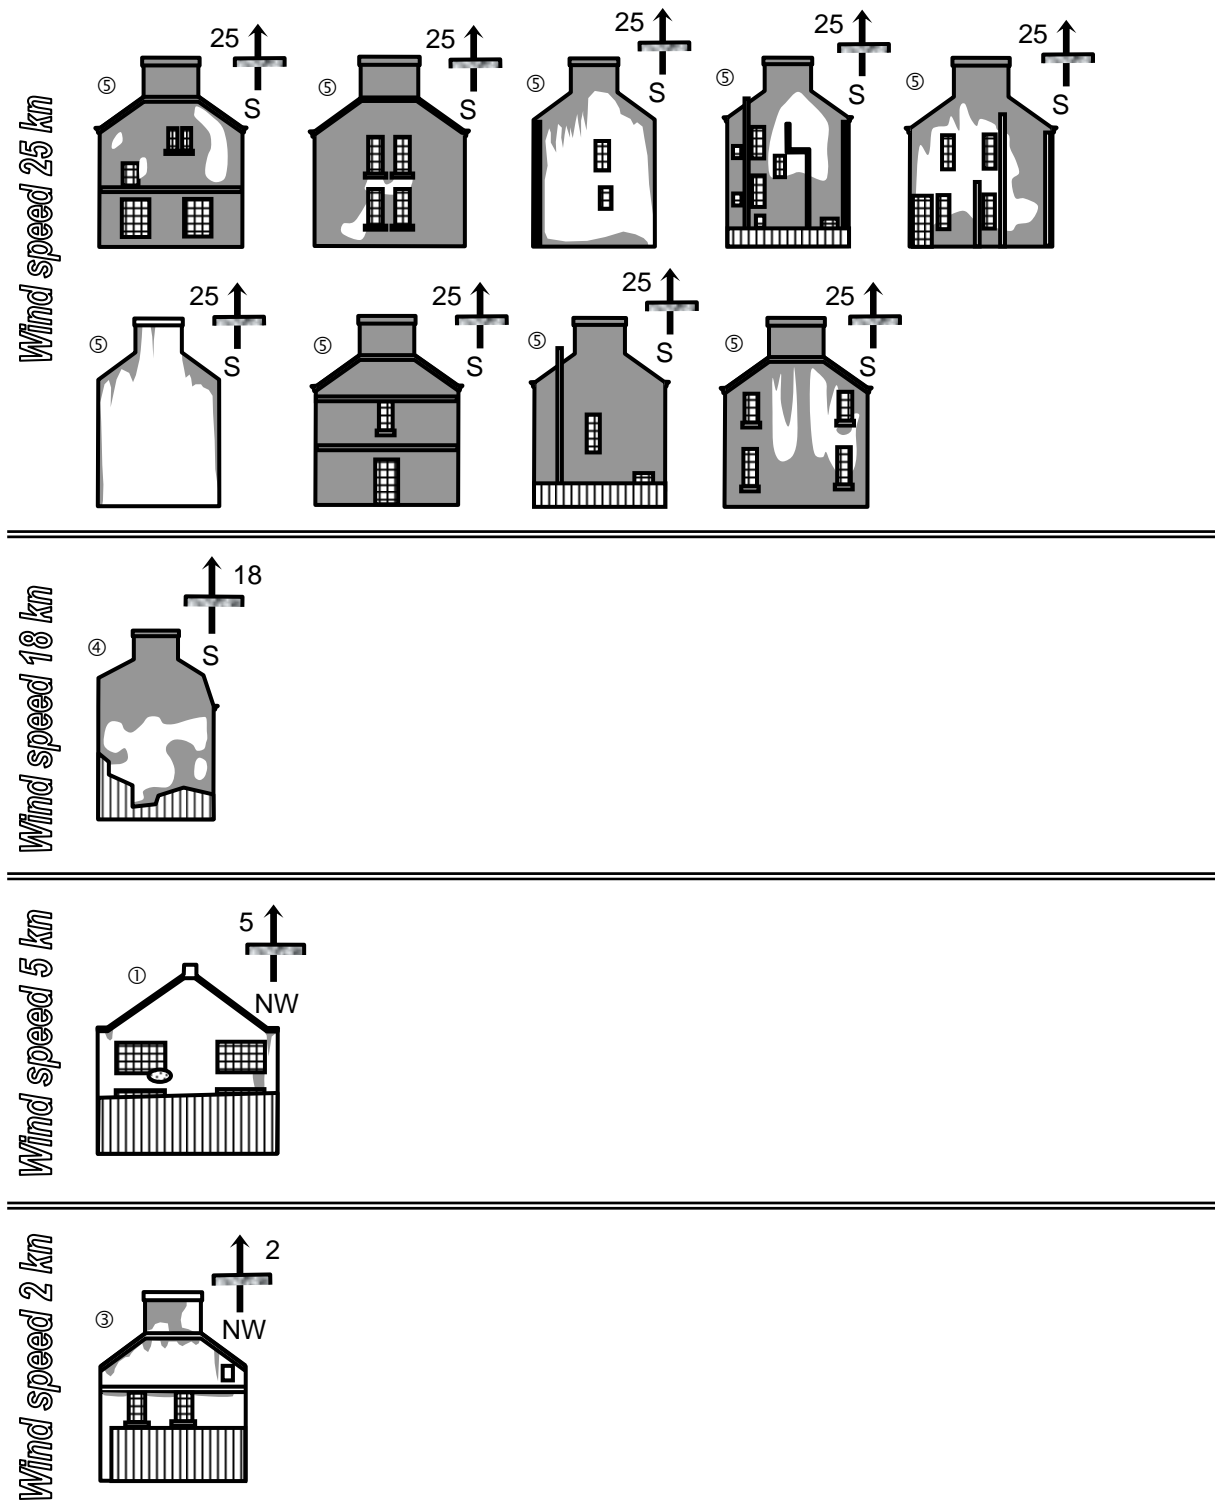
Figure 2.4a Facing 180° to wind direction.

The diagrams in Figure 2.4 show the wetting patterns on a number of gables. Given a long enough period of rain any exposed gable will eventually become completely wetted. However, the wetting patterns during less severe weather provide useful information on areas most commonly affected by deterioration due to wind driven rain and to potential pathways for penetrating damp.
