4 Field studies

4.1 Field visits

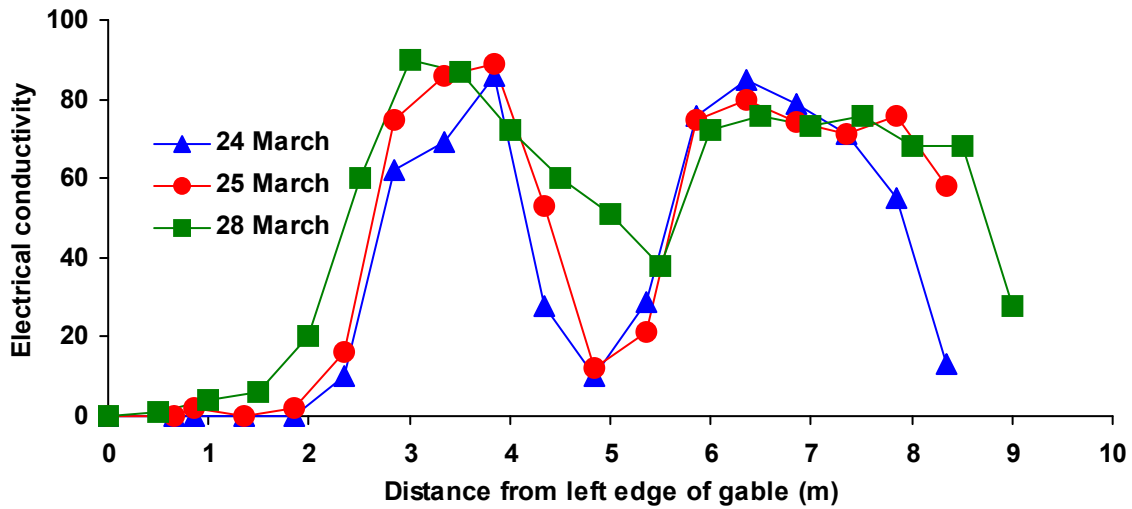
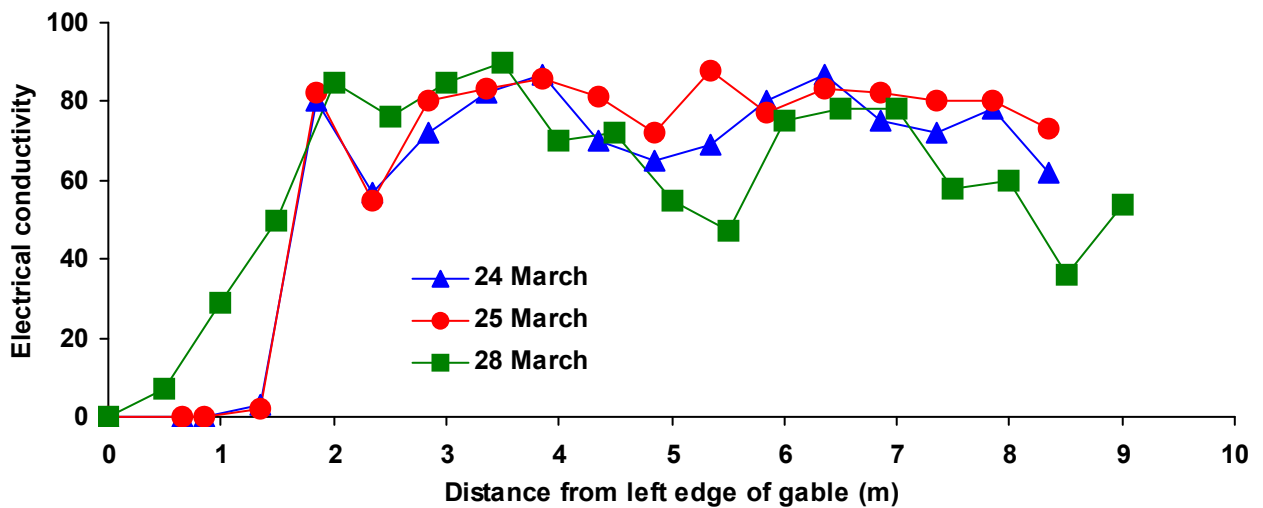
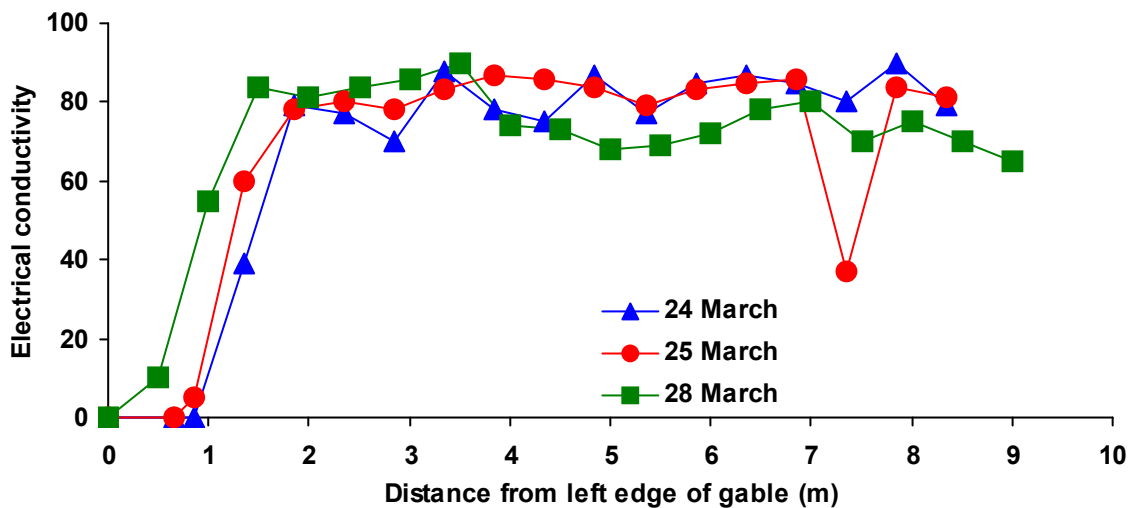
Electrical conductivity data are shown graphically in Figure 4.3 and diagrammatically in Figure 4.4. These figures show zero, or low levels, of conductivity at the left end of the gable over a distance of about 1 to 2.5m in from the corner. This indicates that the left end of the gable (on 'lighter' coloured mortar only) was dry on the surface. Further along the gable, high conductivity levels indicate that the surface was damp. At 0.80 above the platform, levels of dampness were fairly consistent across the gable. Readings at 1.30m and especially at 1.80m indicate a slightly drier area in the centre of the gable (i.e. slightly lower electrical conductivity). This is consistent with the appearance of the gable in Plate 4.28.

Figure 4.3 Graphs showing the levels of electrical conductivity across the gable at various heights above the concrete platform on 24th, 25th and 28th March 2003. NB There was no rain during this period and for at least a week prior to March 24th. (Same data shown diagrammatically on Figure 4.4)

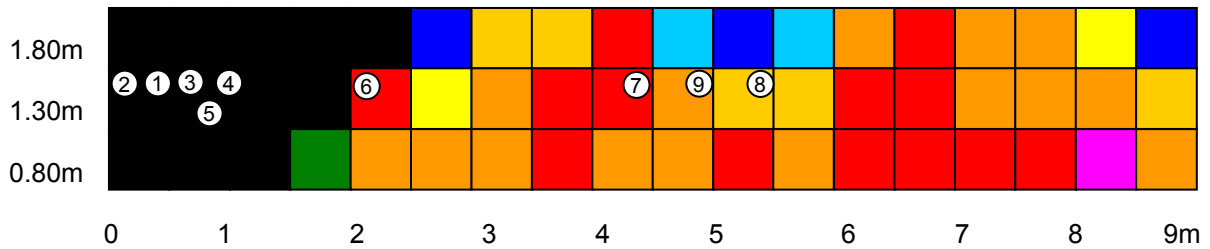
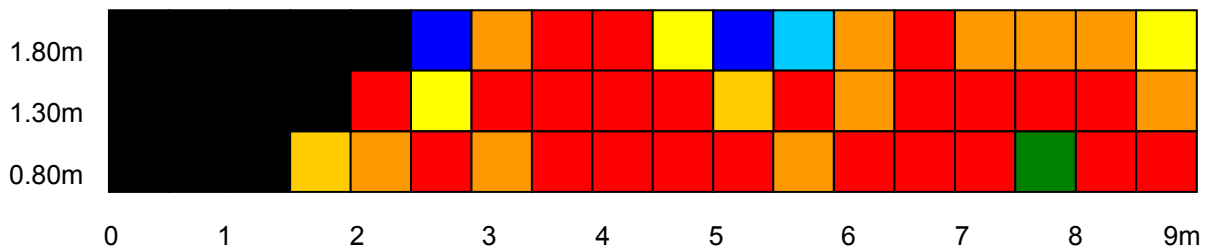
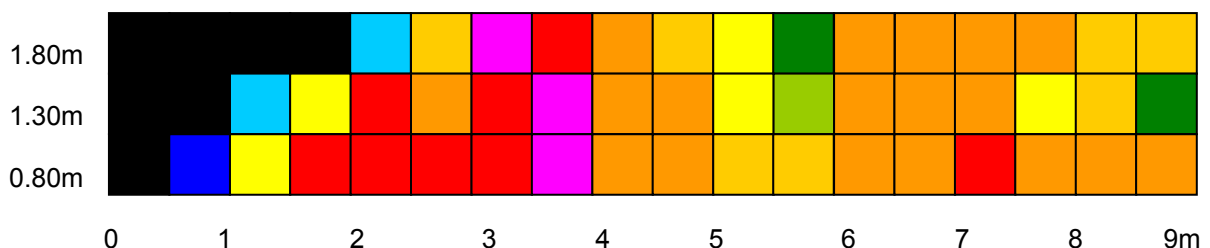
Figure 4.4 (Same data as Figure 4.3) Diagram showing the levels of electrical conductivity across the gable at various heights above the concrete platform on 24th, 25th and 28th March 2003. NB There was no rain during this period and for at least a week prior to March 24th. The numbers in Figure 4.4a. show the positions of water absorption measurement points (see Figure 4.8).

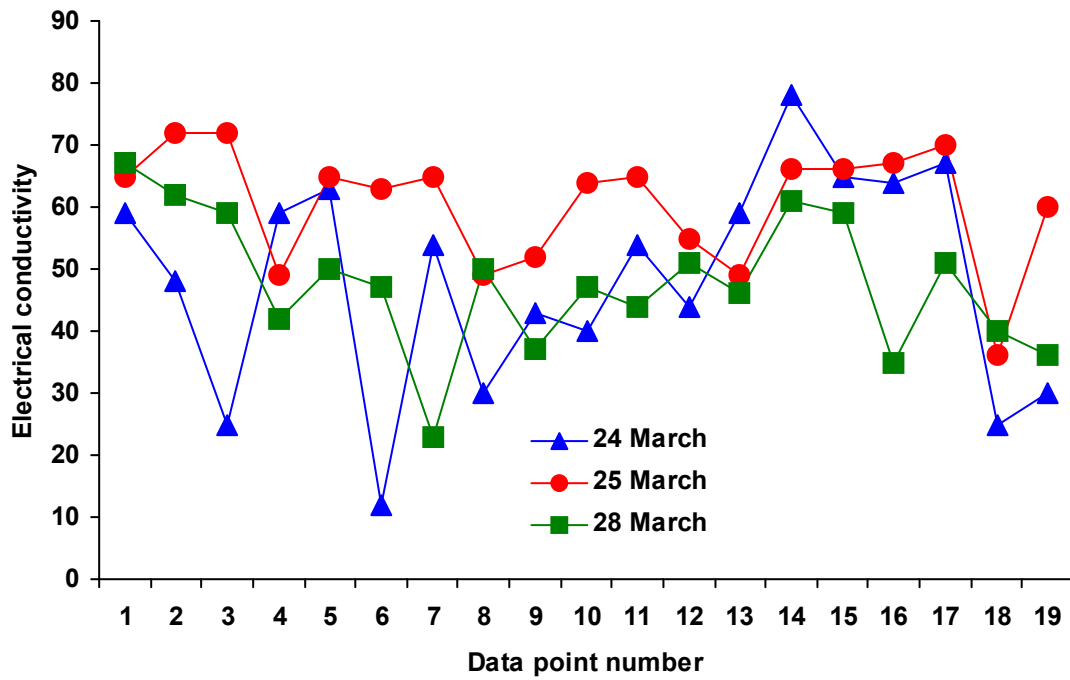
Although the 'lighter' coloured mortar at the left side was dry, there were within it some patches of 'darker' mortar. These were found to have measurable electrical conductivity (Figure 4.5) and were therefore damp. The 'darker' mortar is very impermeable (see Section 4.1.11.3) and hence slower to dry. The remaining wetness in the 'darker' mortar patches may indicate that the subsurface at the left side of the gable is damp, although its surface is dry.

Figure 4.5 Electrical conductivity of patches of 'darker' mortar embedded within the (dry) 'lighter' mortar at the left side of the gable (data in March 2003).

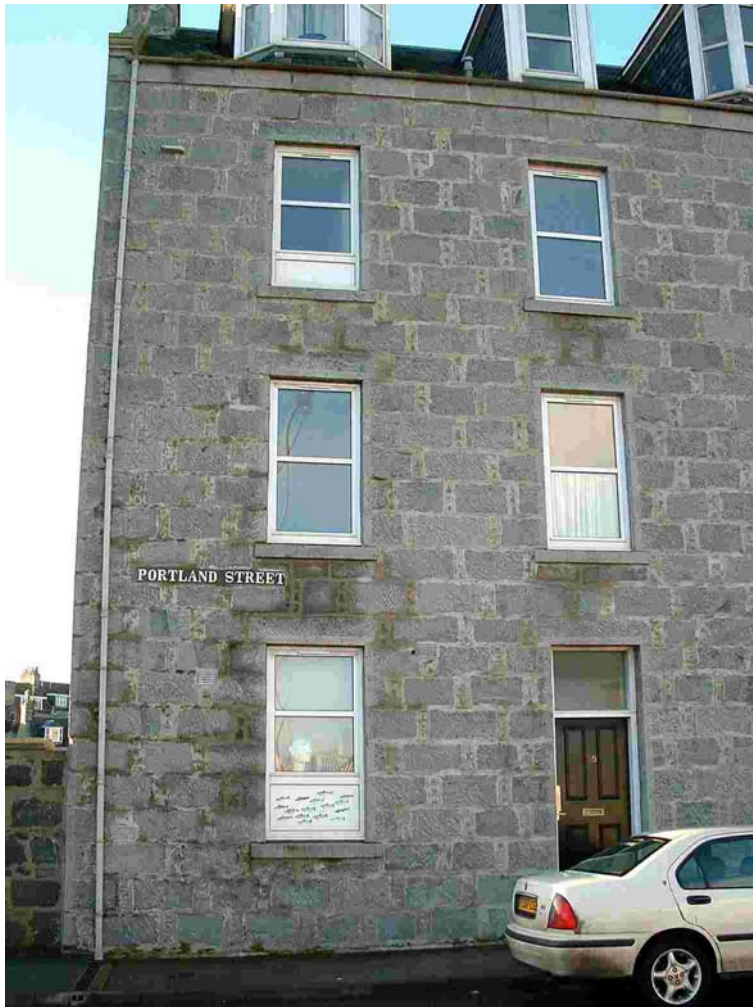
On the 24th March 2003 a series of readings of electrical conductivity were made across the front façade (Plate 4.32). Many areas on the façade were found to have measurable electrical conductivity (Figure 4.6) indicating that the pointing was damp (again, patches of 'darker' mortar had higher levels of dampness). Relatively lower readings on the façade than on the gable implied that the pointing mortar on the façade was not generally so wet as that on the gable. The highest readings (i.e. highest levels of dampness) were found at the left end of the façade, adjacent to the gable and around the leftmost window. Dampness was lower, but still detectable over the remainder of the façade. However, conductivity readings taken on the adjacent façade were all zero, indicating no significant dampness in its pointing mortar. The adjacent façade had a visually different, greyer pointing mortar.

Plate 4.32 Front façade of case study eleven (photographed in January 2003).

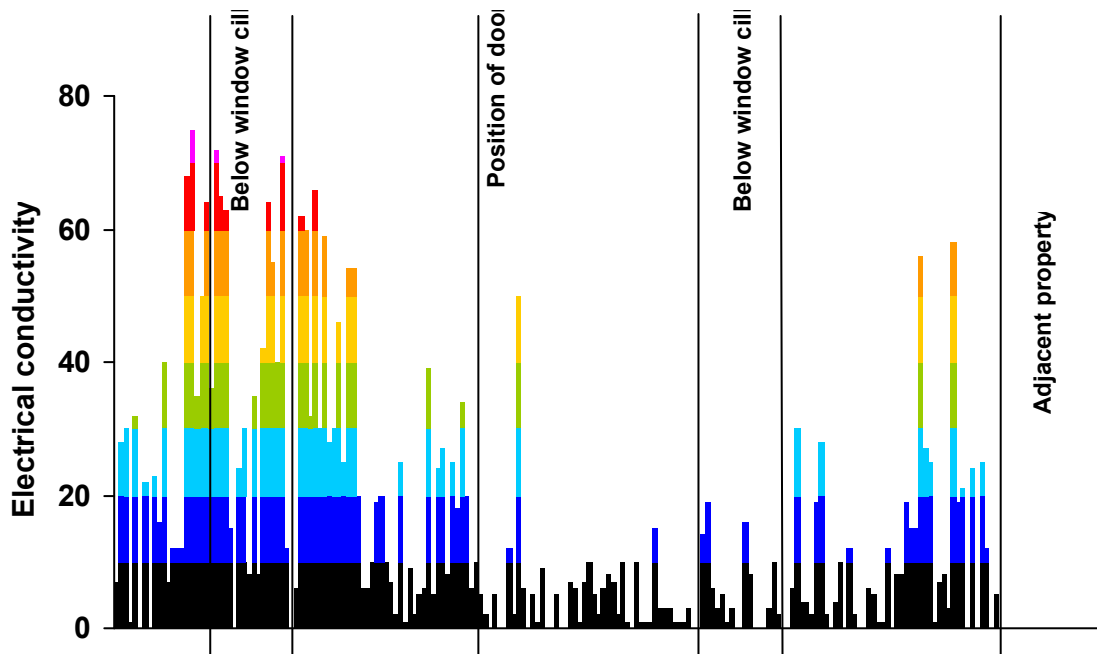
Figure 4.6 Electrical conductivity across the front façade. This includes readings on 'lighter' and 'darker' mortar areas. Both types were damp, but 'darker' mortar was generally wetter. Pinks and red indicate high water saturation, blues and blacks low water content. Readings of zero indicate no significant water content. The positions of windows and the doorway is indicated.

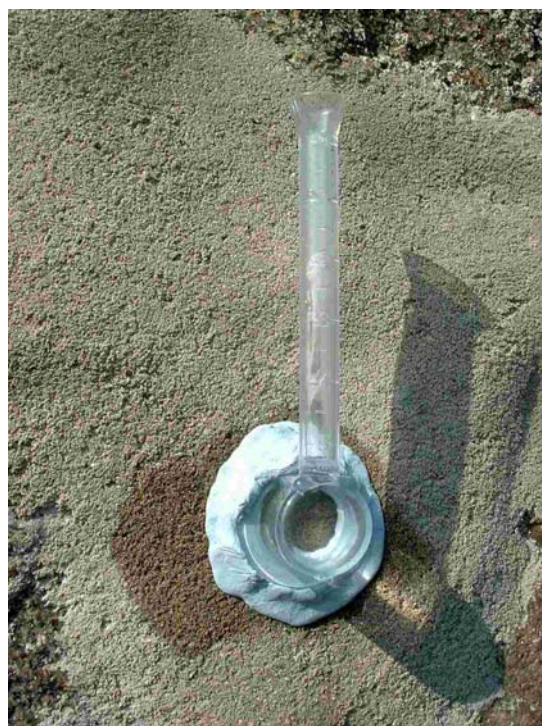
Plate 4.34 After Run 6 showing spread of water after 5mL absorption. Most water has gone deeper into the mortar; only a small proportion is visible on the surface.

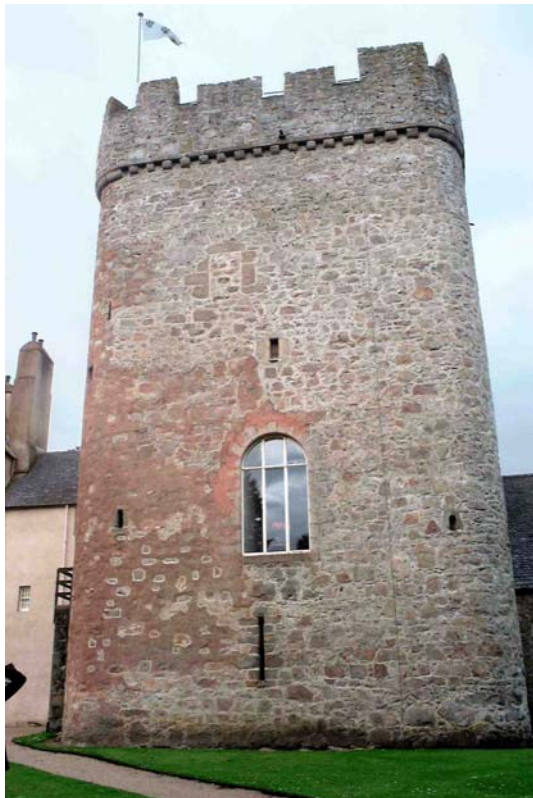
Damp problems in the 13th century keep at this castle were examined. The tower was originally harled and some remnants of the original harling can still be seen. The walls are very thick and it is likely that these have become saturated with moisture which has easy access to the interior since the loss of the original harling. Moisture will move down through the walls, accumulating at lower levels where the internal problems have been observed.

Plate 4.35 East wall of the 13th century keep at case study twelve. The keep was originally harled and some residue of this can be seen on the left.

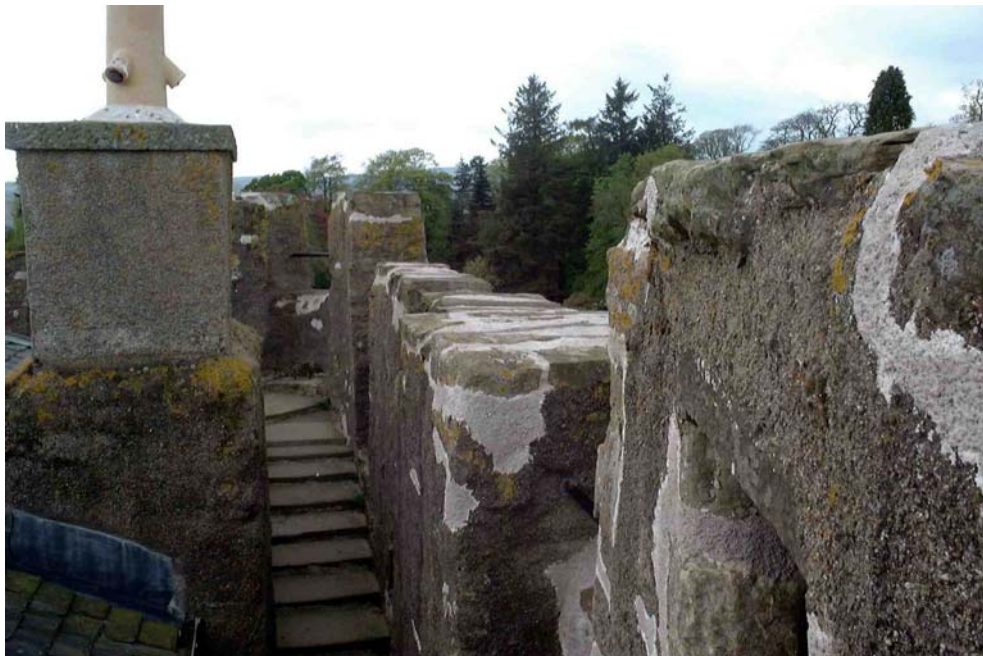
Plate 4.39 Roof of keep. The roof is well maintained and drainage is provided to minimise rainwater penetration into walls.

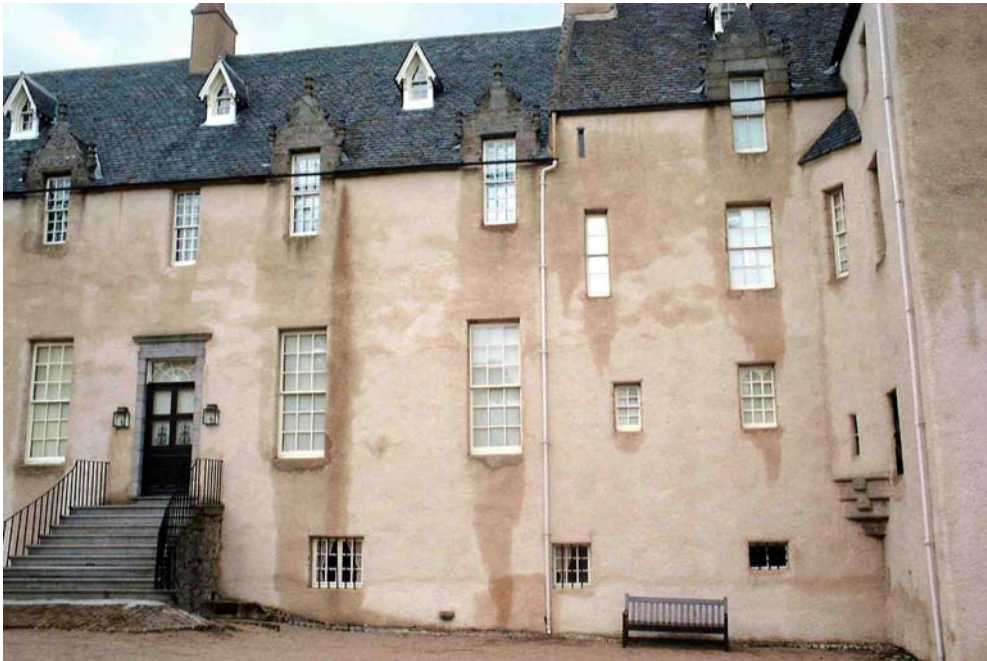
Plate 4.40 The adjoining 17th century mansion house is harled.
