| 5. Site Details | | |
|---|---|--|
| 5.1 | <p>What name would you like the site to be known by?</p> <p>(Please note if the site is currently included within the ALDP2017 please use the OP site number)</p> | Rigifa Farm, Cove |
| 5.2 | Site Address | Land to the east and south of Cove Road<br>Cove<br>Aberdeen |

**DEVELOPMENT BID FOR SITE AT  
RIGIFA FARM, COVE  
LANDSCAPE APPRAISAL**  
on behalf of Mactaggart & Mickel

ABERDEEN CITY LOCAL DEVELOPMENT PLAN  
2018

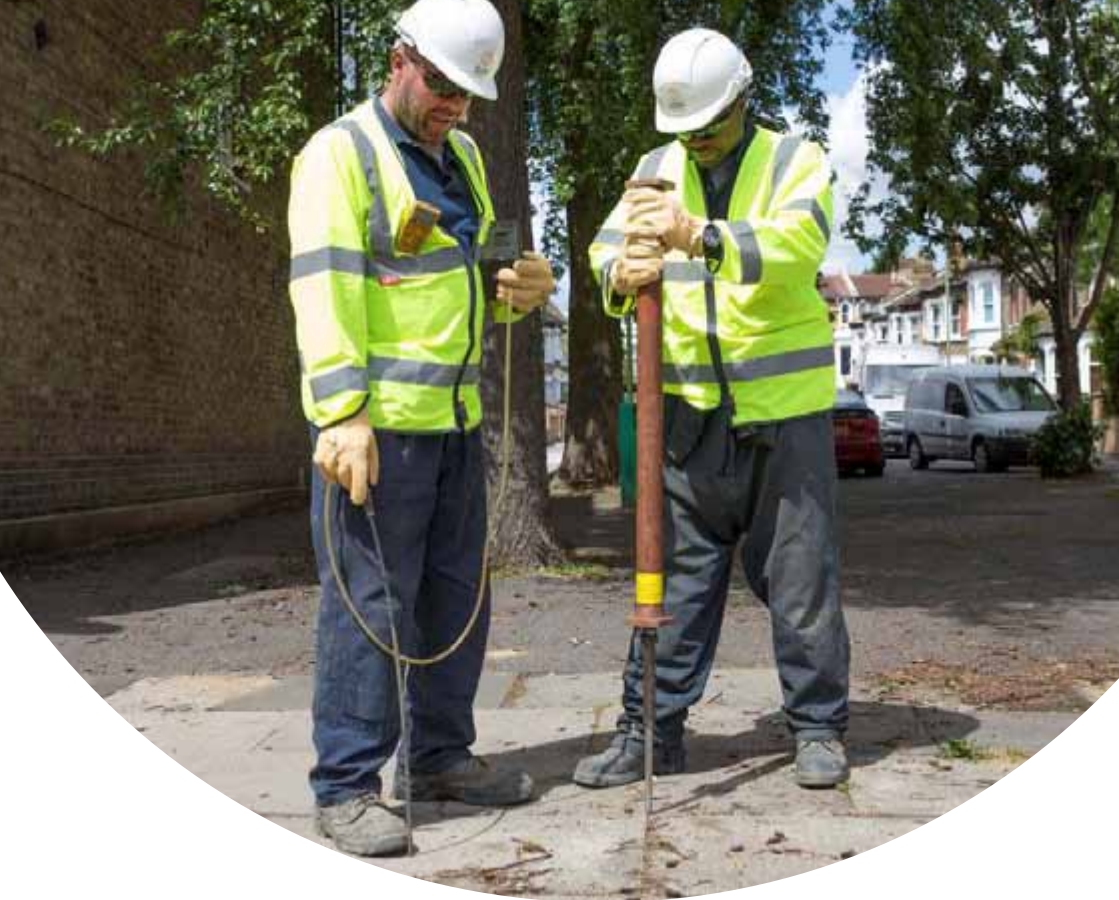
Adequate protection, approved by us, MUST be applied for any deep excavations in the vicinity of our gas mains and services that may affect its security and integrity. Ground movement around gas mains MUST be prevented. We MUST be contacted if a sewer trench or any other water authority is to be constructed at greater than 1.5 metres depth near a buried gas main or service pipe. You MUST give us detailed drawings showing the line and width of the proposed sewer or other trench, together with the soil group classification of the area concerned.

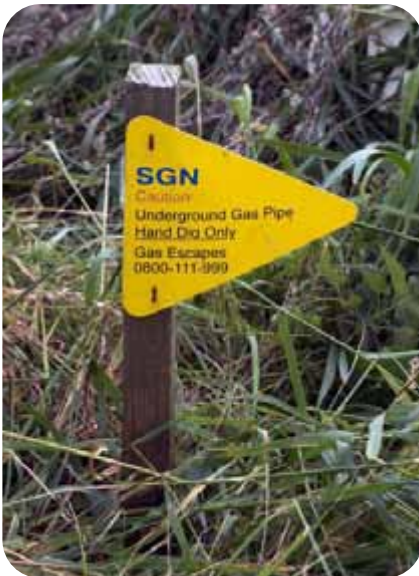
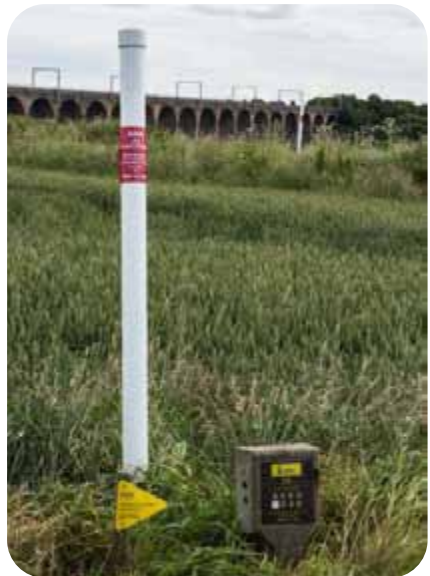
Pipeline markers

**No work is to take place near an HP pipeline until it is agreed with us.** After agreement and before any work does take place, the location of our pipeline **MUST** be marked up and its position confirmed by digging trial holes with our personnel in attendance.

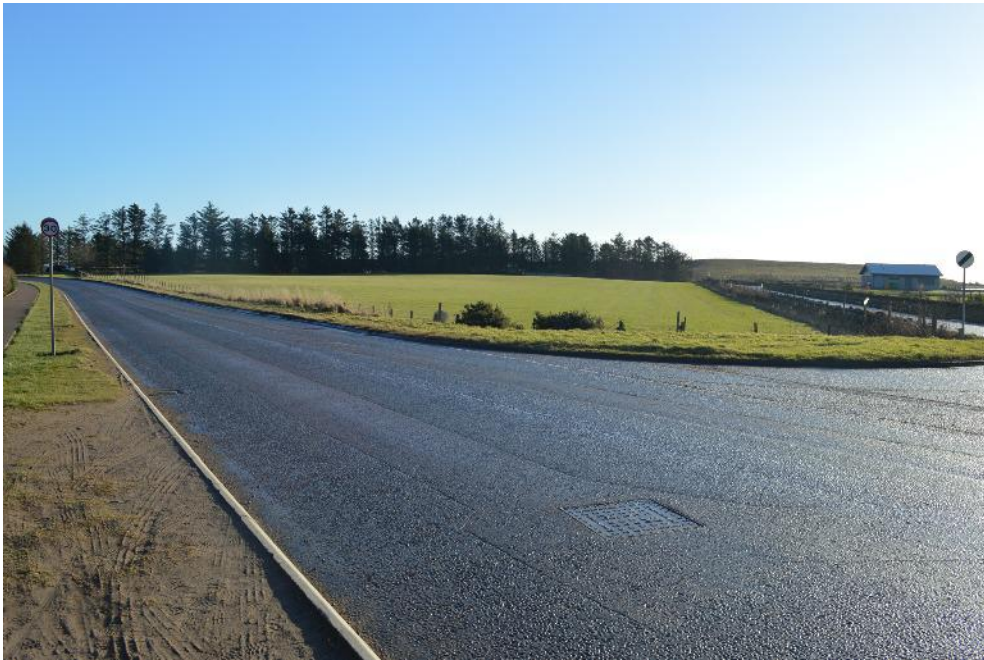
Area 3 open to view and to the elements on two sides

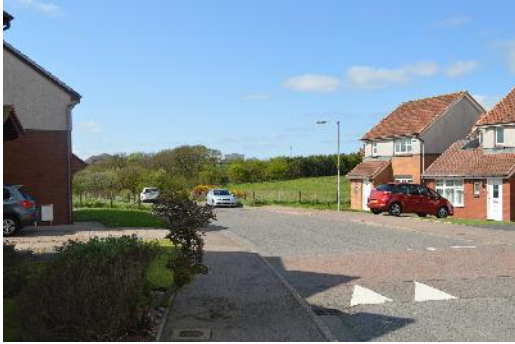
Coastal path links east of Area 1

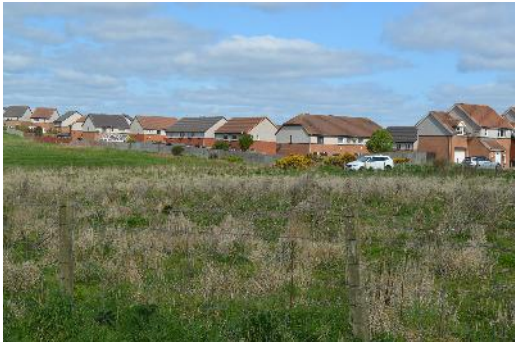
existing cul-de-sac links to the site

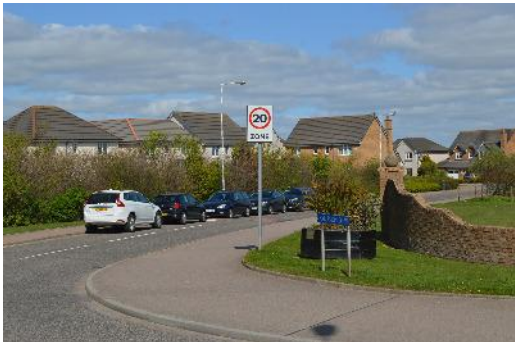
Area 1 bounded by existing houses

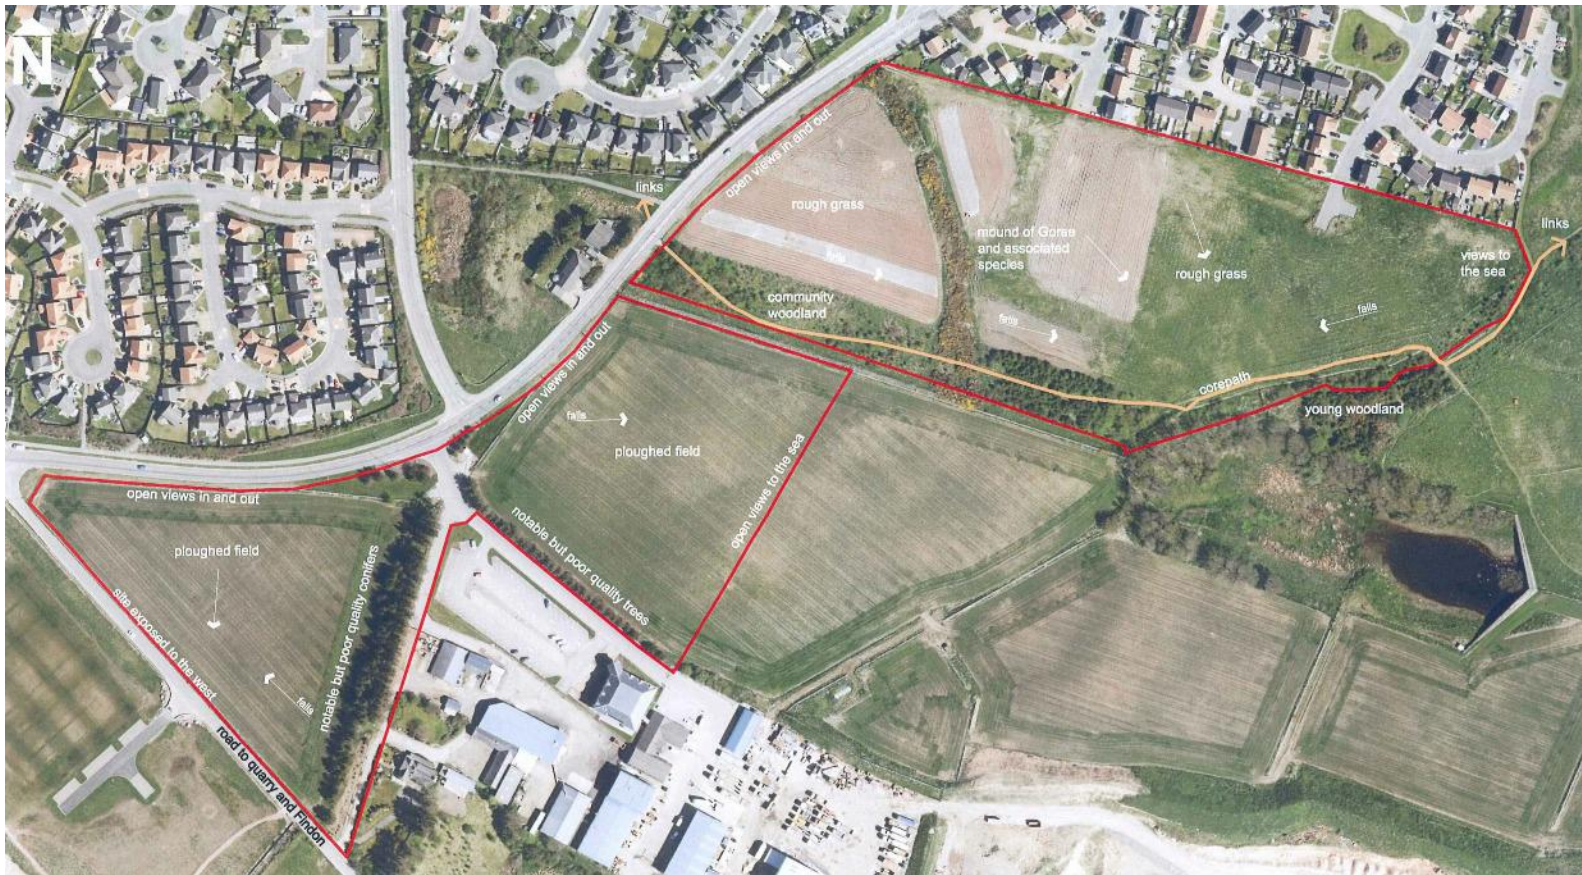
### KEY APPRAISAL POINTS

- site surrounded on 3 sides by residential and commercial development
- gently sloping ground presenting no difficulty for housing development
- boundaries of stone dykes and fences containing shelterbelts and visual screen planting that with some degree of enhancement could visually absorb new development
- site is a destination and hub for a well developed footpath network through Cove, including corepath 78, the coastal path northwards from Cove
- the surrounding residential properties are both visually connected and at the same time exposed to the site

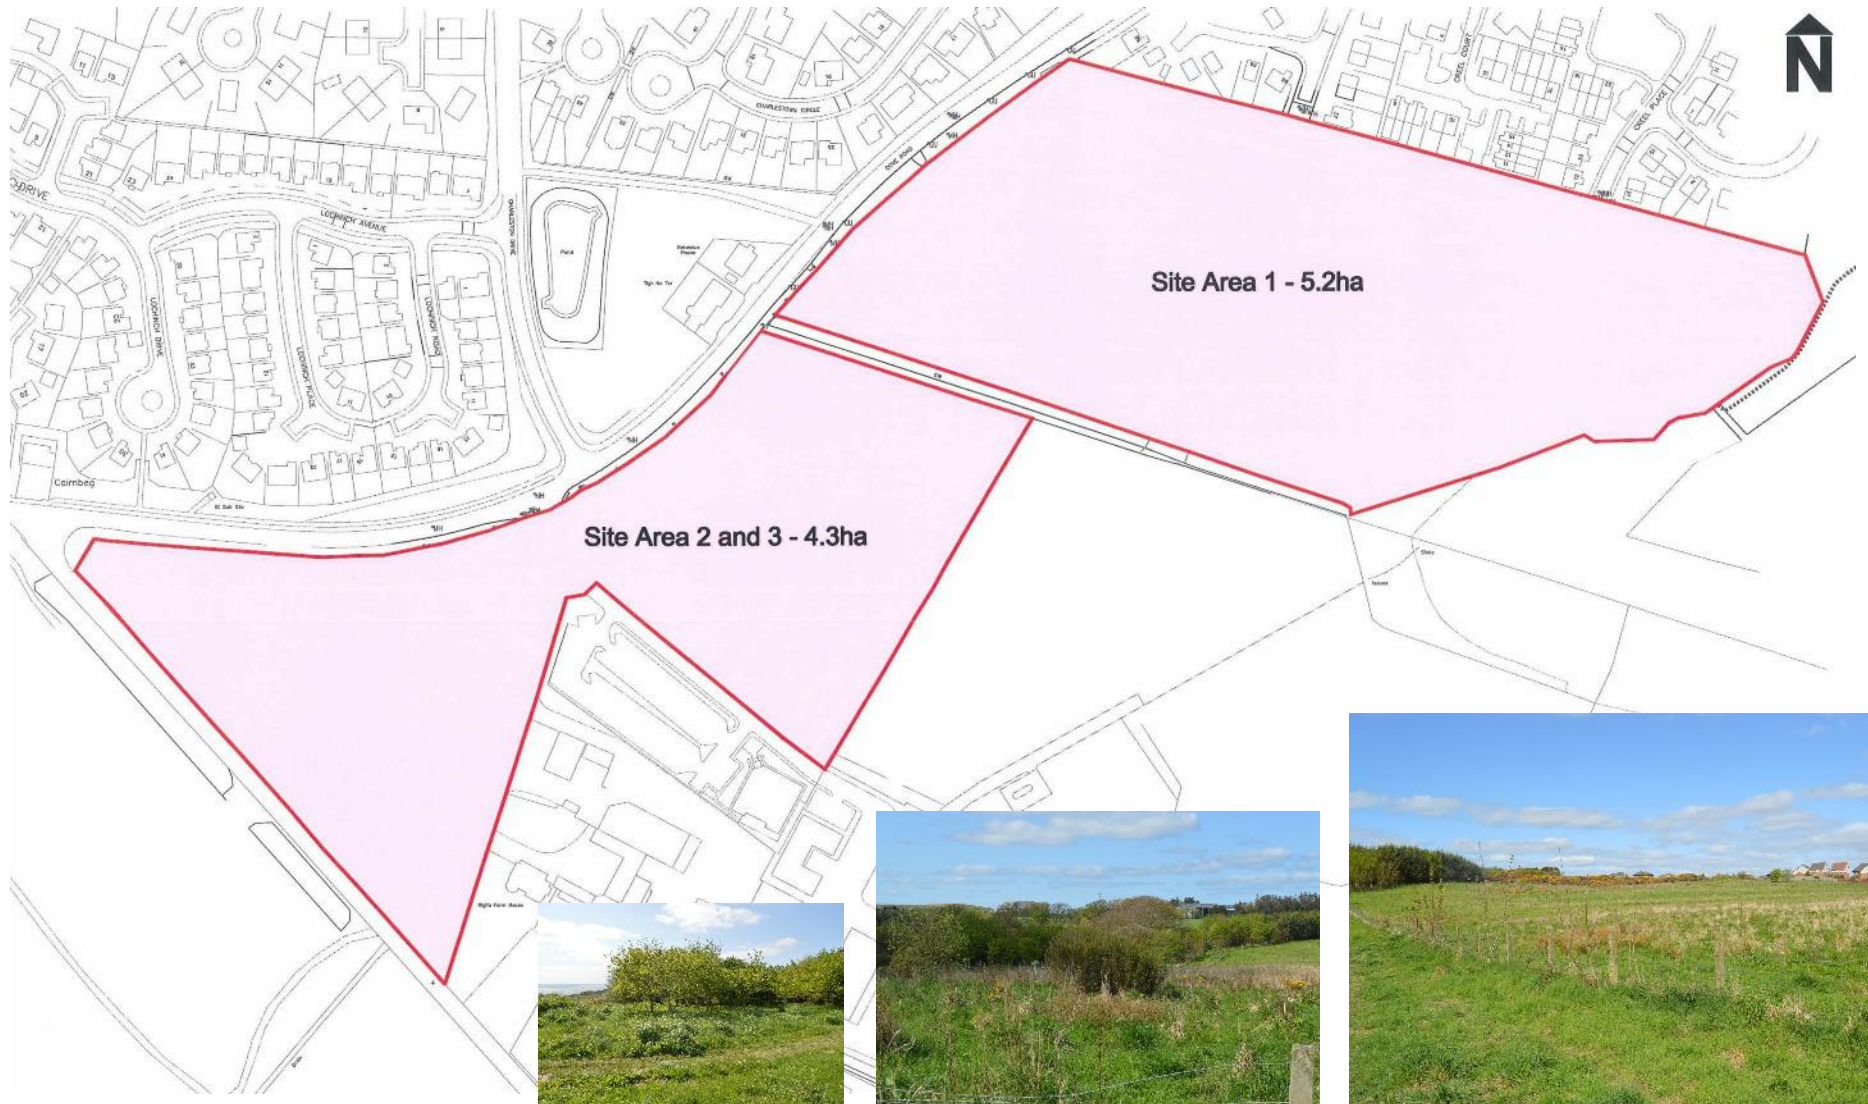
5.0 development site plan

- site area 9.5 ha
- 123 open market houses
- 41 affordable houses
- “Designing Streets” layout

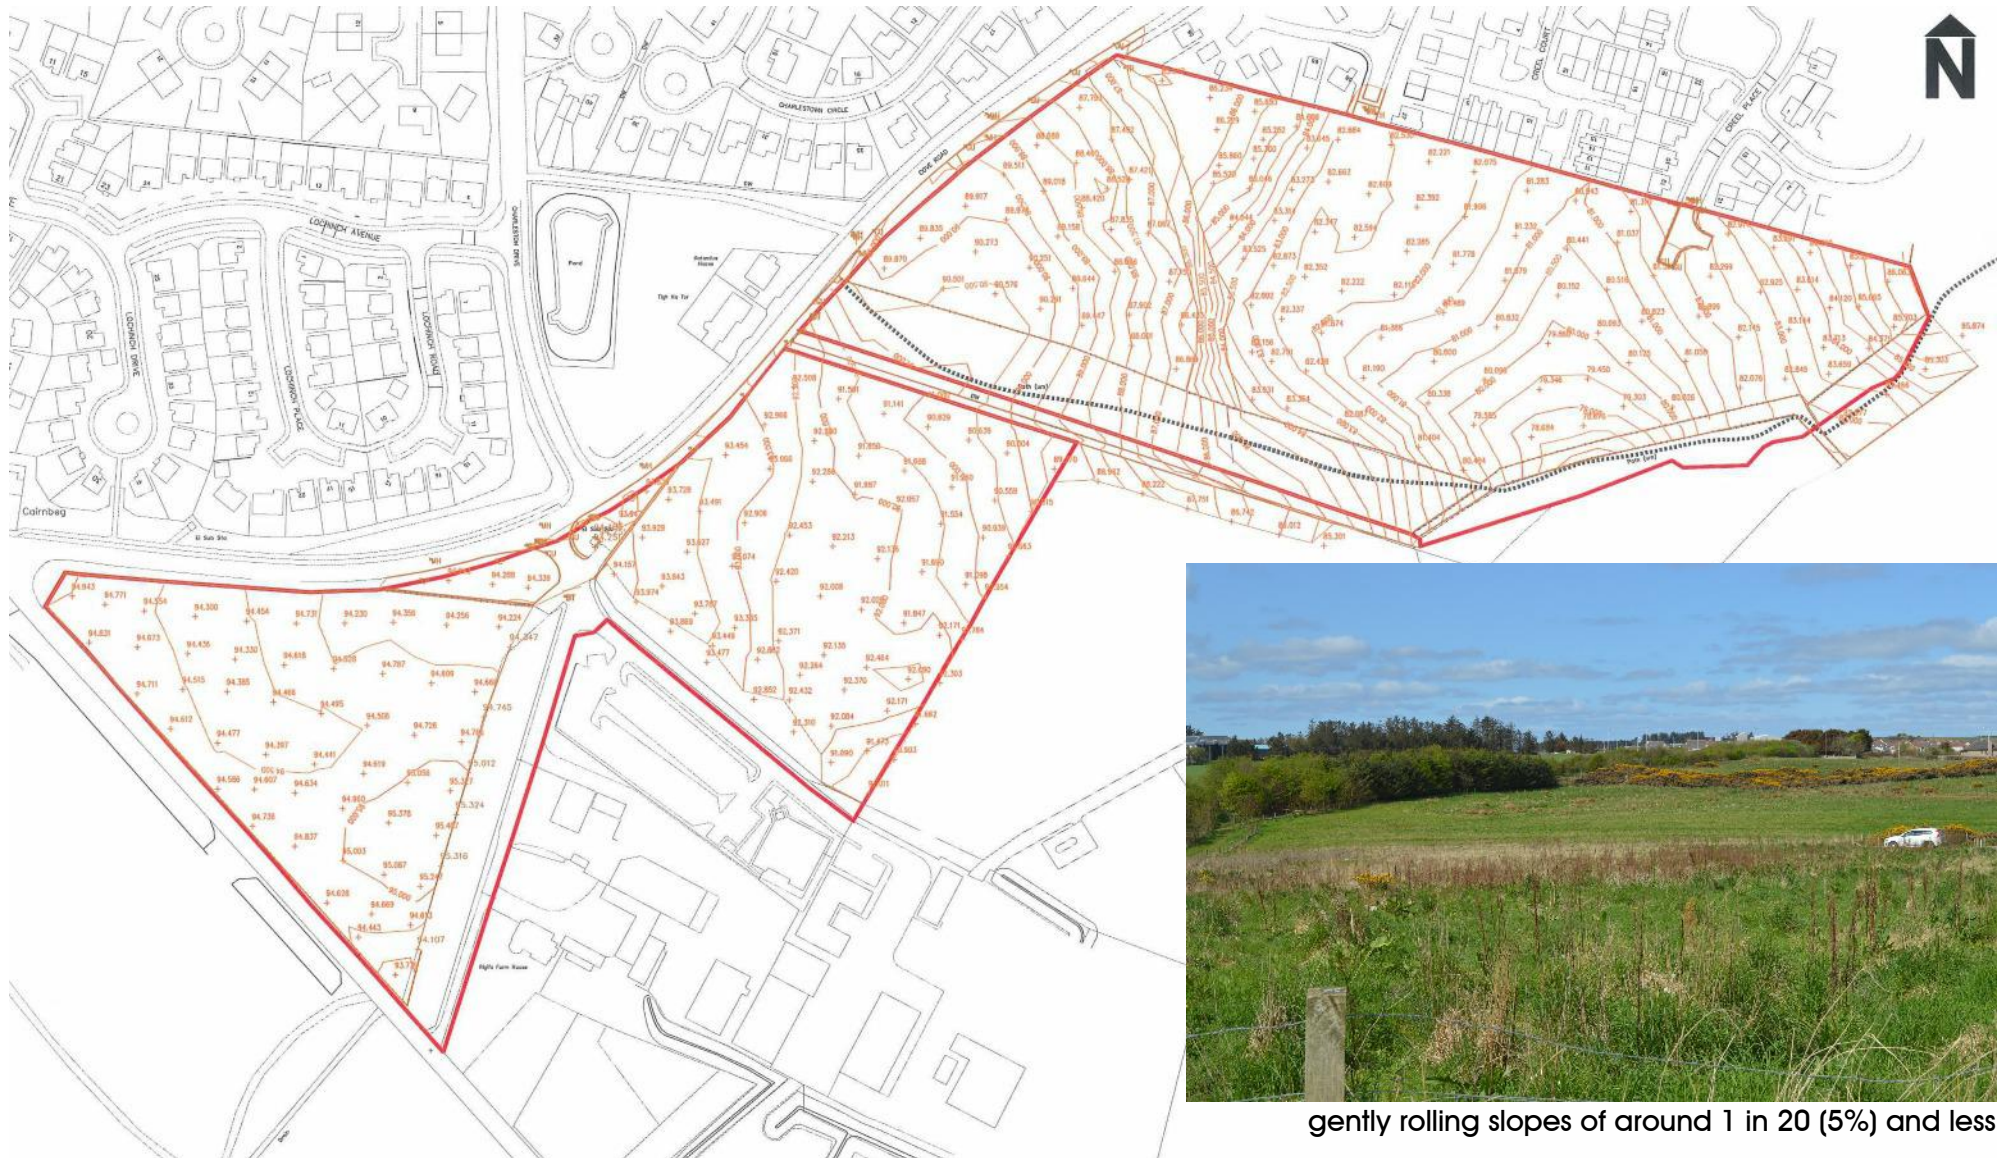
**6.0 topography**

gently rolling slopes of around 1 in 20 (5%) and less

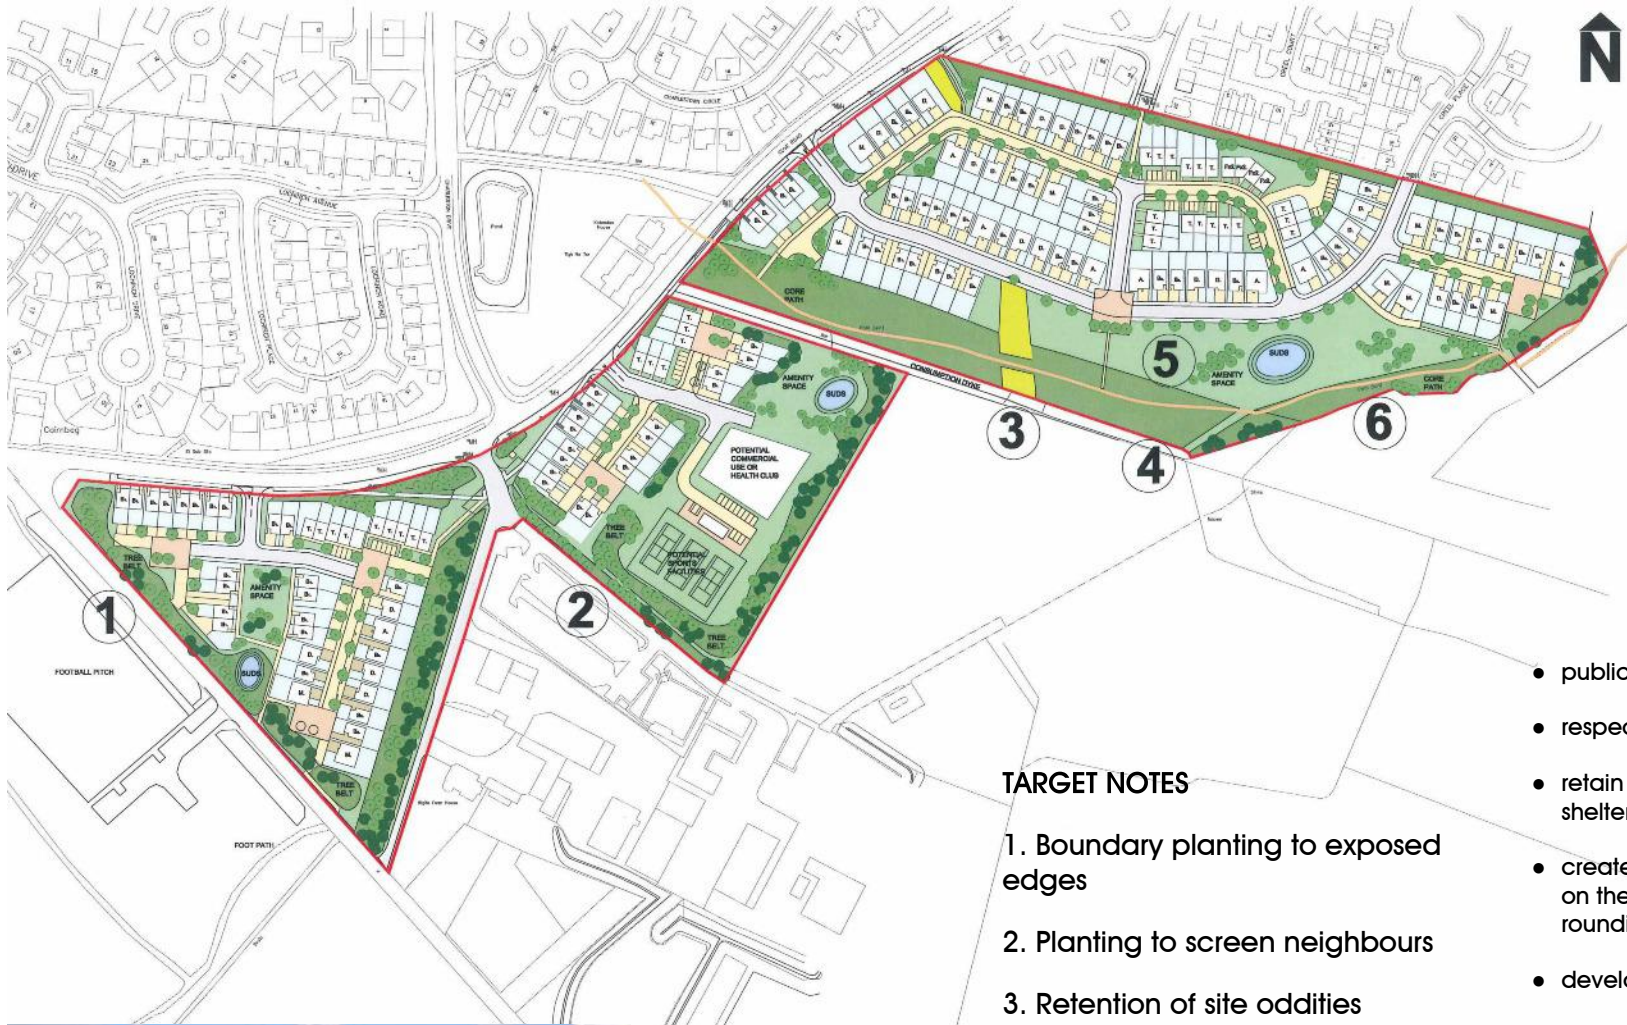
## 7.0 landscape masterplan

## key features

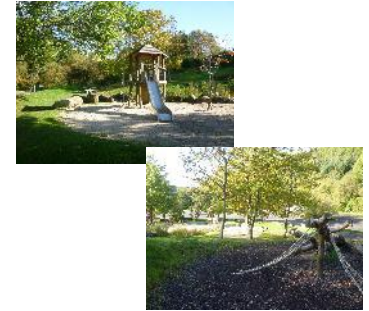
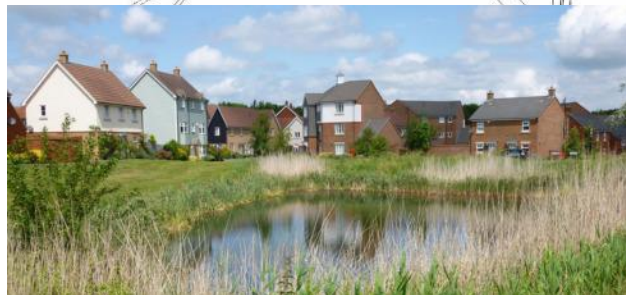
1. Boundary planting to exposed edges
2. Planting to screen neighbours
3. Retention of site oddities
4. Add to mix of species to enhance woodland walk
5. Use the introduction of SUDS to create diverse amenity spaces
6. Bolster young native woodland with additional planting

- public open space in excess of 40%
- respecting site topography
- retain and enhance woodland blocks and shelterbelts
- create new blocks of woodland particularly on the boundaries to extend the surrounding vegetation into the site
- develop strong tree structure within the site
- retain and enhance sea views
- Incorporate “natural” play area(s)
- existing corepath enhanced
- shelterbelt management by introducing a mix of species

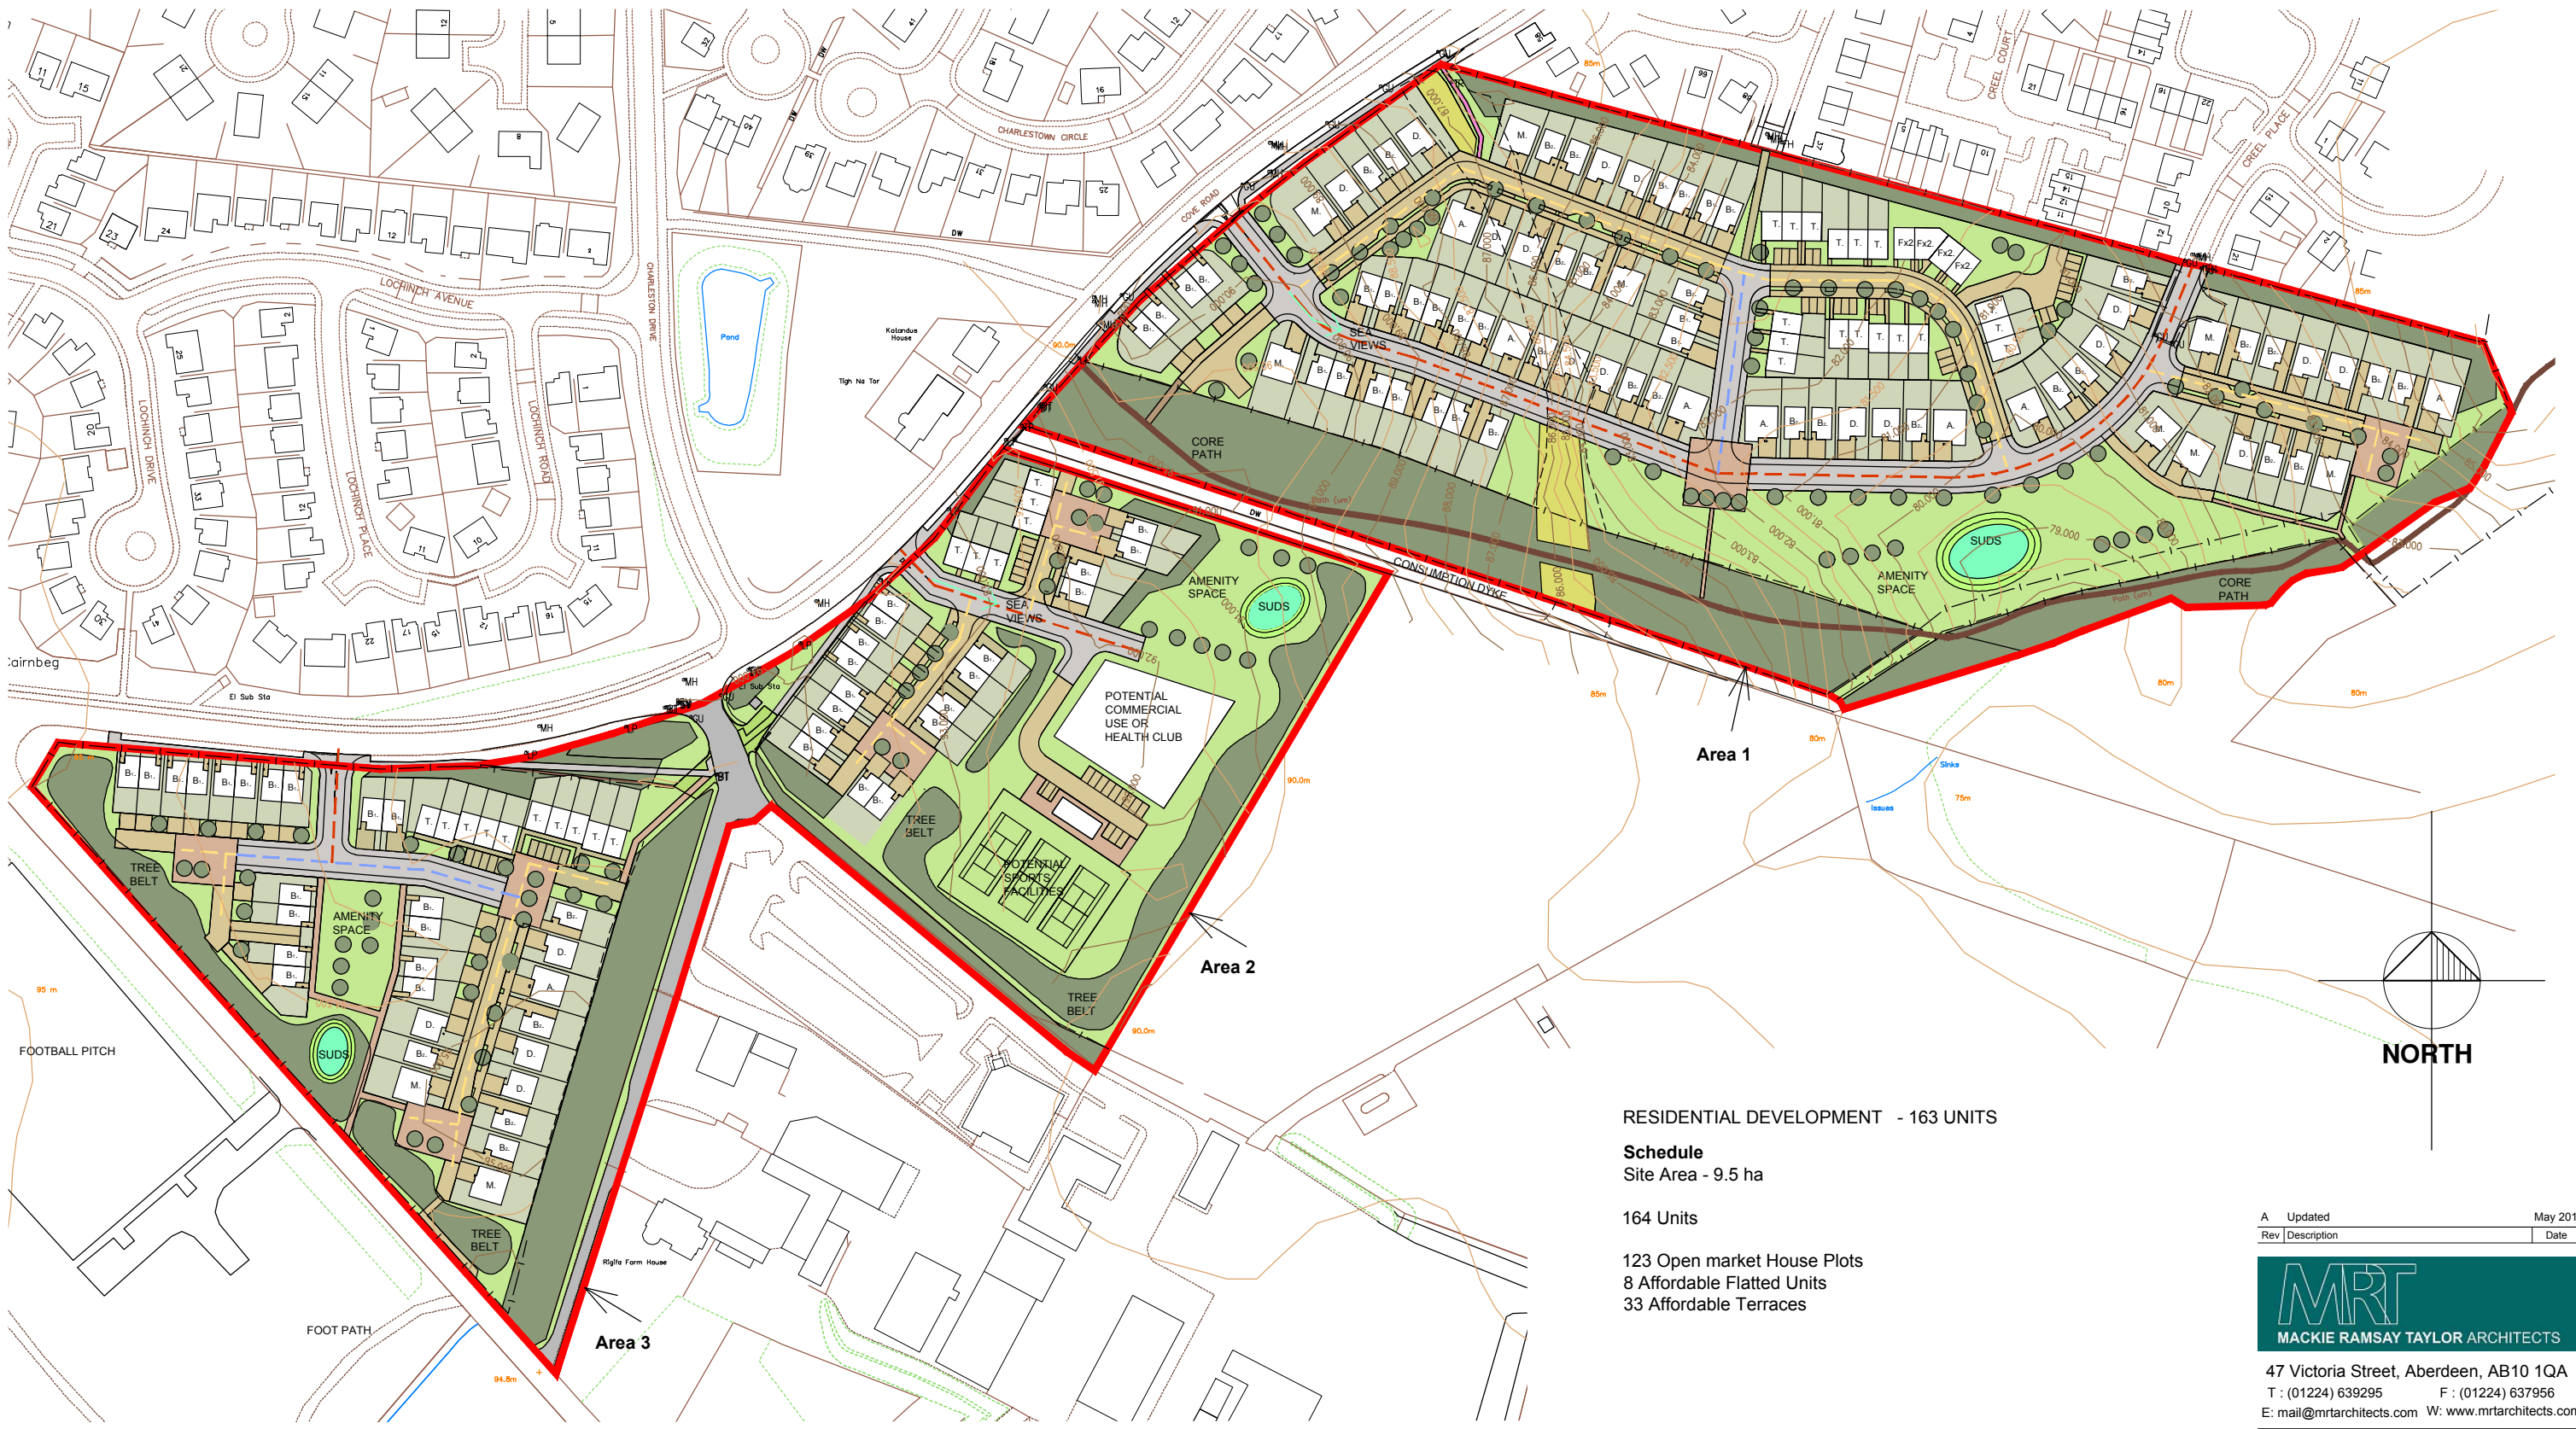
- ROAD TYPE 1 - 2m/ 6m/2m (PRIMARY ROAD)
- ROAD TYPE 2 - 2m/ 5.5m/2m (SECONDARY ROAD)
- ROAD TYPE 3 - 2m/ 4.8m/1.2m/2m (TERTIARY ROAD)

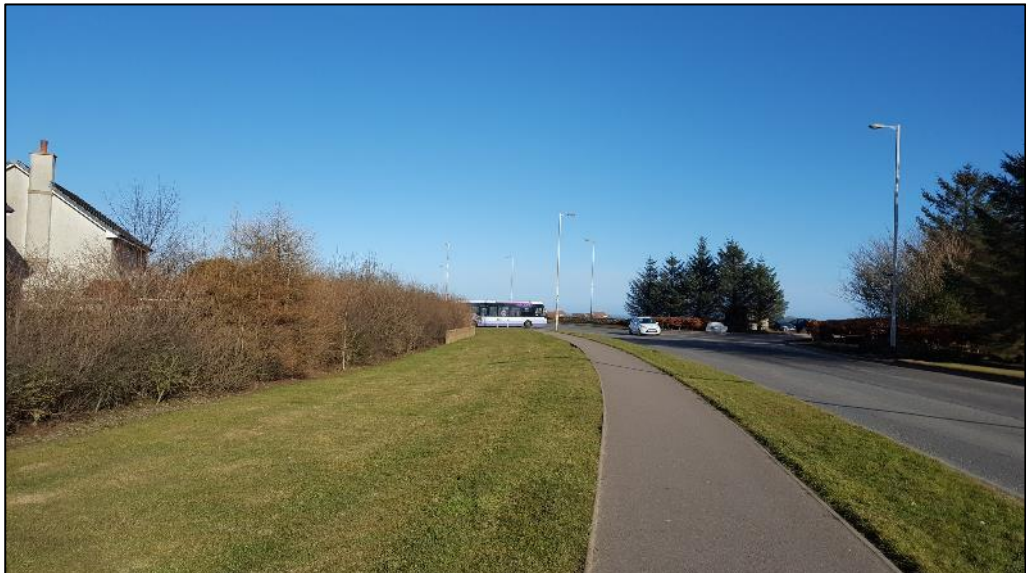
*Footway on northern side of Cove Road*

2.3 There is a footway on the northern side of Cove Road as it passes the proposed allocation site. This footway provides a link to existing residential areas served to the north of Cove Road. There is a footway on the southern side of Cove Road, but its western extent is at the western edge of the existing houses served by Creel Road immediately to the east of the proposed allocation site.

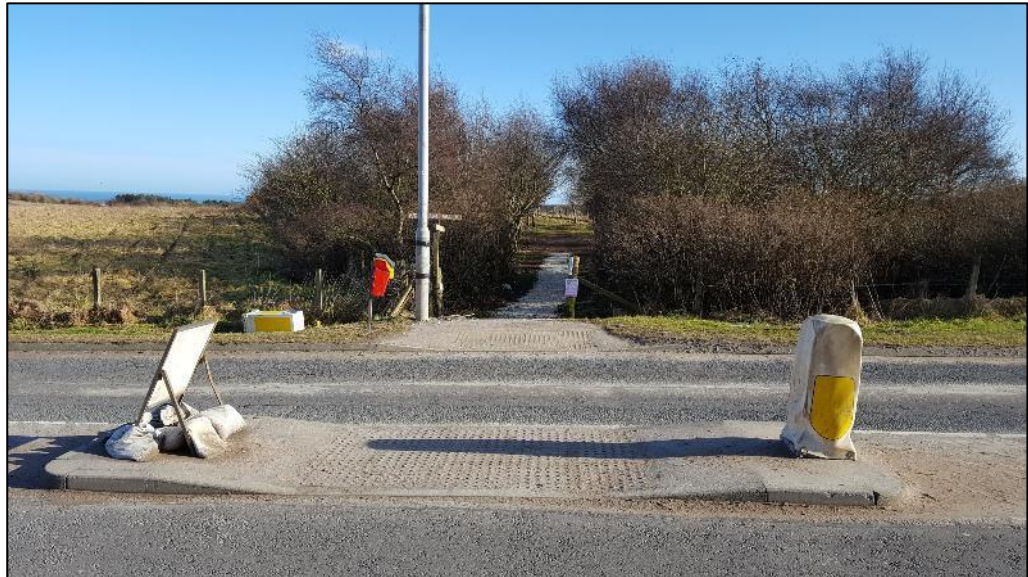
*Core Path 78 to south of Cove Road*

- 2.5 Core Path 78 leads southwards from Cove Road and passes through the proposed allocation site. A copy of the Core Path plan is provided in Appendix B. Core Path 78 provides a route to the residential areas served from Cove Crescent and Cove Gardens and emerges on Cove Road at the junction with Loriston Road, where there is a local shop. It would be around an 11-minute walk (around 950m) from the eastern edge of the proposed allocation site to this shop.

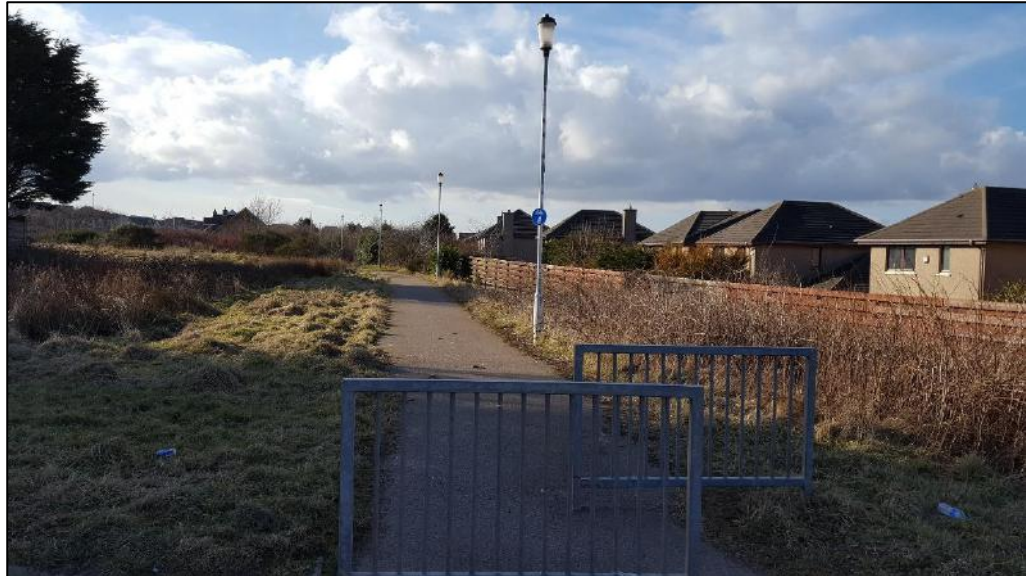
*Shared-use path north of Cove Road*

- 2.6 A shared-use pedestrian and cycle path leads from the north of Cove Road (in the vicinity of where Core Path 78 meets it) and emerges onto Charleston Drive around 130m north of its junction with Cove Road. This would provide a more direct route for pedestrians between the part of the proposed development north of Core Path 78 and the existing residential area served from Charleston Drive.

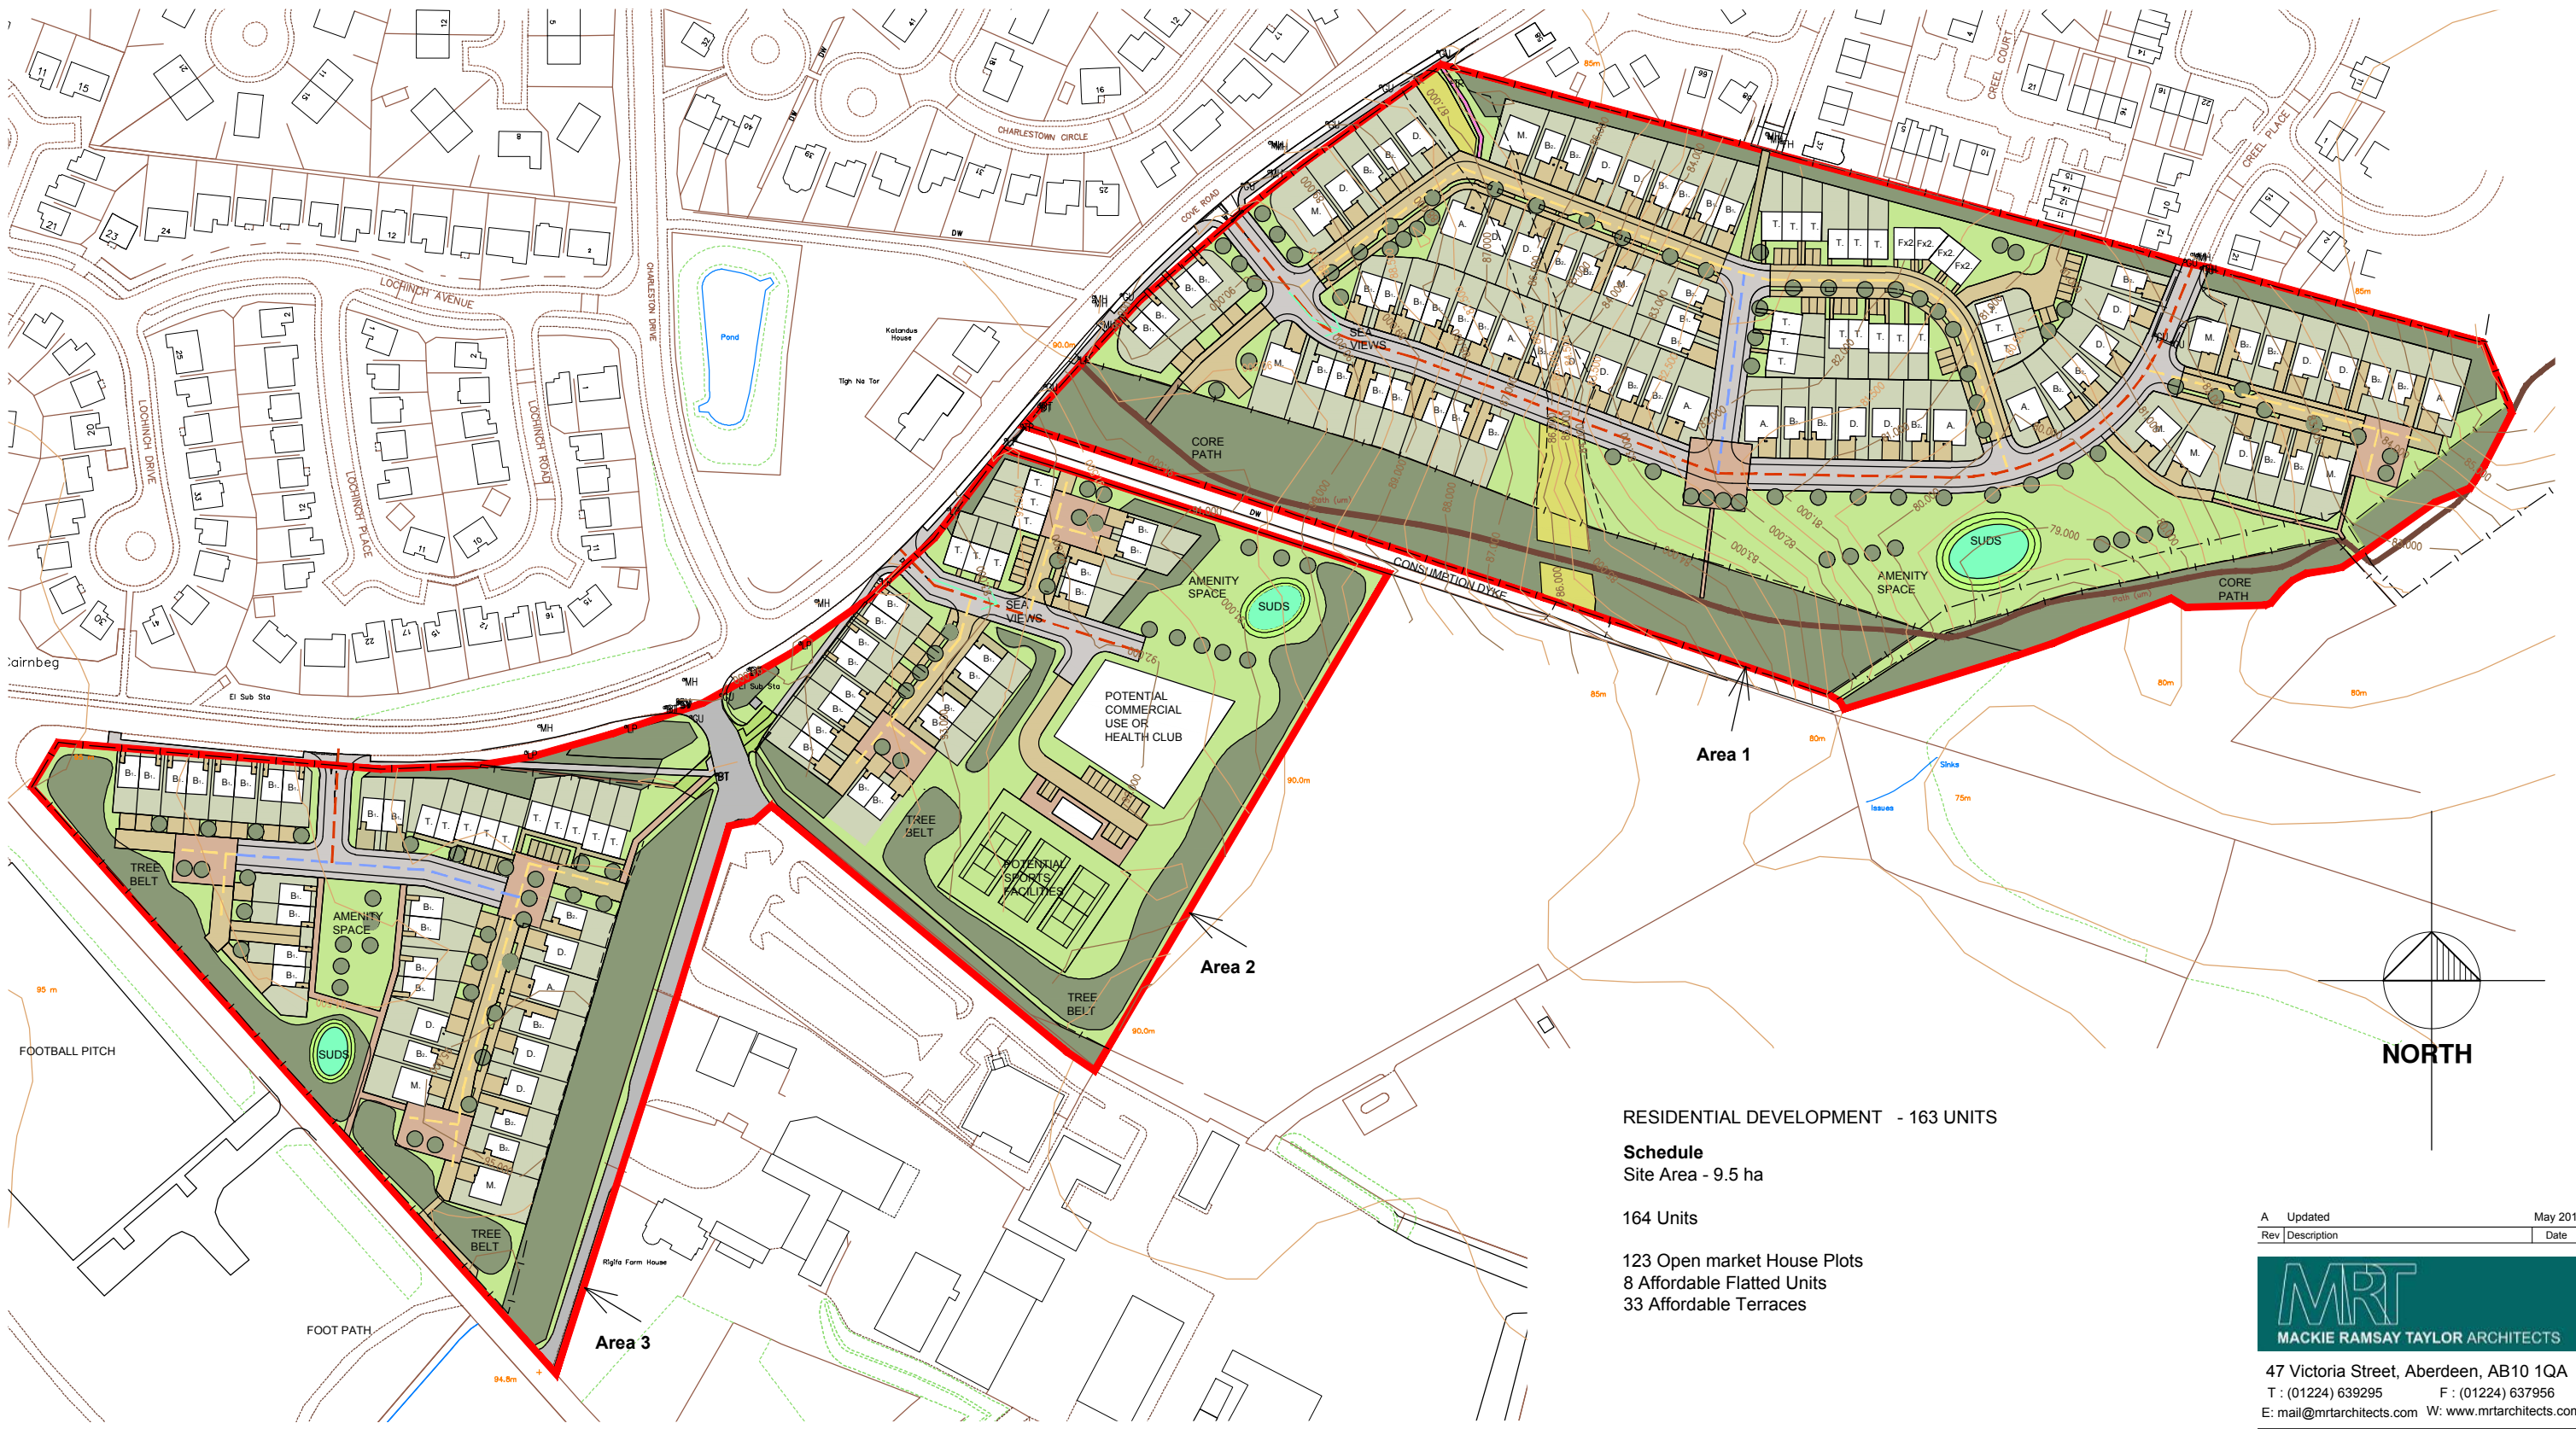
| Project No.<br>2064 | Drawing No.<br>L(00)011 |

- ROAD TYPE 1 - 2m/ 6m/2m (PRIMARY ROAD)
- ROAD TYPE 2 - 2m/ 5.5m/2m (SECONDARY ROAD)
- ROAD TYPE 3 - 2m/ 4.8m/1.2m/2m (TERTIARY ROAD)
